- **Level 2 Tree Risk Assessment Qualification (TRAQ) evaluation dated June 01, 2015**
- **Basic Tree Risk Assessment Form dated May 14, 2015, Tree B**

Re: Level 2 TRAQ Assessment for Two Prominent Coast Live Oaks at Cupertino Senior Center

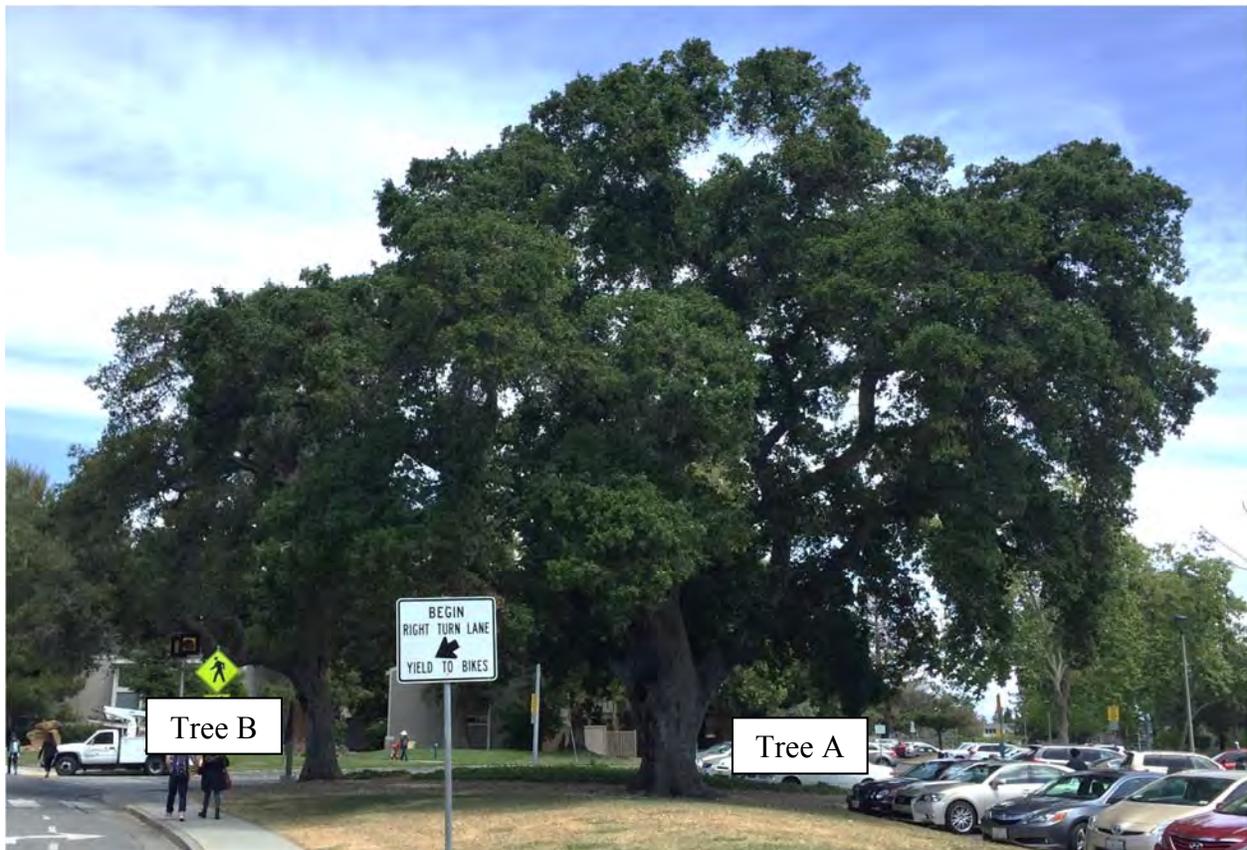
Poor pruning in the past has resulted in lion's tailing² of major branches on both trees (**Image 1**). Copious sprouting has occurred in response (**Images 7, 14**).

This tree is highly vigorous, evidenced by strong shoot extension and a dense, healthy canopy (**Image 1**). All visible defects are surrounded by a great deal of response growth (**Images 2, 3**).

Image 1 – Trees A (right) and B (left), as Seen from Mary Avenue

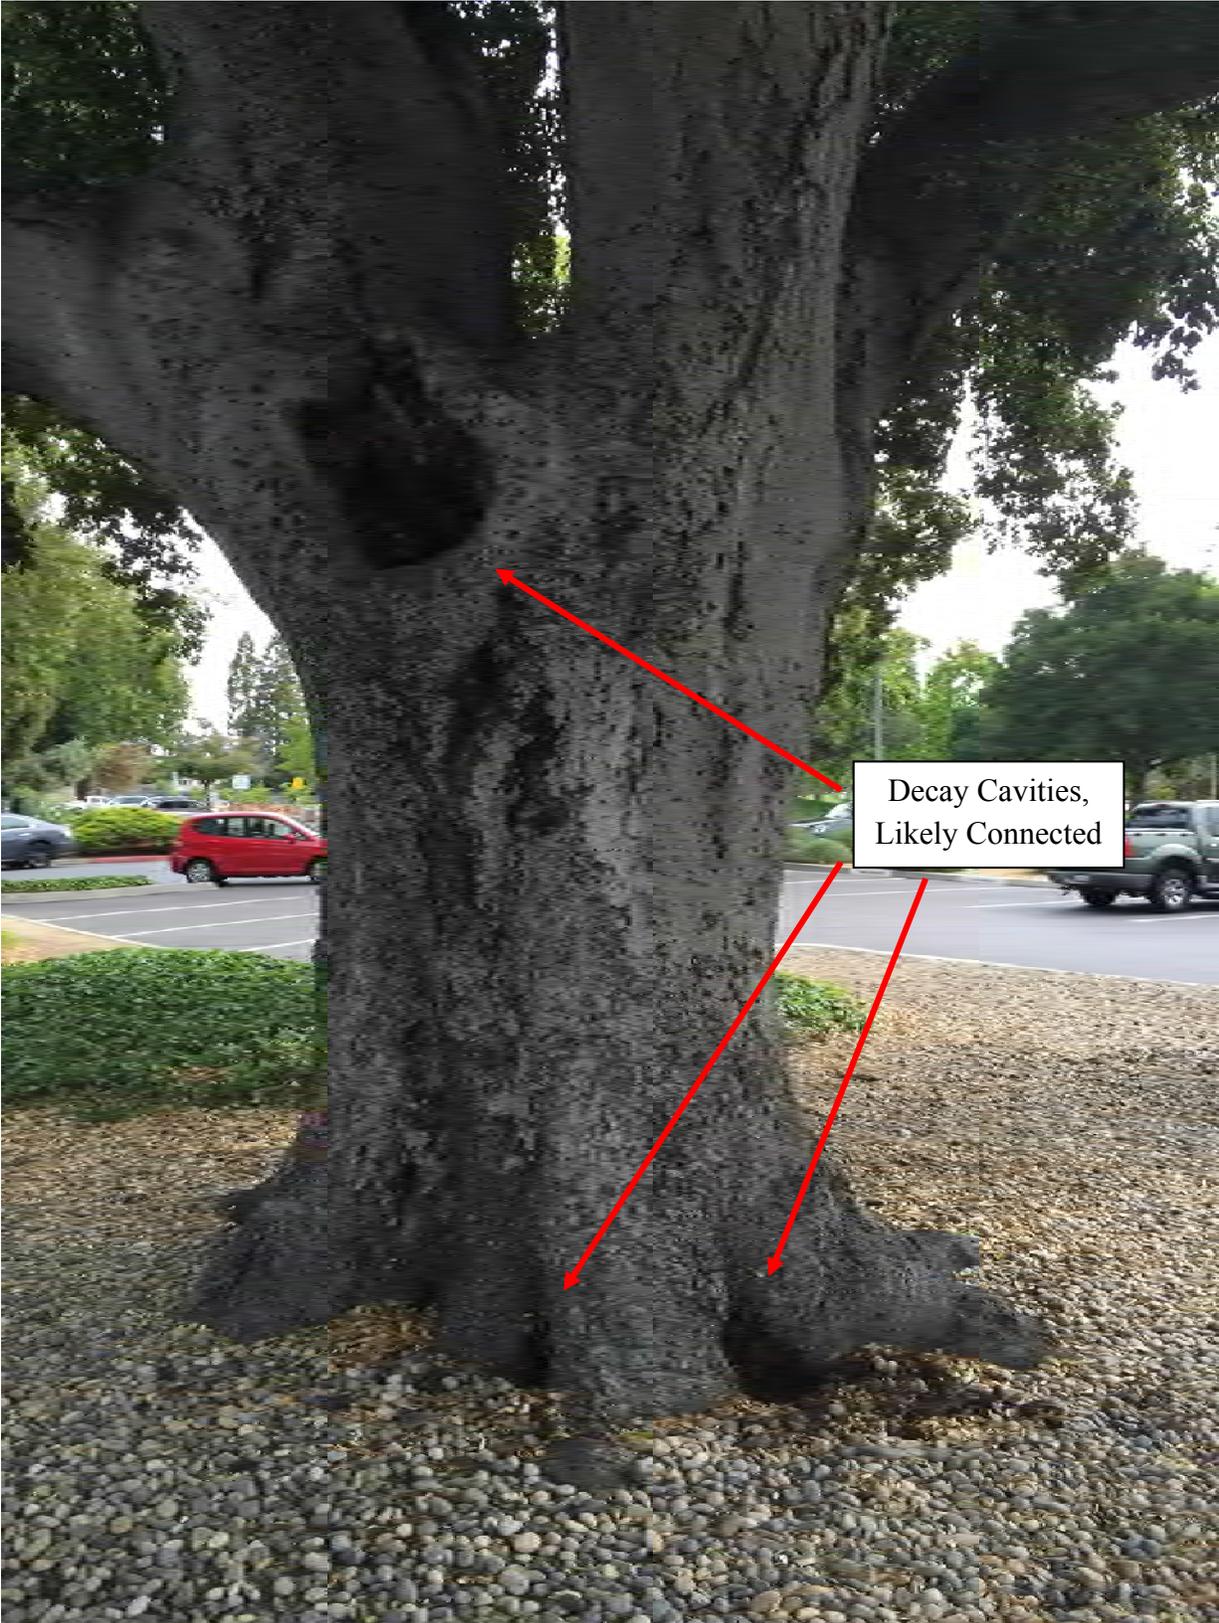
River rock is present around the base of both trees, extending out to the curb and to the dripline³ of Tree A (**Images 2, 5, etc.**). The layer of river rock is several inches thick. Rocks are in contact with both trees' trunks, and some are embedded in the cambium of both trees.

Large decay cavities are present in both trees (**Images 2, 11, etc.**). It is unclear whether these cavities result from limb failures or pruning wounds. All appear many years old.

Two cavities at the base of this tree appear to be connected to a cavity approximately eight feet above grade by a column of decay (**Images 2, 3, 4, 5**). Strong response growth is evident along the full length of this area (**Image 2**).

Response growth around the decay cavities present in this tree appears sufficient to mitigate the structural weaknesses caused by these defects.

Image 2 – Tree A 8-foot Column of Decay on South/Southwest Side

1. Remove all river rocks under and around these trees. Pay particular attention to the area directly around these trees' trunks.
2. Install wood chips to replace river rocks.
3. Consider other site remediation techniques, such as aeration and radial trenching/composting.
4. Craft a plan to manage the risk posed by Tree B. Options to consider include, but are not limited to: tree removal, pruning, prop installation, root crown excavation, and site remediation.
5. Perform structural pruning on Tree A in order to avoid future structure issues created by sprouting. Timing and extent of pruning is at the discretion of the Arborist of the City of Cupertino.
6. Inspect cables in both trees on a regular basis, and consider replacing with through-bolt hardware.

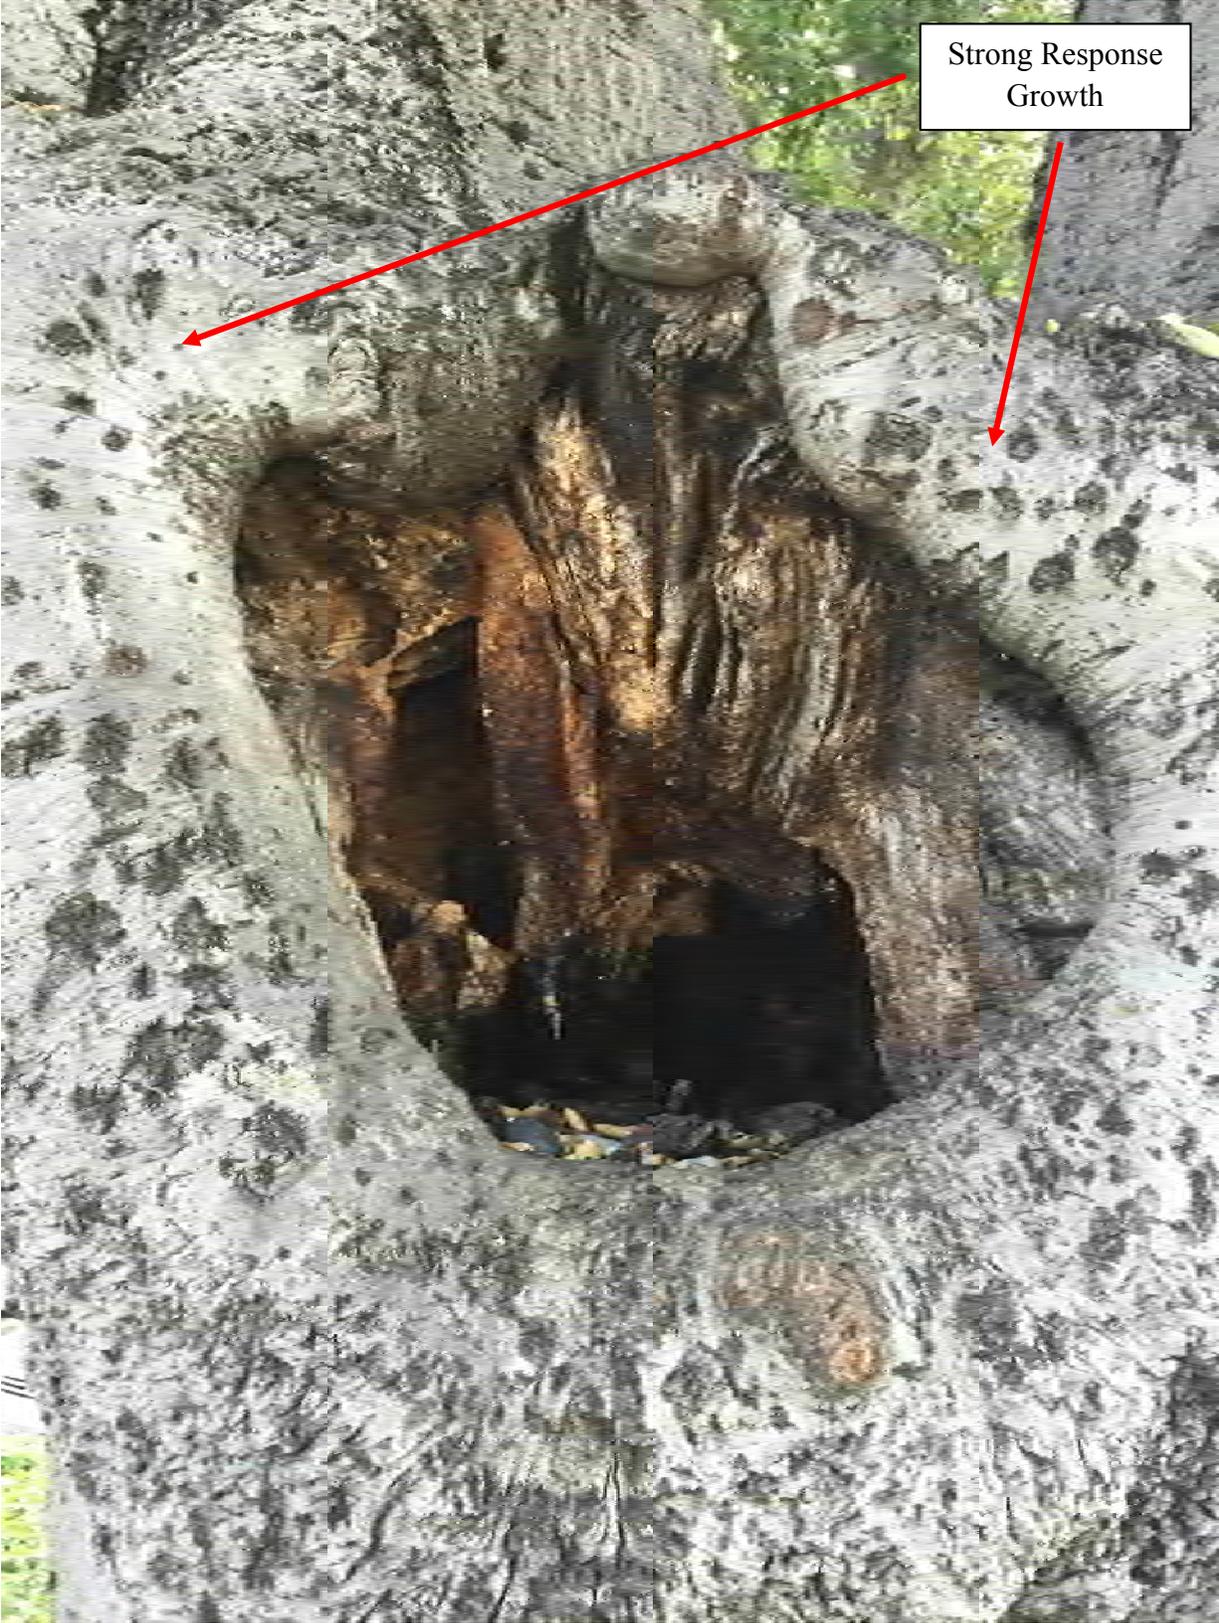
Image 3 – Tree A, Closeup of Decay Cavity in Trunk

Strong Response
Growth

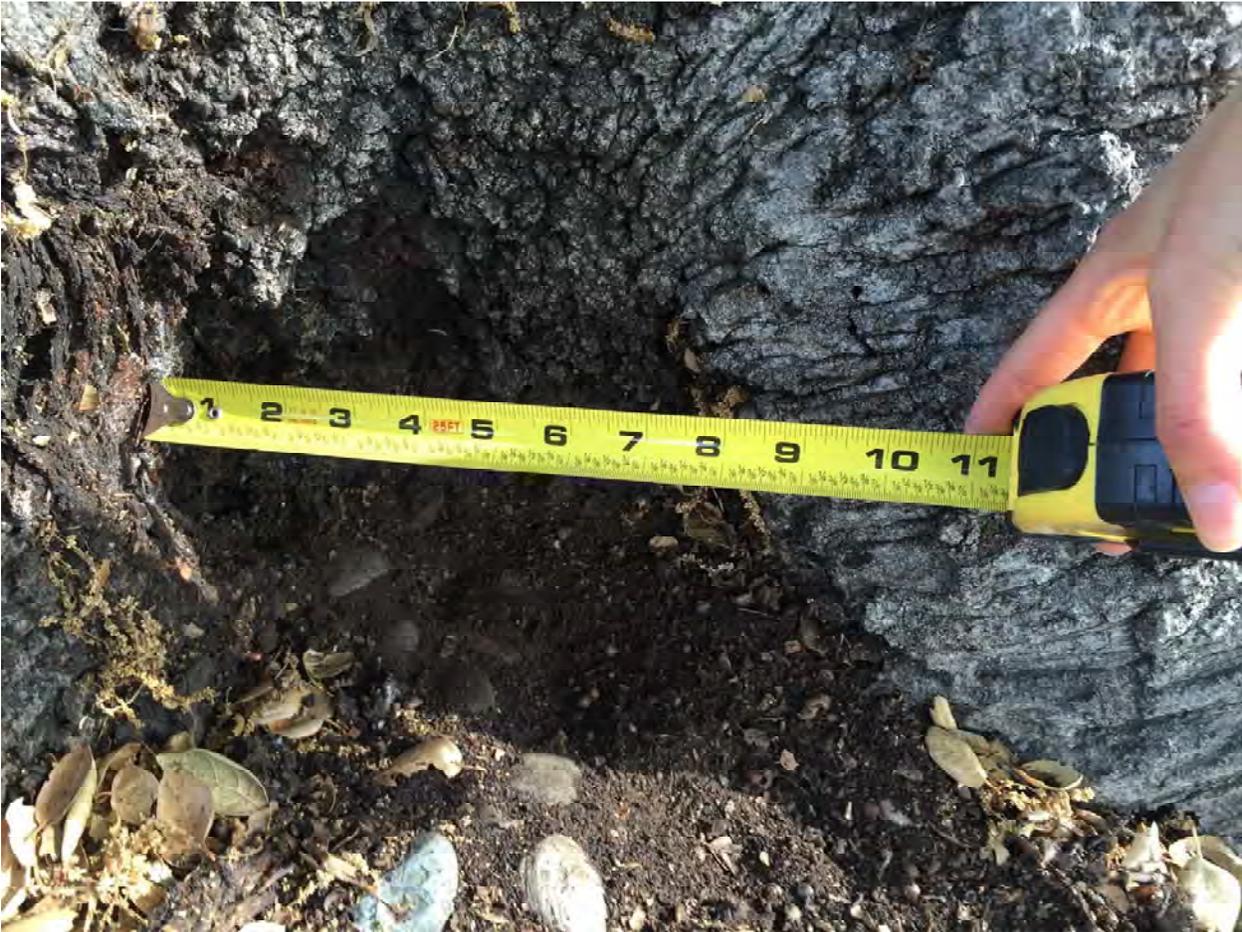
Image 4 – Tree A 8-Inch Decay Cavity on South Side

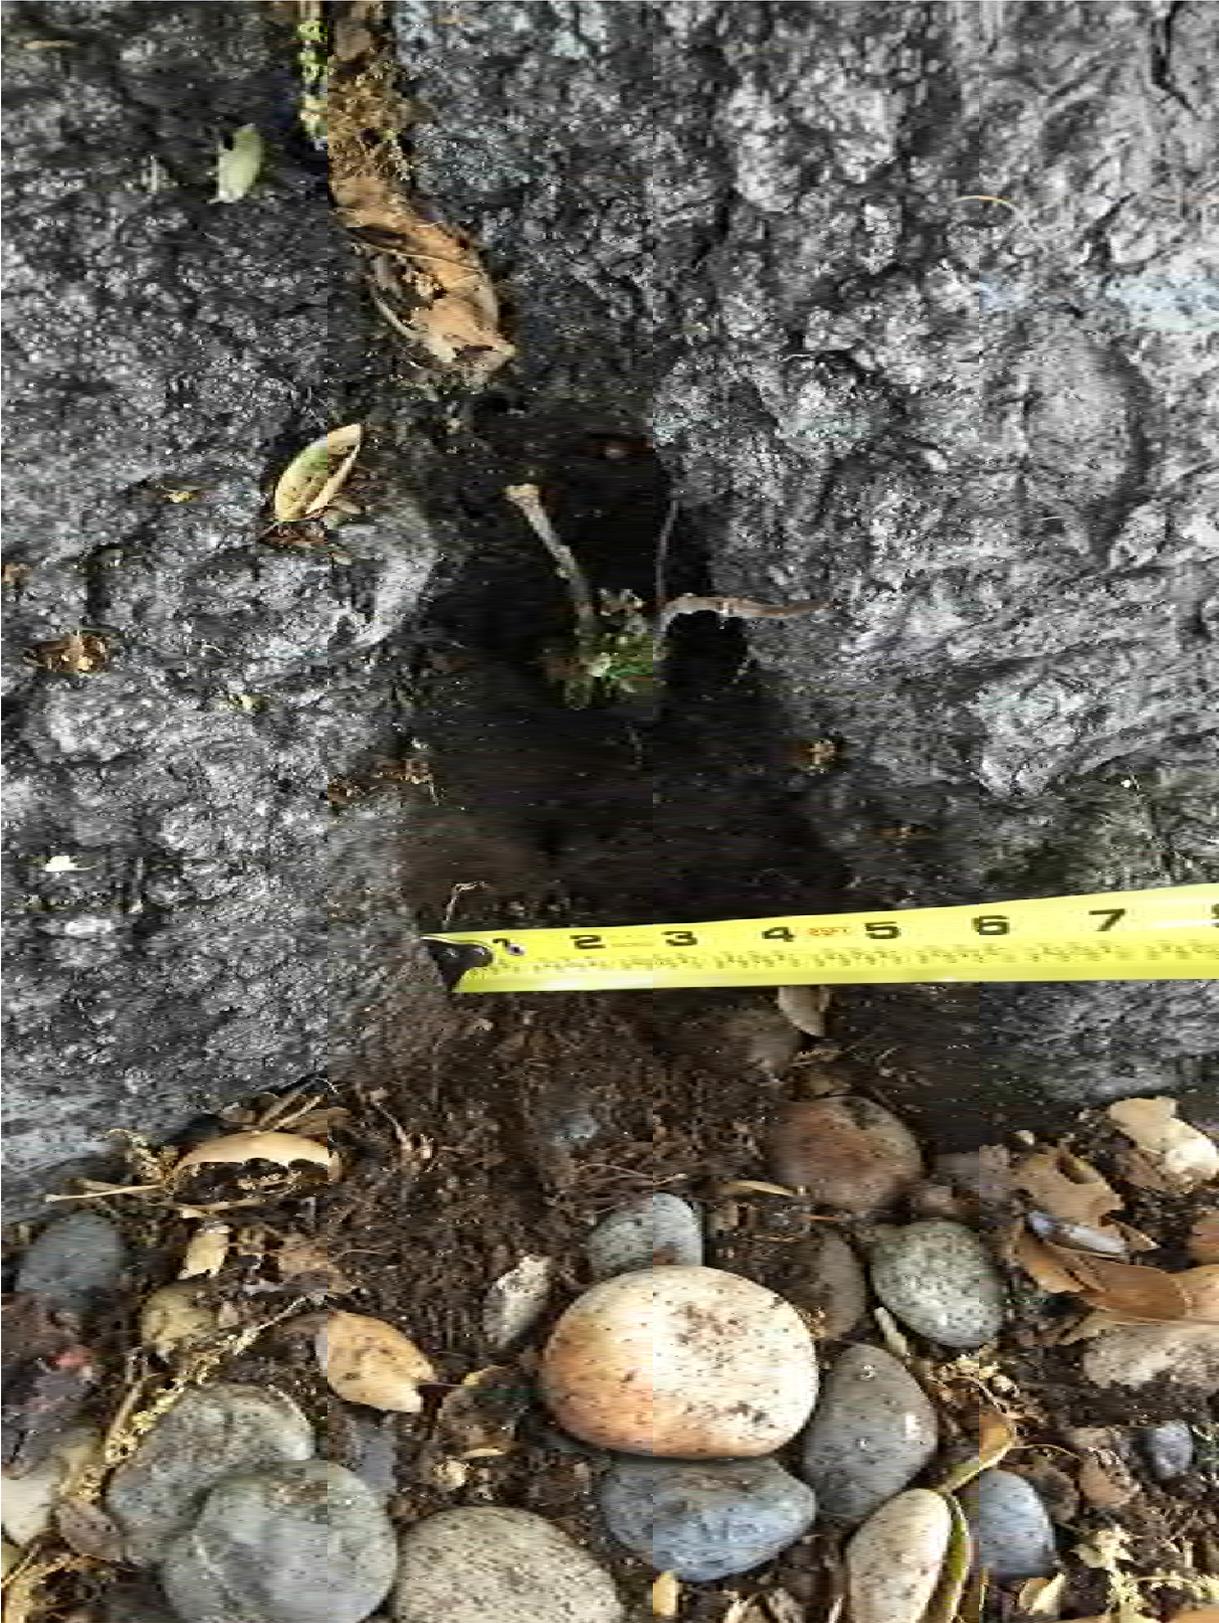
Image 5 – Tree A 4-inch Decay Cavity on Southwest Side

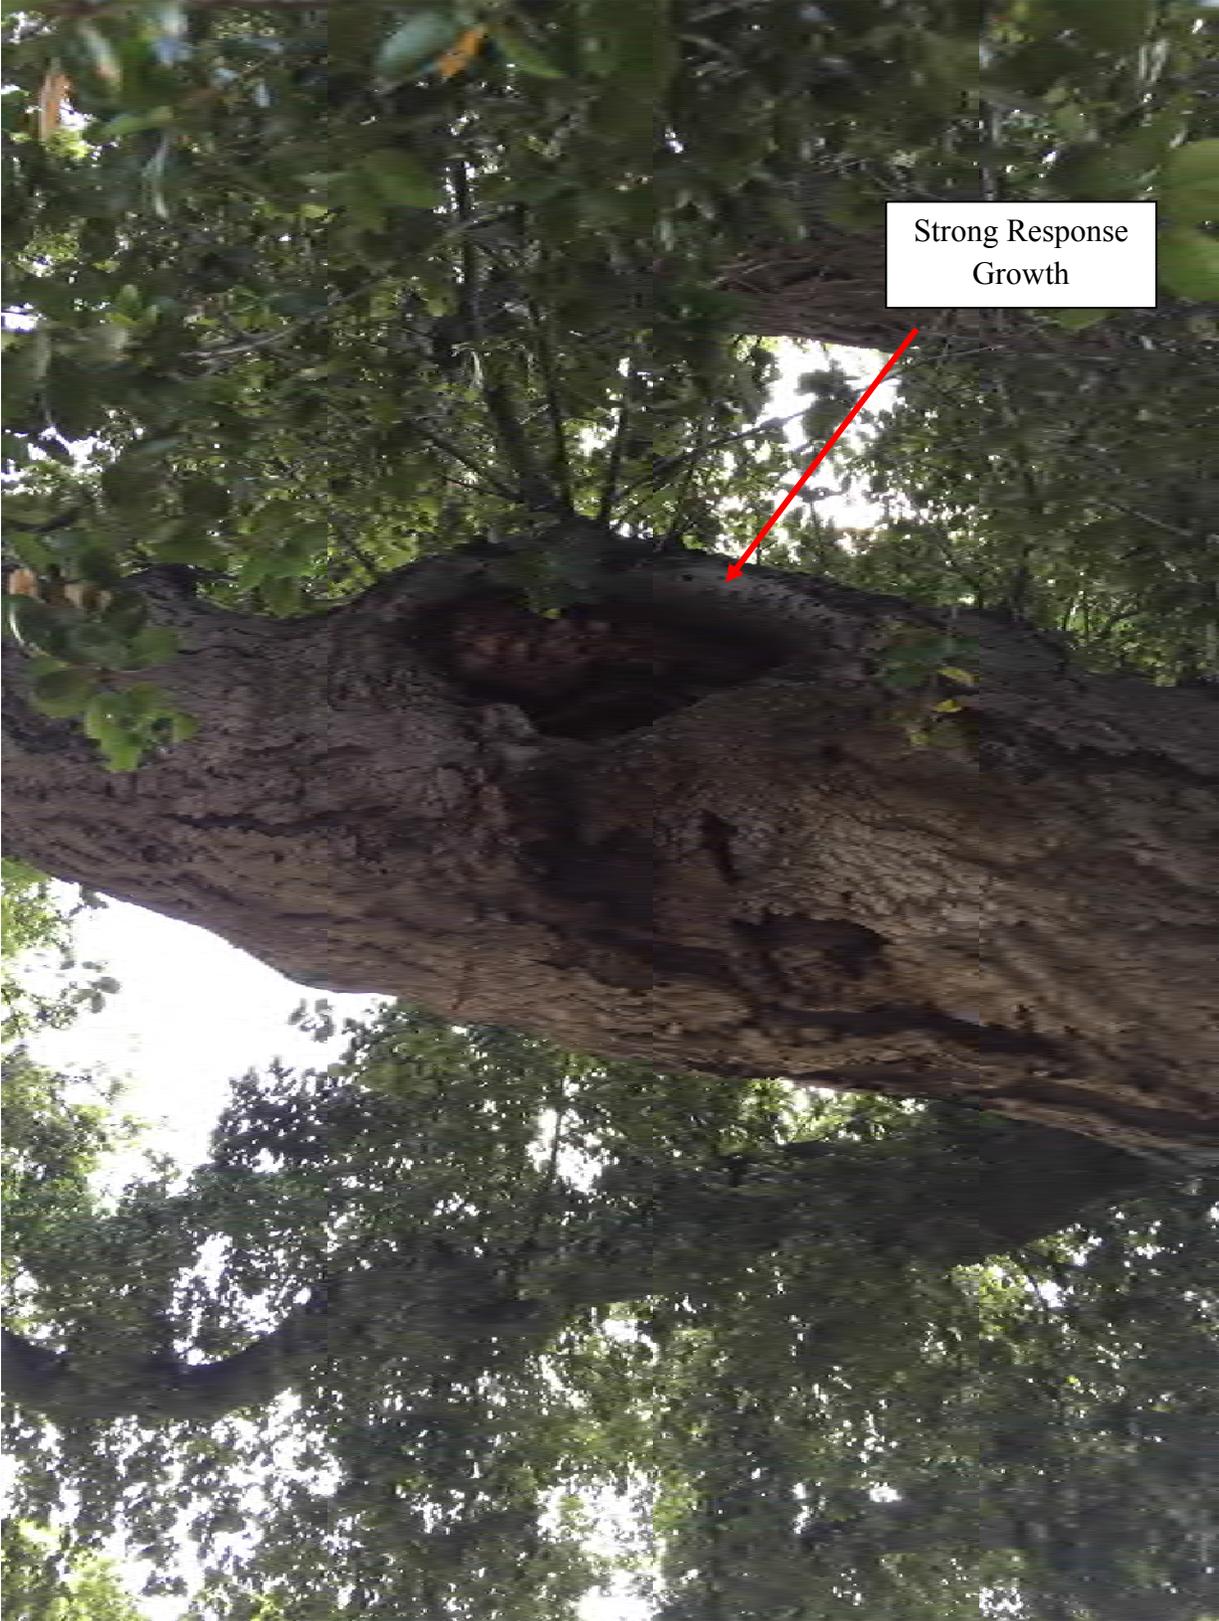
A decay cavity is visible in a scaffold branch on the southwest side of the tree (**Image 6**). A cable was installed in this limb at a previous time.

Image 6 – Tree A Decay Cavity on Scaffold Branch on Southeast Side

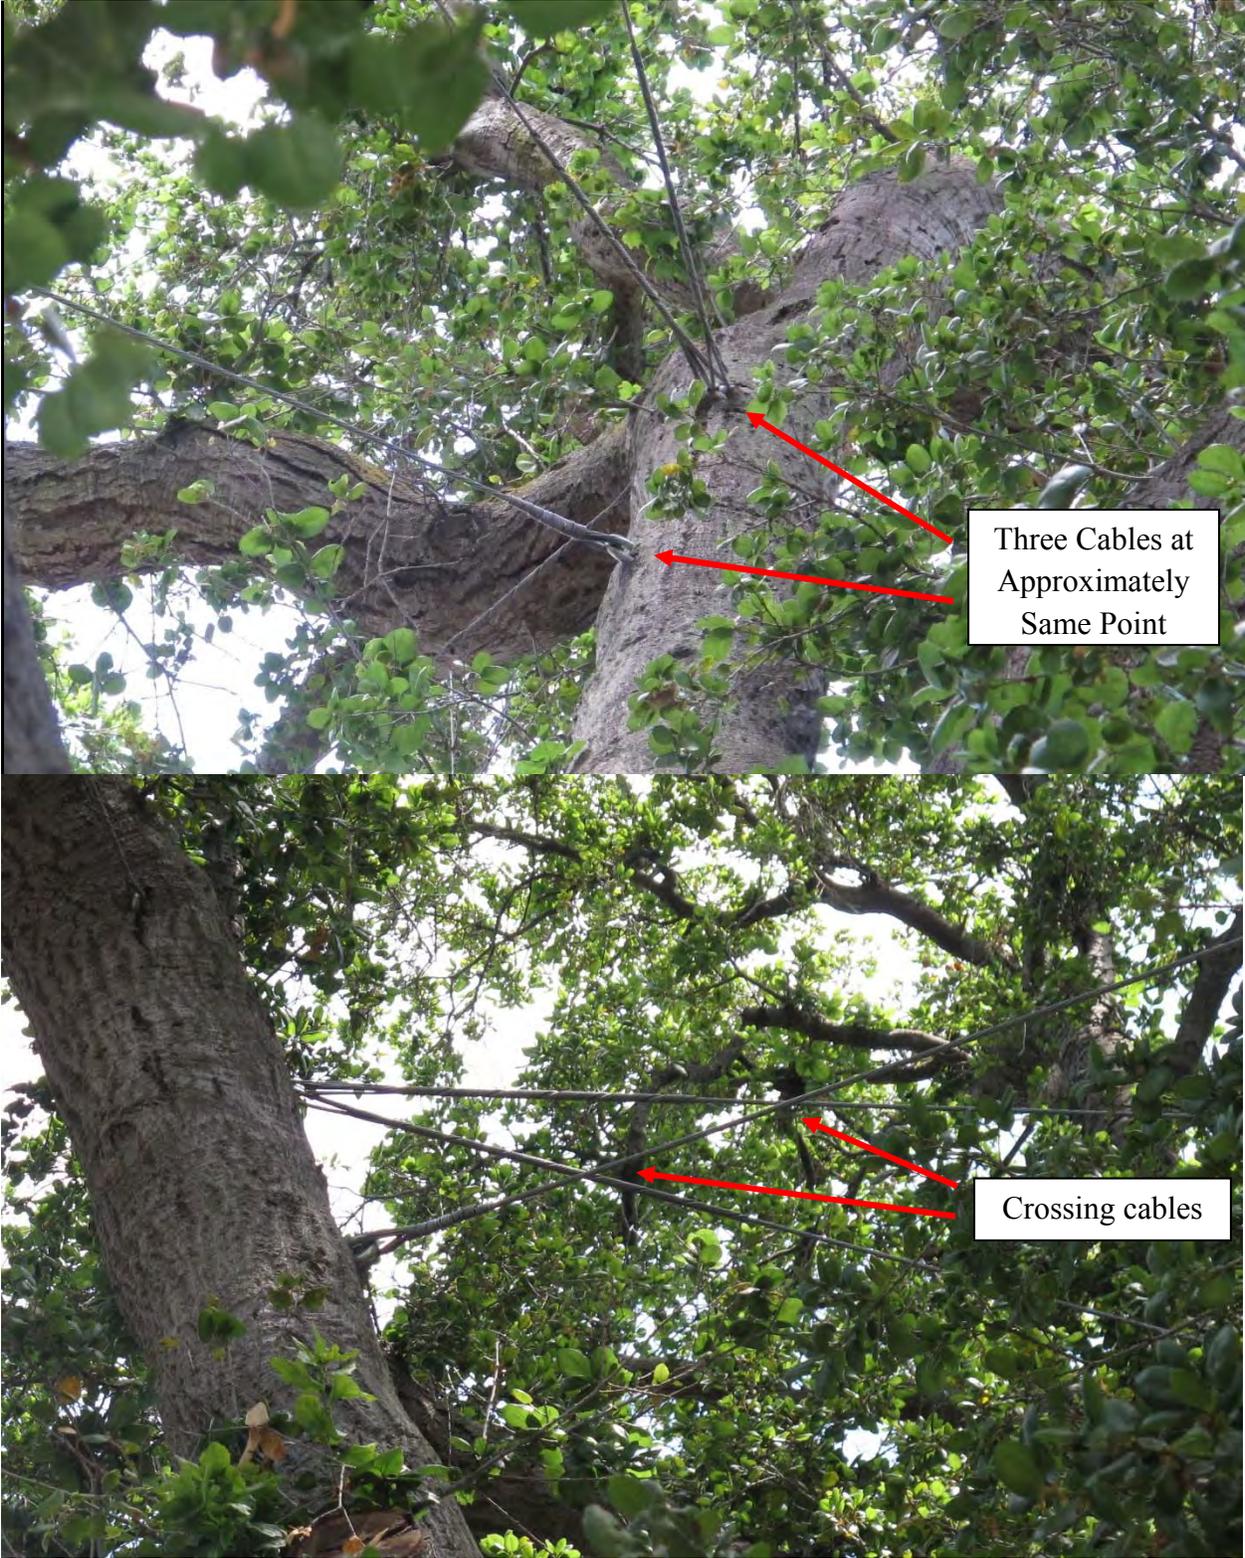
Cables are present in both trees (**Images 7, 14**). All appear many years old. All are installed incorrectly, with multiple cables sharing attachment points and none being horizontal.

Five cables are present in the canopy of this tree (**Image 7**).

The cables in these trees are unlikely to have had any positive impact, and may increase both trees' likelihood of limb failure.

Image 7 – Tree A Cables, Improperly Installed

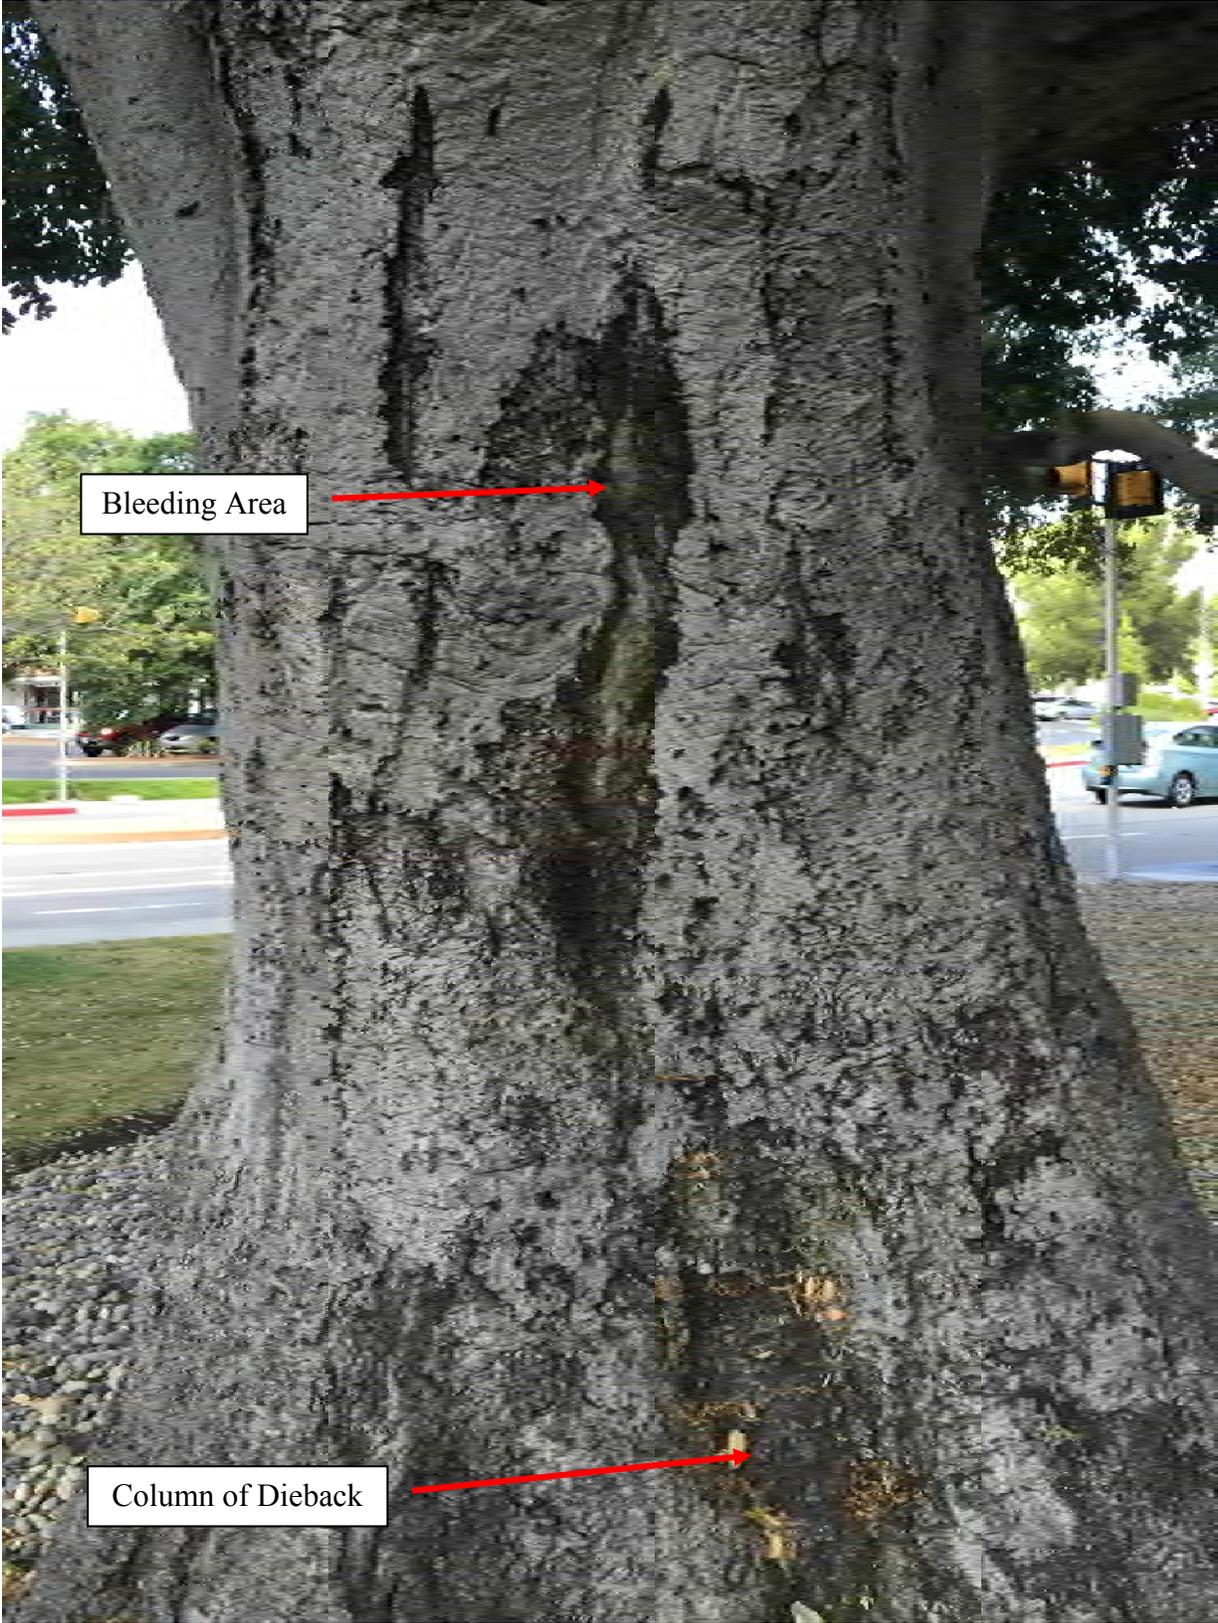
There is a bleeding area on the east side of the tree, above an eight-inch column of dieback, with no wounding visible (**Image 8**). No other bleeding areas are present.

The bleeding area and corresponding dieback on this tree's trunk appear to be caused by Phytophthora, or a similar pathogen. Response growth appears sufficient to mitigate these defects. The tree's vigor does not appear to be substantially reduced by the infection.

Image 8 – Tree A Bleeding Area and Column of Dieback on East Side

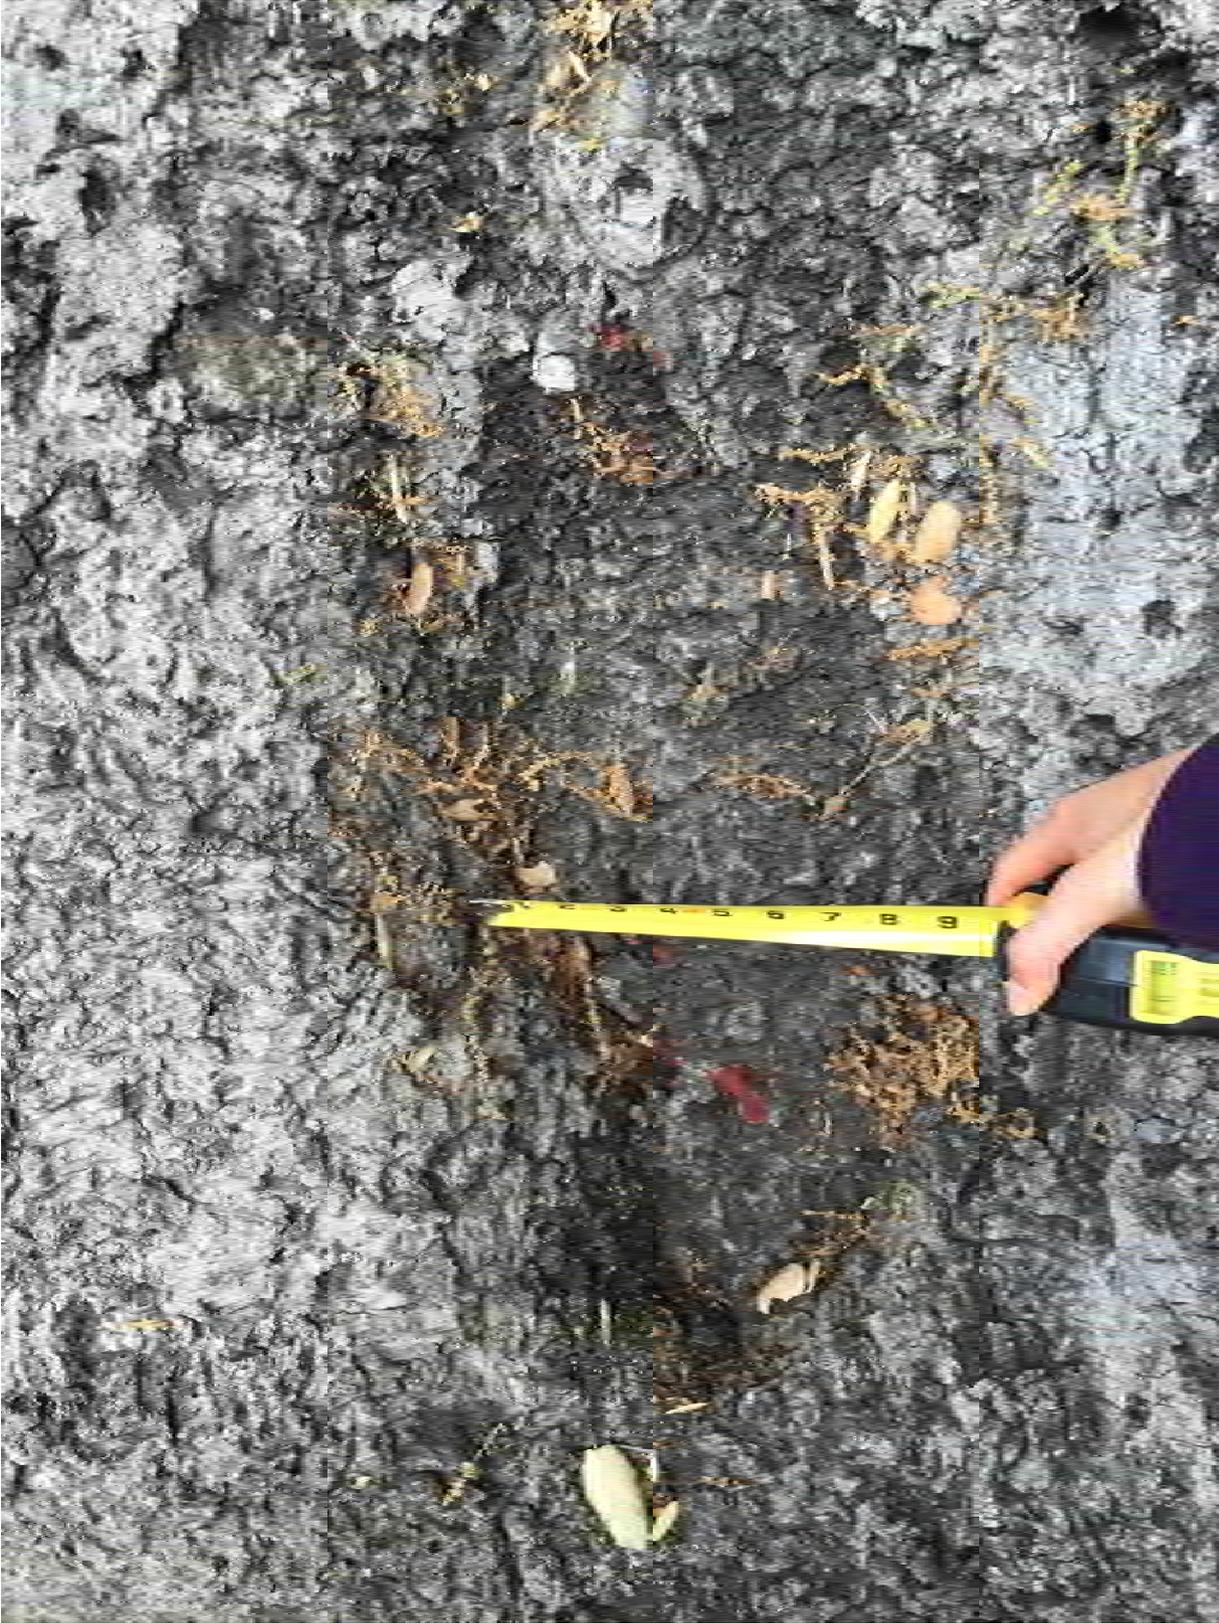
Image 9 – Tree A 8-inch Column of Dieback on East Side
