Preliminary Arborist Report

**Marina Plaza
10122 Bandlely Drive
Cupertino, CA**

**PREPARED BY:
HortScience, Inc.
325 Ray St.
Pleasanton, CA 94566**

September 3, 2015

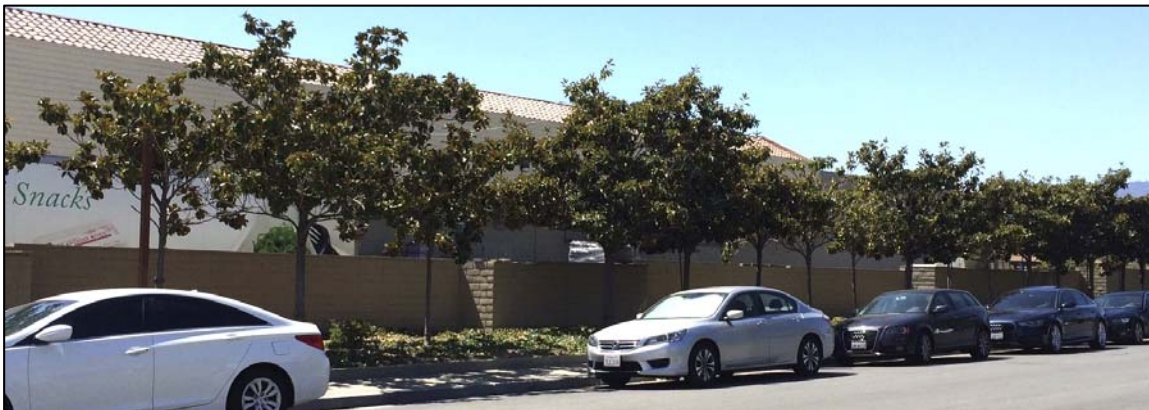
The most common species present was southern magnolia, with 59 trees (59% of the population). Trees were growing in small parking lot planters and in a row along Alves Drive (Photo 1). Overall, trees were in fair (42 trees) and poor (17 trees) condition. Southern magnolias were characterized as being stunted in growth – none of the trees was larger than 12 inches in diameter – and many had thin crowns and twig dieback, conditions that were likely caused by

Photo 1: A row of southern magnolias (#80-95, r-l) along Alves Dr. were in fair and poor condition with small crowns and dieback.

inadequate irrigation. Trees in poor condition had very thin crowns, dieback, and chlorotic (yellow) foliage.

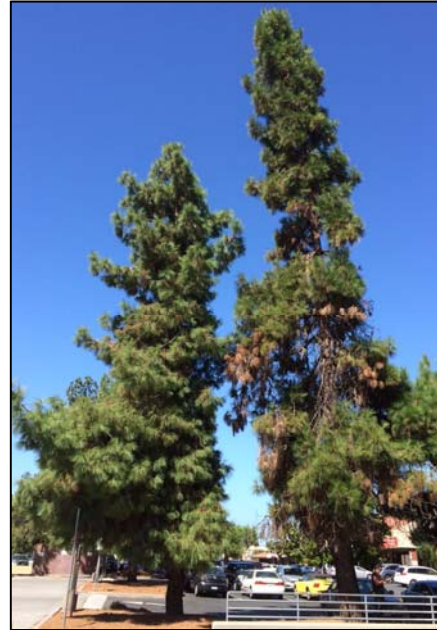
Photo 2: Canary Island pine #16 (l) was in good condition. Tree #17 (r) was in fair condition with good structure and thin lower crown.

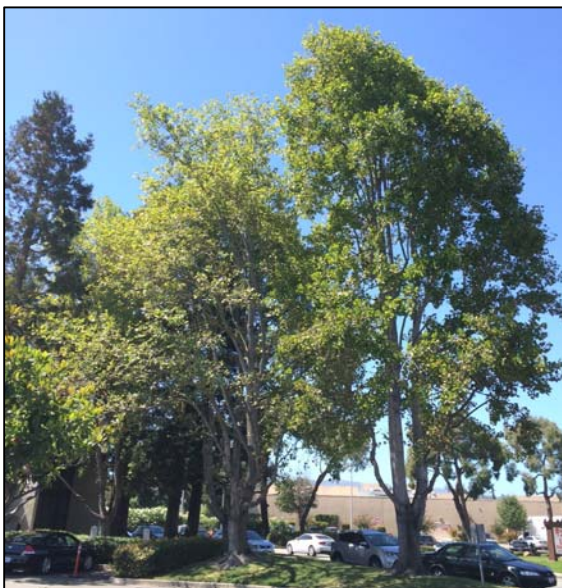
Two tulip poplars (#65 and 66), located on the west perimeter, were in fair condition and were mature, with 25-inch diameter trunks (Photo 4). Trees had fair structure, with codominant and multiple stems, and slightly thin crowns. Tree leaves and surrounding pavement were sticky with honeydew – an indication of either scale or aphid infestation.

Photo 3 (left): Tulip poplars #65 and 66, growing on a landscape mound along Bandlely Dr., were in fair condition.

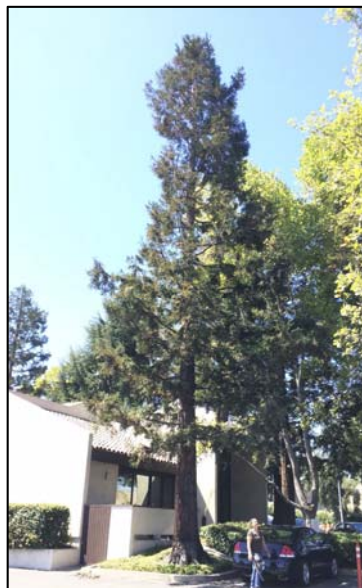
Photo 4 (right): Coast redwood #64 was located to the south of the tulip poplars and was in fair condition.
