ARBORIST REPORT

Cupertino Civic Center Master Plan & Parking Garage Conceptual Planning
Cupertino Civic Center, Torre, Rodrigues & Pacific Drive, Cupertino, California

JANUARY 2, 2015

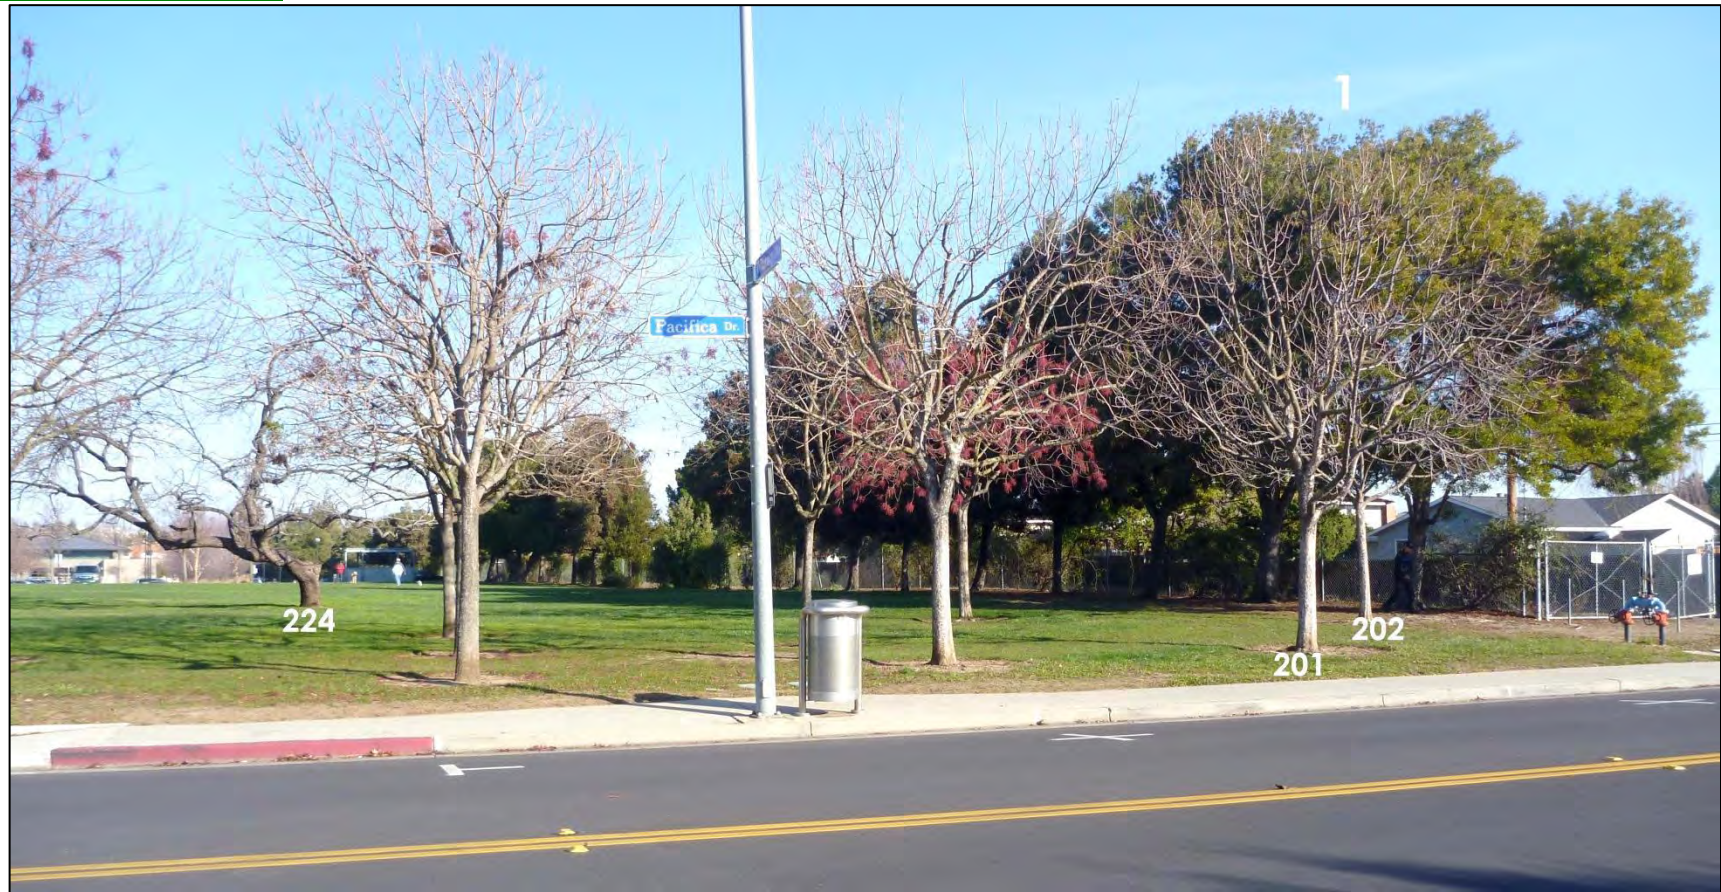
Pacifica Drive (foreground) with the creek perimeter at right. Tree numbering begins with the row of black acacia trees starting with **tree #1**. In the foreground is a double row of Chinese pistache trees including **trees #201 and 202**. Old **black walnut #224** is in the background at left.

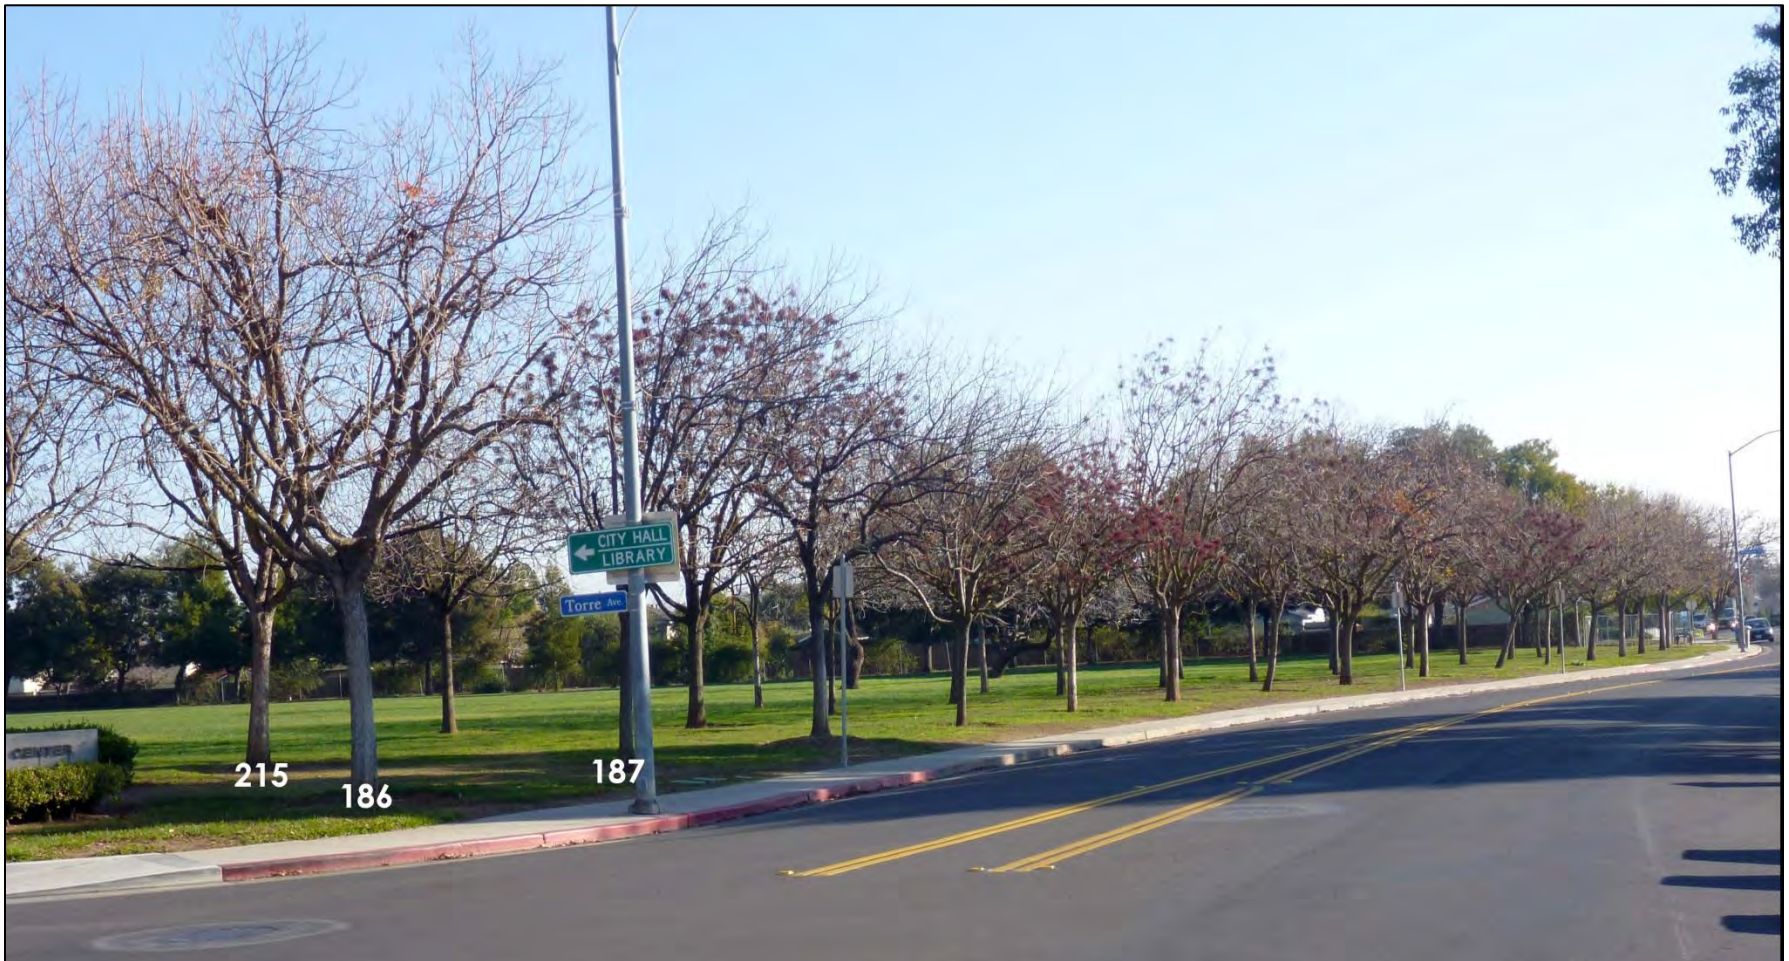
The corner of Pacifica Drive (right, foreground) with Torre Avenue to the left. The triple row of Chinese pistache trees is visible, with trees #186, 187 and 215 labeled.

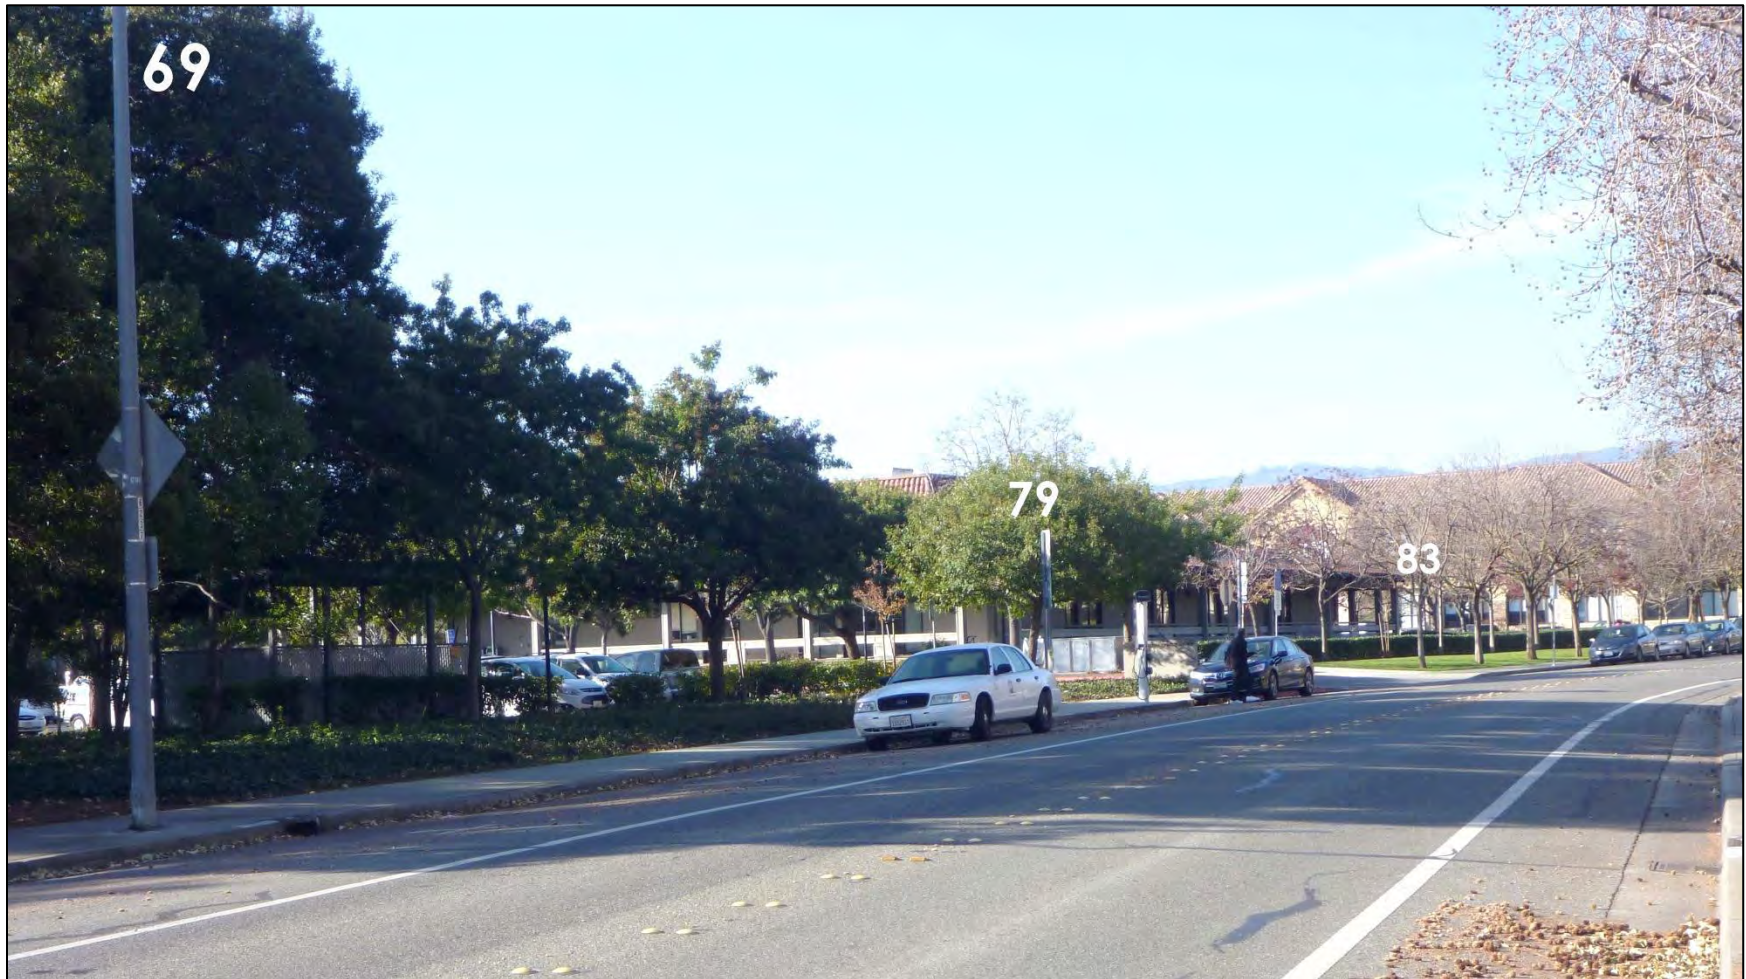
Rodrigues Avenue looking toward Torre Avenue to the right (not visible in photo). **Black acacia #69** is labeled, as is **Brazilian pepper #79** and **Chinese pistache #83**.

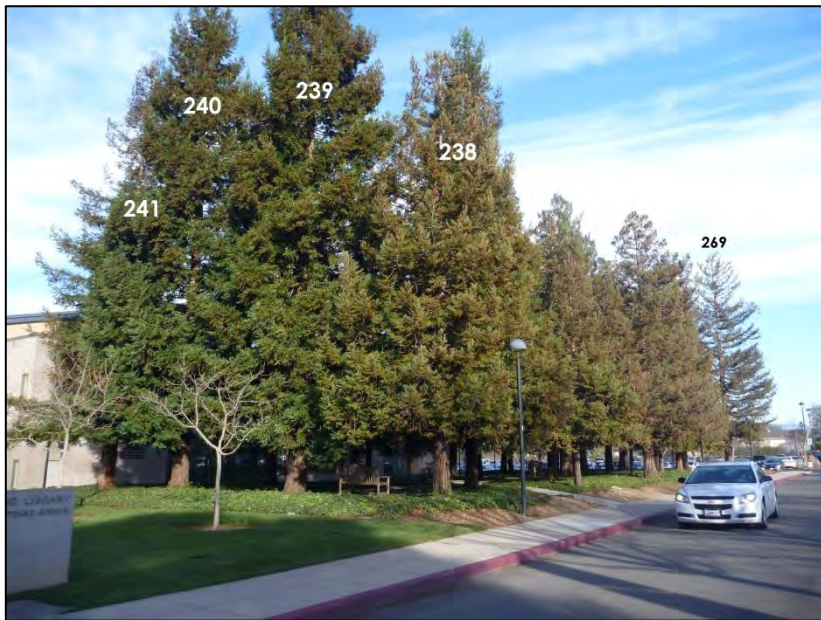
- **Coast redwoods:** probable suffering from drought stress
- **Many other tree species:** lack of young tree training pruning, leading to structural defects that are easily correctable now on young trees, but more difficult on older, larger trees.

Upper Left: the grove of **coast redwoods #238-270** on the south side of the Library building.

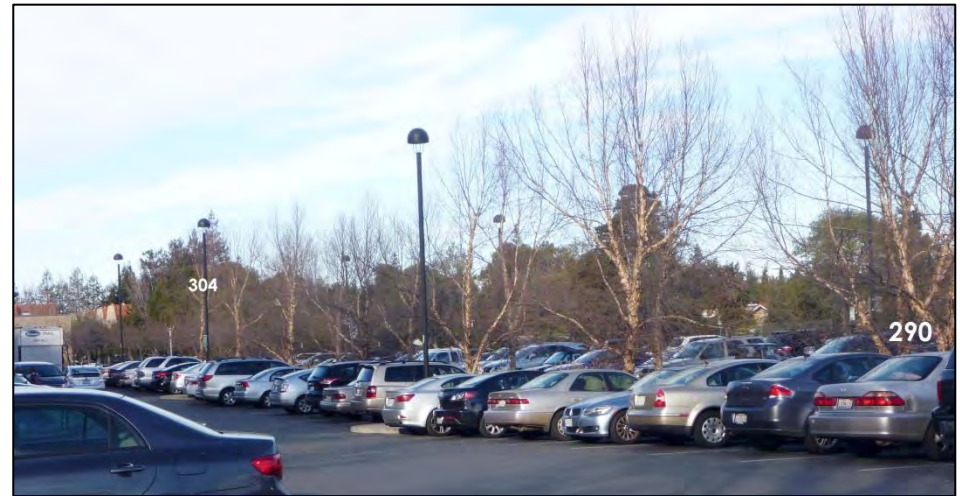
Upper Right: **river birch trees #290 - 304** planted in a bioswale in the Library parking lot.
