2.0 Assignment & Background

Walter Levison, Consulting Arborist (WLCA) was initially retained in 2015 to tag and assess 895 trees throughout the existing site that extends from perimeter road west to perimeter road east, and from freeway 280 to Stevens Creek Boulevard, Cupertino, California, including median trees along North Wolfe adjacent to the project site. The east boundary of the survey area was a property owned by Apple Inc. The west boundary of the survey area was a developed single family residential area. Tags in this area are tagged #1 through #875 (round-shaped tags), with median trees tagged as #1,106 through #1,125 (racetrack-shaped tags) along N. Wolfe Road.

WLCA was later retained in September 2015 to prepare a formal written arborist report that was to include the following items:

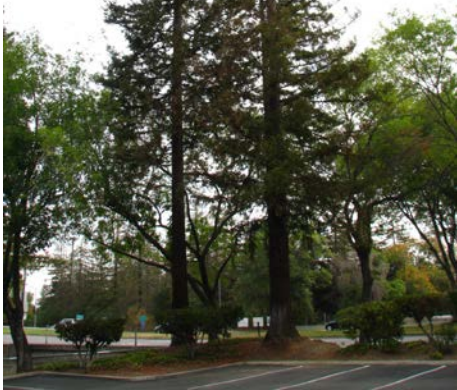
Tree #	Image	Tree #	Image
285 to 289 to be removed, looking northeast

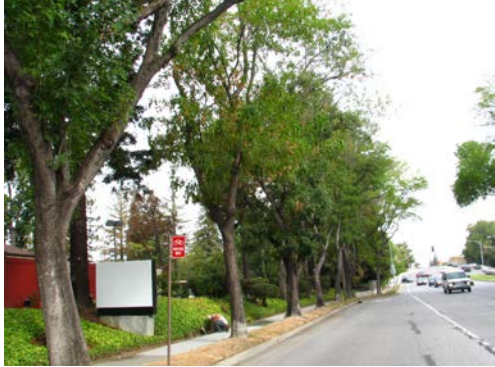
277 to 284 to be retained, looking north

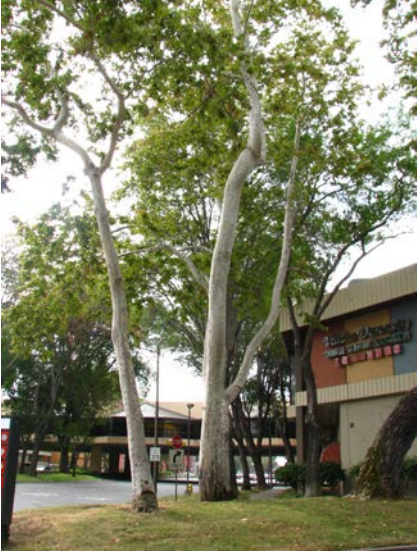
Tree #	Image	Tree #	Image
261 and 262 to be transplanted, looking south

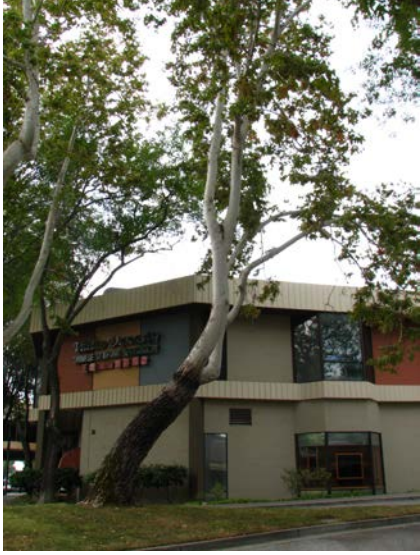
Sycamore 260 initially proposed by team to be transplanted. WLCA suggests removal of tree, or redesign the plan to work around it.

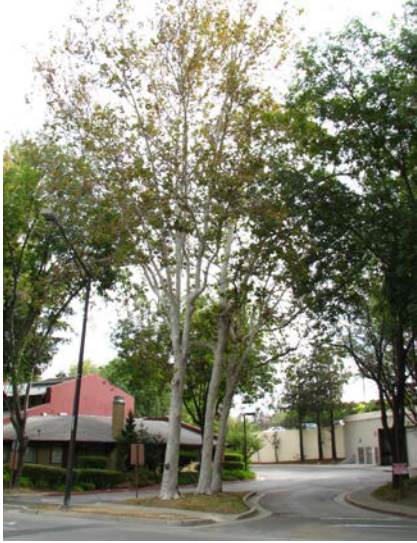
414, 415, and 416 to be transplanted per current proposed plan.

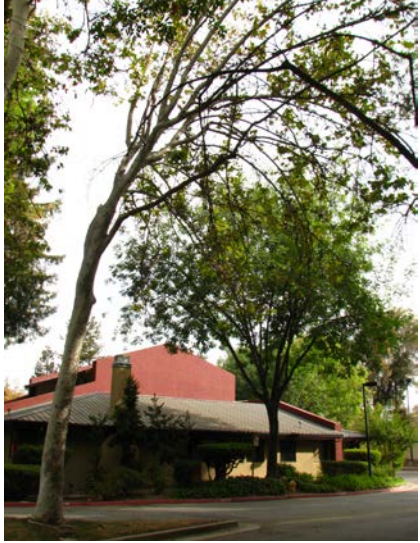
416 initially proposed by the project team to be transplanted (WLCA suggests removal of the tree, or redesign of the project to work around it)

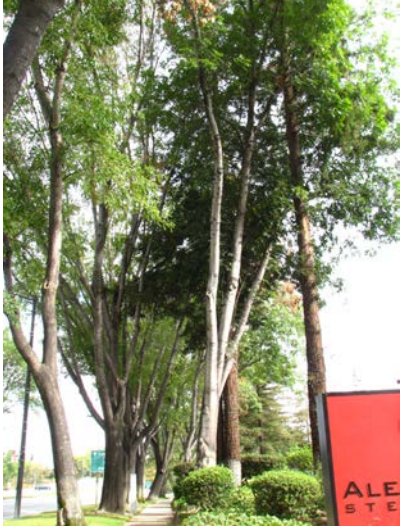
Tree #	Image	Tree #	Image
<p>426 to 444 along west side of Alexander's Steakhouse</p> <p>Some of these trees are to remain, and others are suggested by WLCA to be removed due to safety (risk) concerns</p>

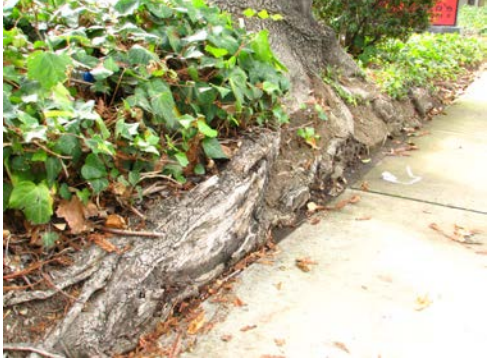
<p>Close-up of the roots severed along the west side of tree 438, (suggested by WLCA to be removed), during sidewalk replacement.</p>

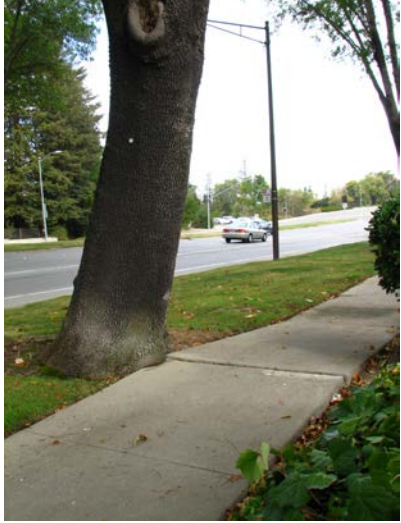
<p>Sidewalk heave (vertical displacement) along the east side of tree 431 to be retained. Infrastructure such as this with roots likely travelling under the hardscape should be left in-situ instead of being removed (if possible), since severe root loss could occur if the walk were rebuilt. Use diamond grinding to level.</p>

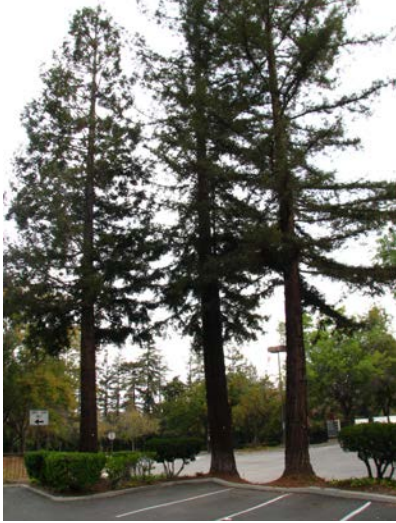
<p>Redwoods 423, 424, 425 to be removed at the steakhouse parking lot.</p>

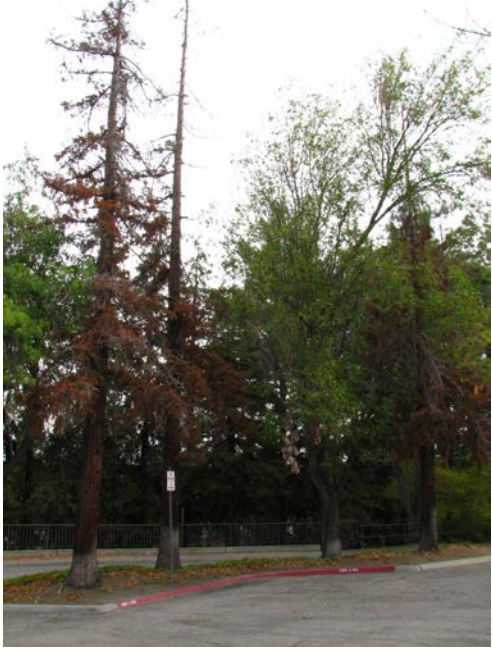
<p>Example of redwoods and ash specimens 332, 333, and 335 in very poor condition due to soil moisture deficit, at the JC Penny parking lot.</p>

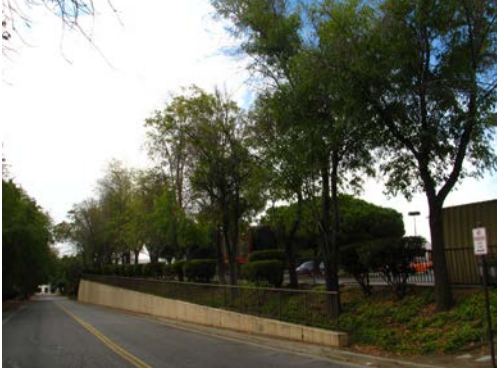
<p>Trees 338 to 358 to be removed along the east side of the JC Penny parking lot.</p>

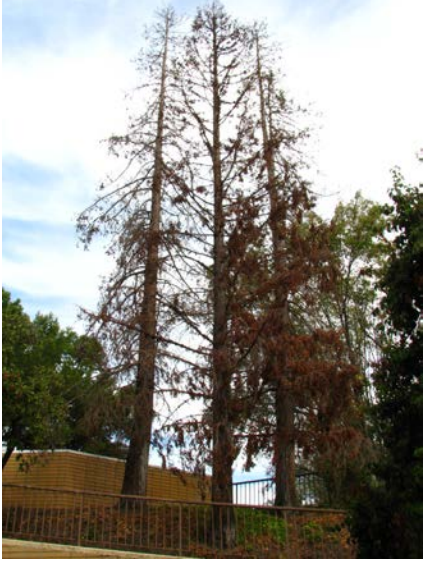
Tree #	Image	Tree #	Image
<p>Redwoods 500, 501, and 502 are dead in the southeast corner of the JC Penny parking lot area. These trees are planned to be removed.</p>

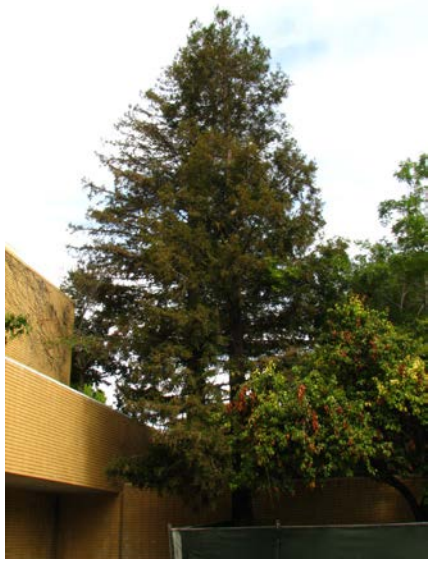
<p>In contrast to dead redwoods 500, 501, and 502 shown in the image at left, redwoods 505 and 510 at right are in decent condition just 30 or 40 feet west. The trees are to be removed.</p>

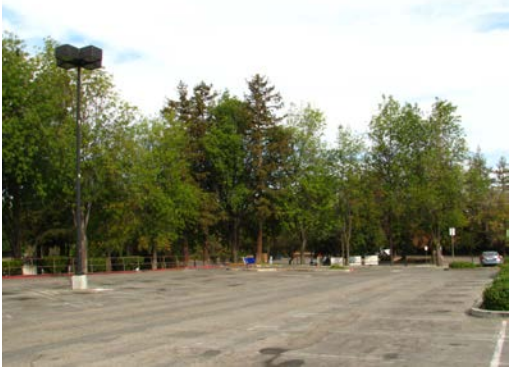
<p>Shamel ash and redwoods 396 to 404 to be removed at the west side of JC Penny parking lot</p>

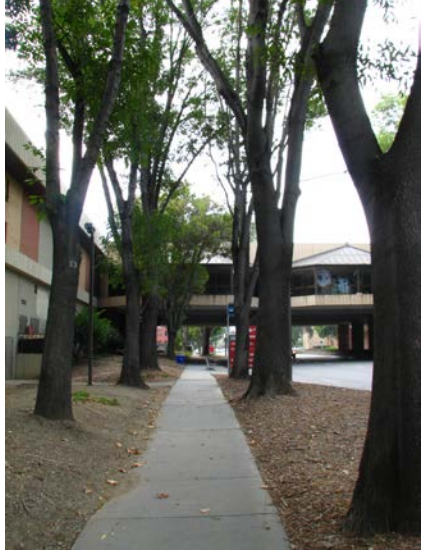
<p>Shamel ash 452 to 457 to be removed from the east side of N. Wolfe Rd.</p>

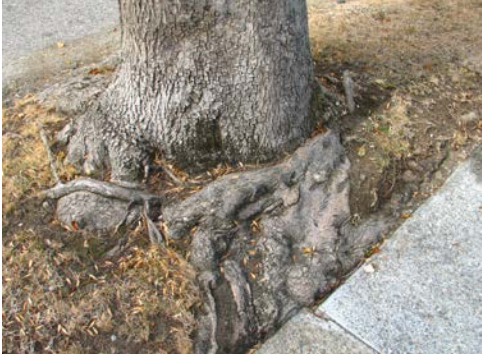
Tree #	Image	Tree #	Image
<p>Close-up of tree 267 to be removed, which exhibits a severe girdling root issue due to planting strip width which severely restricted normal lateral root extension from the trunk</p>

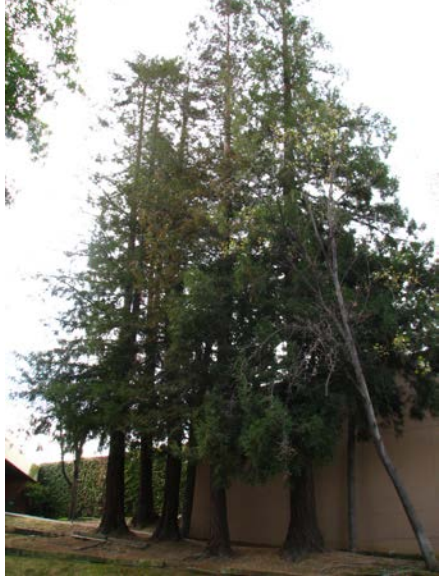
<p>Grove of redwoods 204 to 218 to be removed just west of Dynasty Restaurant.</p>

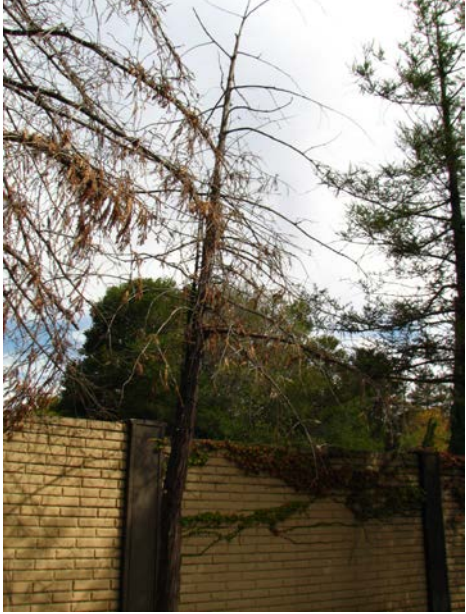
<p>Redwood specimens along the west side of west perimeter road are suffering severely from soil moisture deficit, and are generally declining or dying</p>

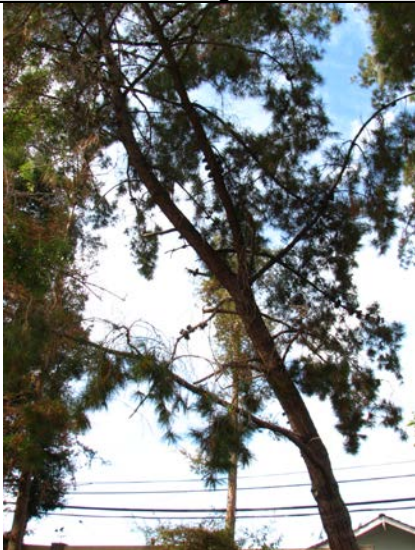
Tree #	Image	Tree #	Image
<p>Monterey pine 726 rates out with a probable risk of failure due to lean, girdling roots, etc. This tree is in WLCA's suggested removal list.</p>

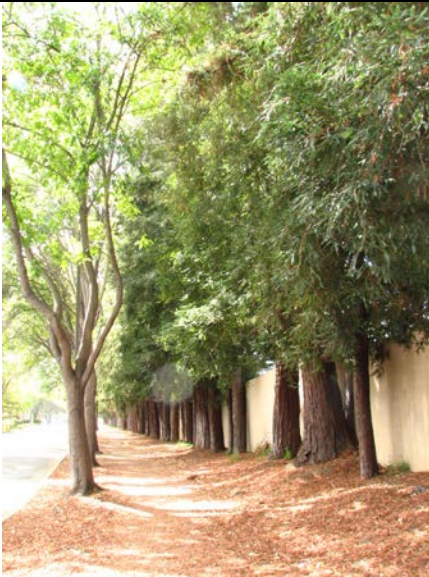
<p>The dense screen along the west side of west perimeter road as shown here near tree 771 is in danger of dying due to soil moisture deficit. Replacement of these high water use trees with drought tolerant evergreen species is a viable option.</p>

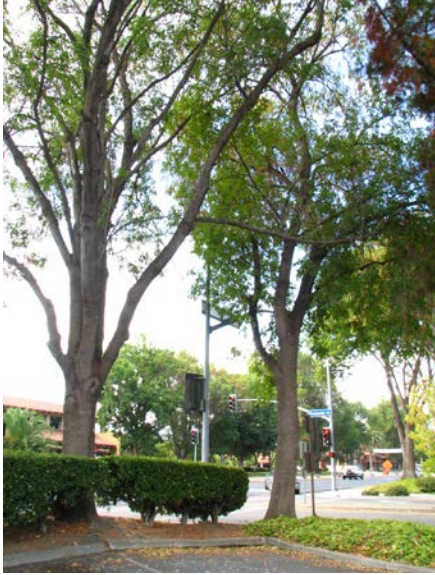
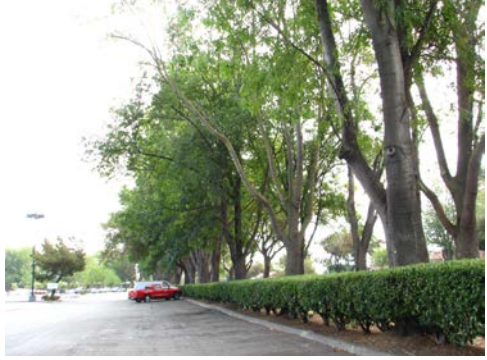
Tree #	Image	Tree #	Image
<p>Shamel ash trees 8 and 9 to be retained at the southwest corner of the project site.</p> <p>Note curb and asphalt displacement from root growth. If this hardscape is removed and replaced, severe root loss and root damage may result, ending in further tree decline or death.</p>

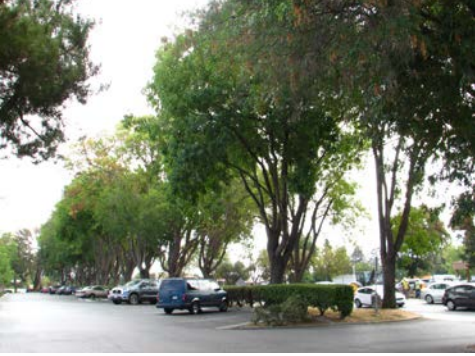
<p>Shamel ash 9 to 36 to be retained along this south border of the site, looking east. Again, removal of or alternation of existing curb and asphalt materials could cause severe root damage to these already drought-stressed specimens, resulting in further tree decline or death.</p>
<p>Shamel ash 23 through 36 to be retained, looking southeast.</p>

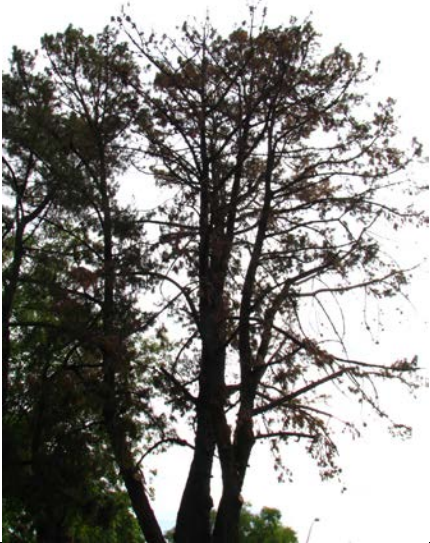
Tree #	Image	Tree #	Image
<p>Monterey pine 51 at southeast corner of the project site. This tree is dead, and needs to be removed at this time as a high risk of failure and impact to targets.</p>

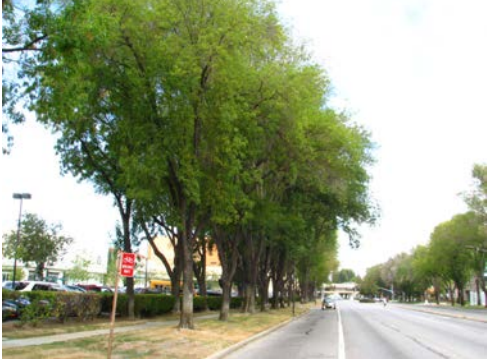
<p>Looking north at shamel ash 55, 57, 59, 61, 63, 65 to be removed.</p>

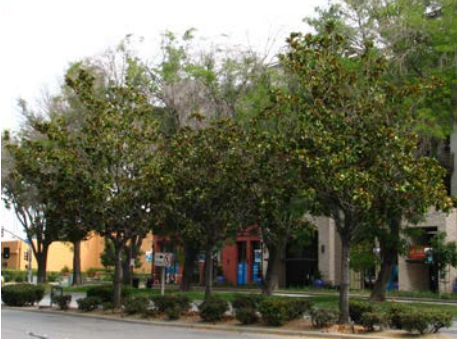
<p>Southern magnolias 1106, 1107, 1108 proposed by the project team to be removed, are in decline due to severe soil moisture deficit.</p>

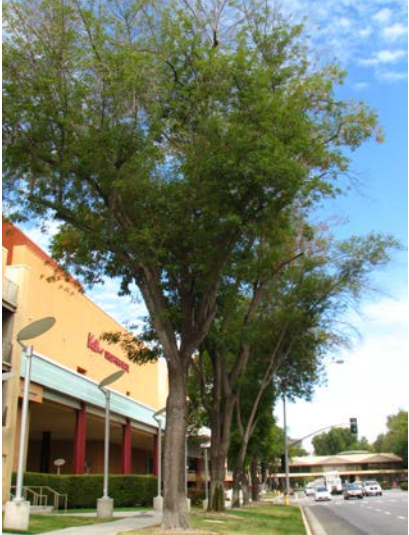
<p>Looking north at shamel ash 102, 103, 104, and 105 to be removed. Note canopy dieback in the form of live twig density decline.</p>

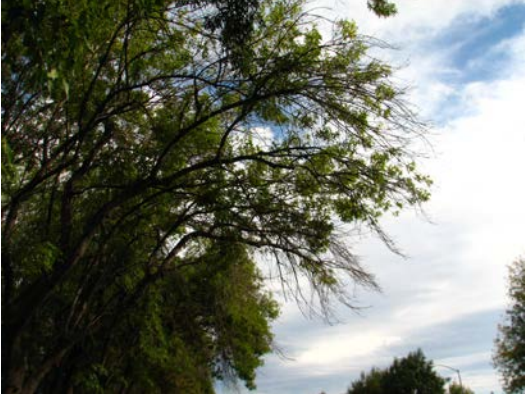
<p>Looking north along N. Wolfe Rd. The shamel ashes, although they are referred to as “evergreen ash”, actually go deciduous to some degree, with leaf drop ranging from zero to +/- 50% of the entire foliar canopy.</p>

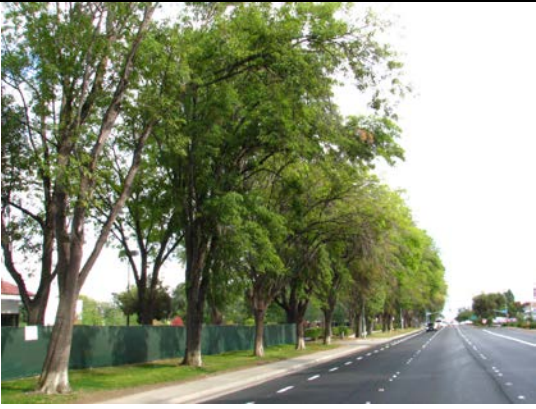
Tree #	Image	Tree #	Image
Looking east down Stevens Creek Blvd. The evergreen ash specimens along this south boundary section of the site exhibit both bare areas where fruit clusters dropped, and dead stems scattered throughout the trees, simultaneously.

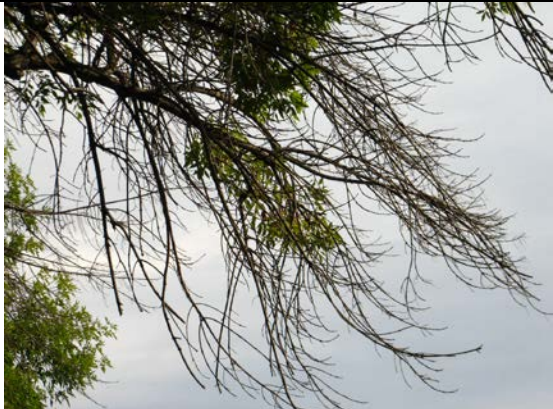
A combination of dead stems and live bare fruit cluster branches extended south over Stevens Creek Blvd. (a close-up of an evergreen ash specimen in the center of the left-hand image).
