Subject: Report of December 7, 2018, Inspection and Notice of Violations of the Industrial Stormwater General Permit and Technical Report Requirement, Stevens Creek Quarry, Inc., 12100 Stevens Canyon Road, Cupertino, Santa Clara County

**State of California – Environmental Protection Agency
California Regional Water Quality Control Board – San Francisco Bay Region**

**STEVENS CREEK QUARRY, CUPERTINO
INSPECTION REPORT**

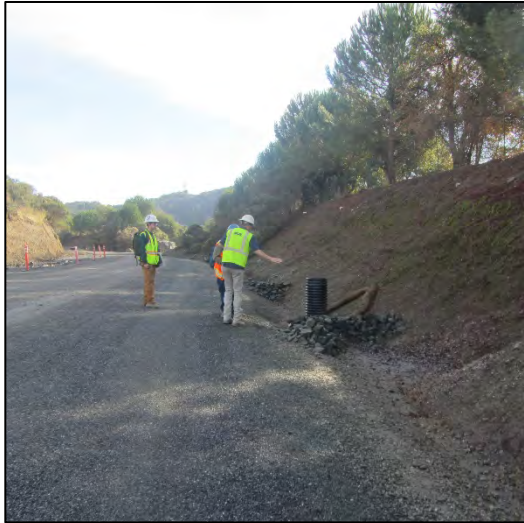
Photograph 1

Notes: Photograph of new BMP (pea gravel) placed along a portion of the dirt road.

Staff recommended that the pea gravel be extended along the full length of the dirt road to minimize sediment discharges into drop inlets (DIs) and tracking off-site. See required corrective actions needed in Photograph 3.

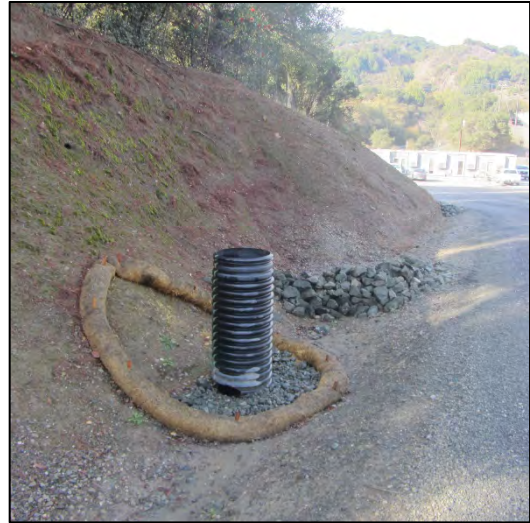
Photograph 2

Notes: Closeup of DI in Photograph 1 showing good BMPs in place around the DI.

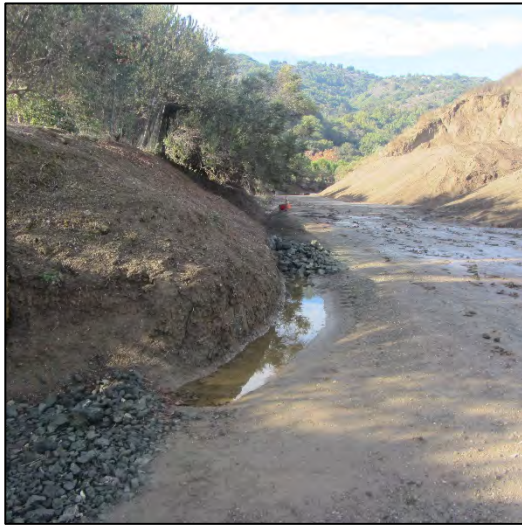
Photograph 3

Notes: Sediment discharging from topsoil piles and dirt road to stormwater conveyance ditch was observed. This stormwater conveyance ditch leads to Outfall No. 4 (We also observed this in our 9-8-17 inspection). No sediment control BMPs were along the bases of the topsoil piles. These discharges are likely to continue due to the lack of adequate erosion and sediment control BMPs. Sediment will continue to be subject to wind erosion, sloughing, and sheet flow across the road and into the ditch and DIs.

Violation: Lacking adequate erosion or sediment control BMPs to prevent buildup of sediment in the ditch and DIs, and subsequent discharge to the storm drain and receiving waters.

Implement year-round erosion and sediment control BMPs for all erodible areas (including topsoil piles and dirt roads) to minimize sediment transport and/or dispersion by wind, track-out, and stormwater sheet flow. Keep unpaved dirt road capped and maintained with pea gravel (as shown in Photo 1, or other nonerosive material) to prevent sediment discharges into DIs (which discharge to Swiss Creek at OF-4) or sediment discharges via tracking off-site. Install site entrance and exit control BMPs to prevent sediment being tracked out into streets.

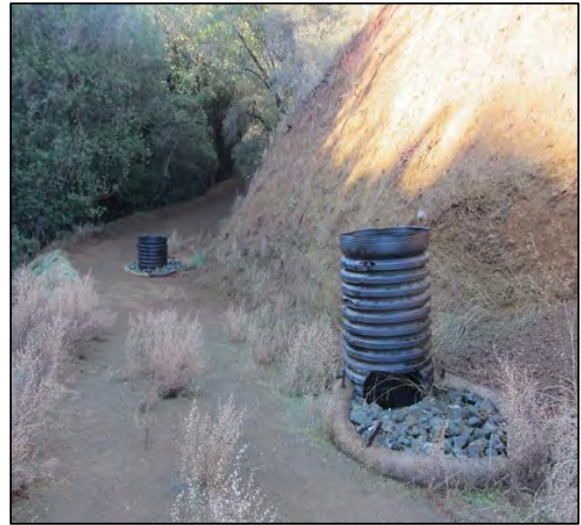
Photograph 4

Notes: No violations observed at the DIs and check dams along the road above Pond 1.

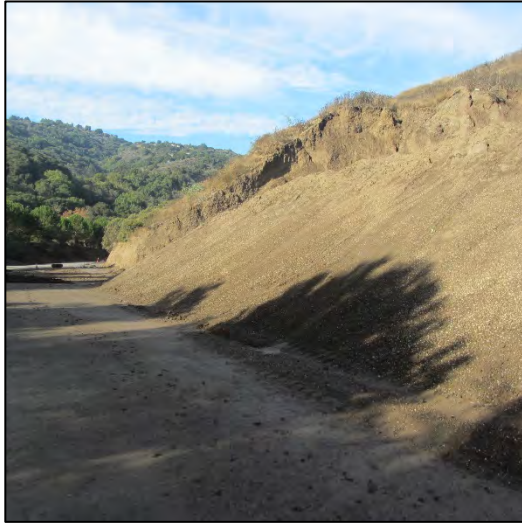
Photograph 5

Notes: Photograph of active topsoil piles.

Violation: No erosion, sediment, or containment control BMPs. This was a violation noted in the previous inspection report.

Staff recommended that 1) the pea gravel located along a portion of the dirt road (as seen in Photo 1) should be extended along the full length of the dirt road to minimize sediment discharging into DIs and being tracked off-site. The unpaved dirt road continues to be a source of sediment discharges into the DIs (which discharge to Swiss Creek at Outfall No. 4 (see Site Map 1, OF-4); and 2) site entrance and exit control BMPs be installed to prevent sediment being tracked out onto streets.

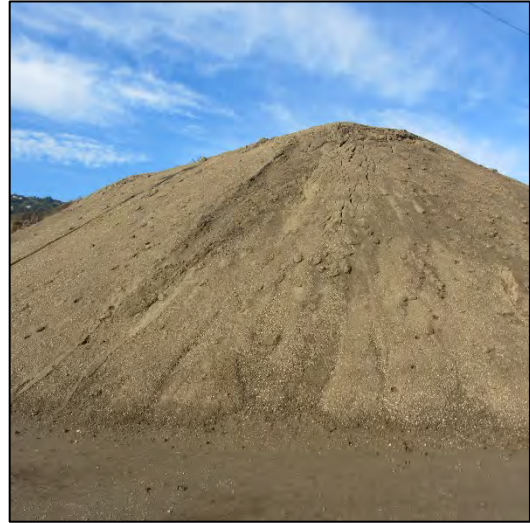
Photograph 6

Notes: Staff observed rilling on topsoil piles. No erosion or sediment control BMPs were observed. This was a violation noted in the previous inspection report.

In response to our concerns, on December 11, 2018, the Quarry installed some 9” wattles along one edge of the topsoil piles.

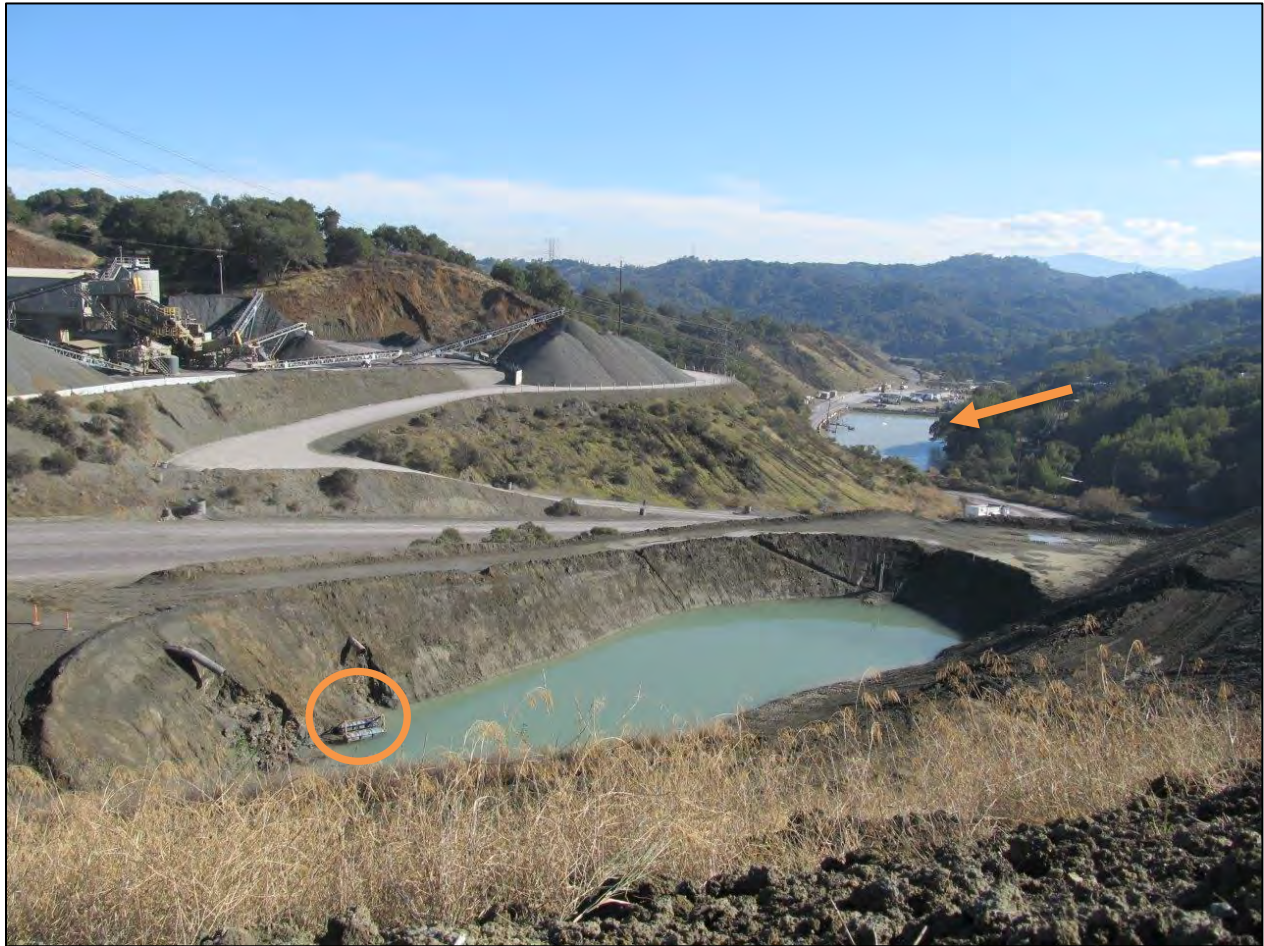
Photograph 7

The Quarry modified the drainage areas in the Upper Quarry Floor area as described in the November 2018 SWPPP. We observed that maintenance work had been done on Sediment Pond No. 5 (Photograph 7) and a floating well pump was installed to pump water from Sediment Pond No. 5 to the Pit Pond in the Upper Quarry Floor (Photograph 8). Sediment Pond No. 5 is reported to have a capacity of 15 times the 85th percentile storm event (calculations provided in November 2018 SWPPP, Appendix F).

Notes: We observed that Sediment Pond No. 5 (center foreground) had been deepened and that a floating pump (circle) had been added to the pond. Mr. Voss said that the pond was used to detain runoff from a portion of the Upper Quarry and that overflow from this pond would discharge at Outfall No. 1 to Rattlesnake Creek. Per the November 2018 SWPPP, the pond was cleaned out in the summer of 2018 and expanded to a capacity of 15 times the 85th percentile storm event. Mr. Voss said that the floating pump that was installed to pump water from this pond to the Pit Pond in the Upper Quarry Floor (Photograph 8). The aggregate processing area can be seen in the upper left of the photo and a pond previously used for sediment detention within Rattlesnake Creek (Sediment Pond No. 4) is visible beyond Sediment Pond No. 5 (arrow).

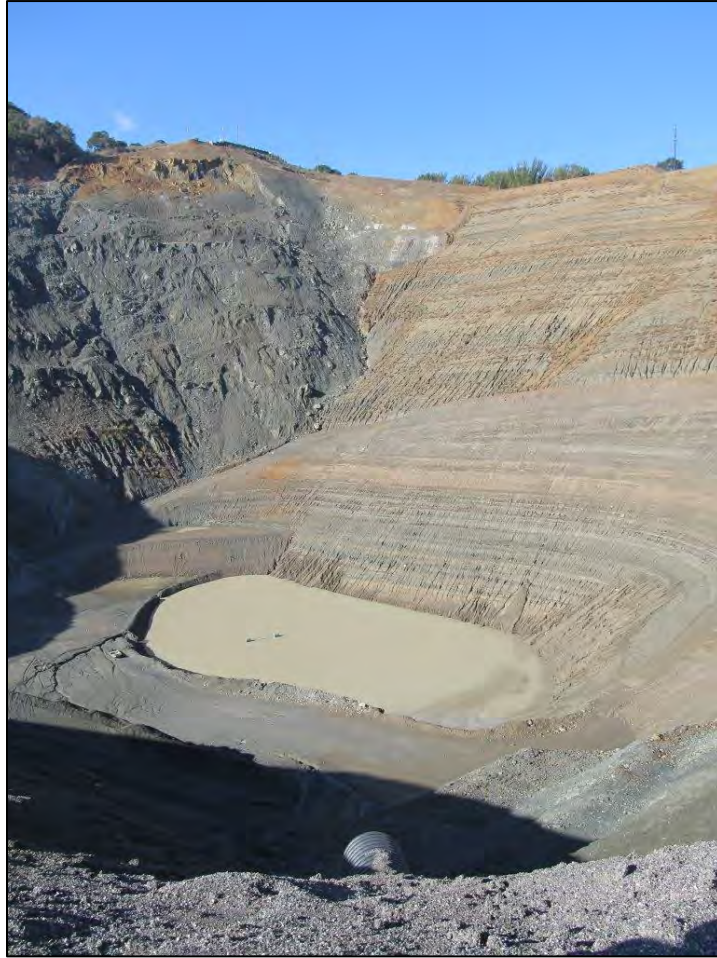
Photograph 8

Notes: We observed the Pit Pond from the southwest rim of the main Upper Quarry Pit. Mr. Voss said that the Pit Pond does not discharge offsite and that the water retained infiltrates or evaporates. Staff did not observe a discharge outlet. The Upper Quarry Floor had been regraded to direct additional flow to this pond, decreasing the areas draining to Outfall Nos. 1 and 5.

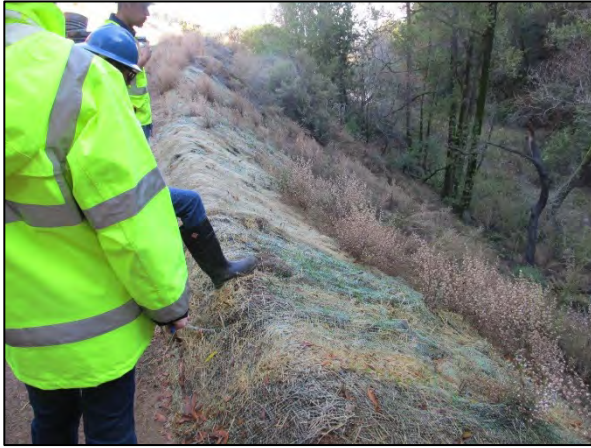
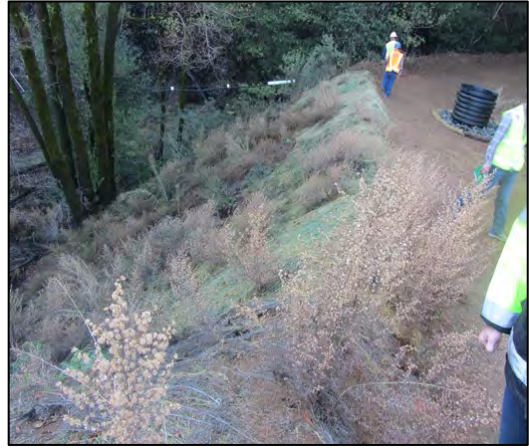
Notes: Photographs 9 and 10 show coconut jute netting and vegetation growth on the hill slope. The slope appeared to be stable.

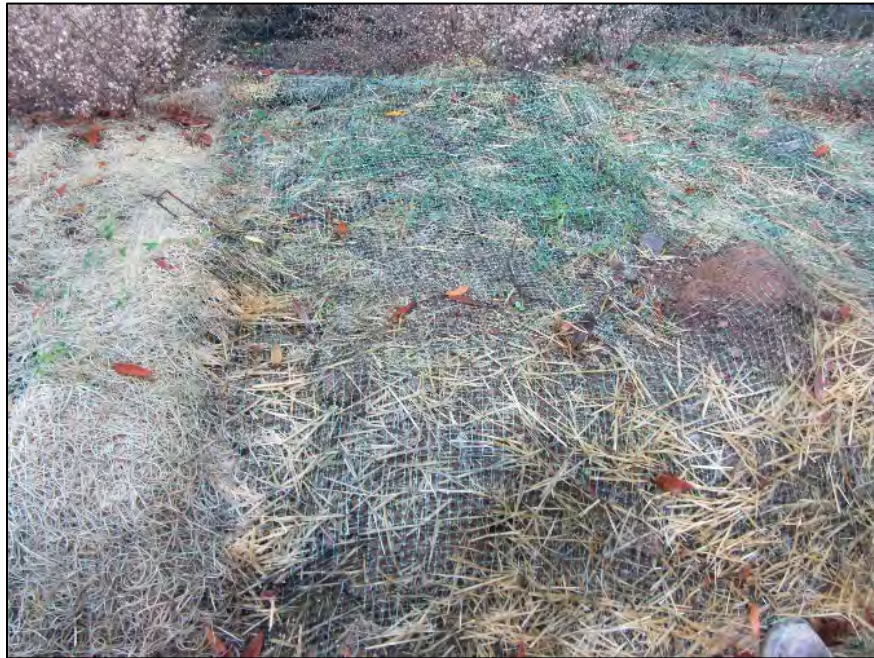
Photograph 11

Notes: Closeup of coconut jute netting shown in Photographs 9 and 10.

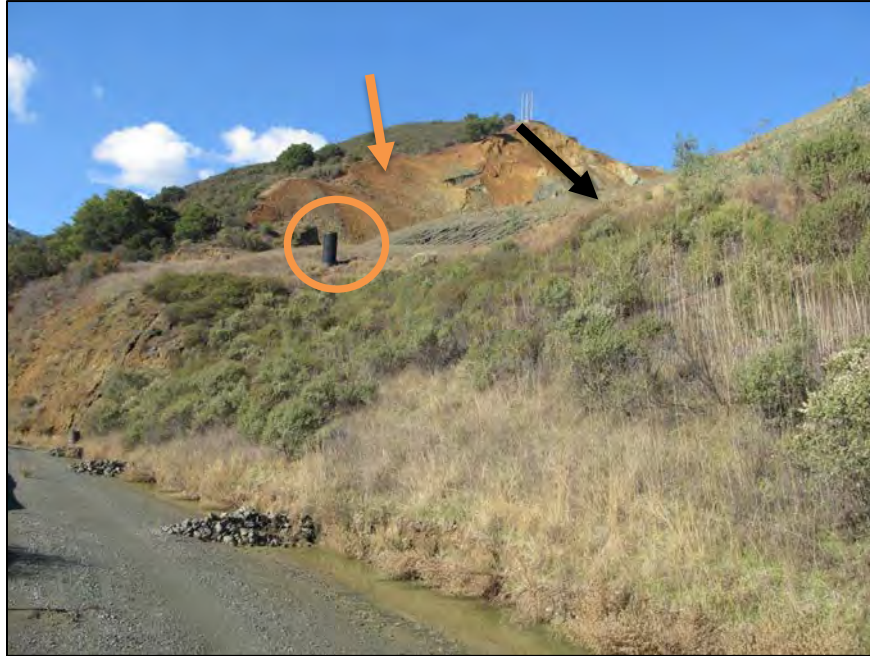
Photograph 12

Notes: The dirt road (lower left) is between the south side of the Upper Quarry area (above the road) and the former Sediment Pond No. 1 in Rattlesnake Creek (below the road and out of the photo). We observed that the road did not have rills or gullies and that the sediment check dams were well-maintained. The black storm drain inlet pipe (orange circle) is in the general area where stormwater and mud discharged down the slope, across the road and into Rattlesnake Creek in late 2017. The slope previously above the black pipe (orange arrow) was mined and regraded so that runoff above the pipe drains towards Sediment Pond No. 5 behind the foreground hill (black arrow).

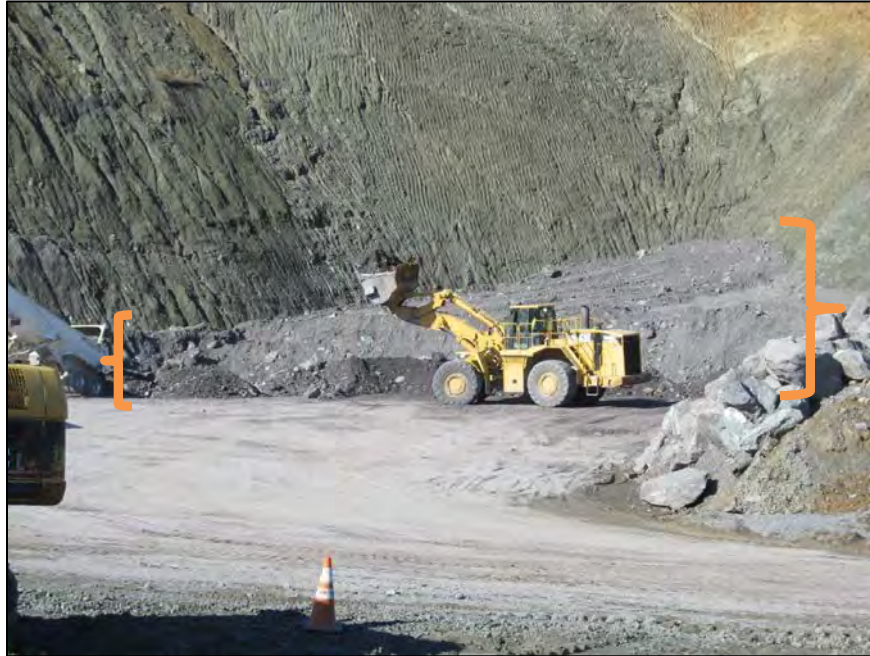
Photograph 13

We observed aggregate material piled against a quarry wall in the Upper Quarry areas (Photograph 13) that was pink-gray in color (distinct from the adjacent quarry wall) and that appeared to be one type of aggregate material, not a mixture of different rock types. Mr. Voss said that it was greenstone overburden recently mined at Lehigh Permanente Quarry and transported to Stevens Creek Quarry for processing and sale. He said that runoff from the area containing this material drains to Sediment Pond No. 5. He also said that the rock and sand processing area drains to Sediment Pond No. 5.

Notes: Aggregate material piled against the quarry wall (between orange brackets) was pink-gray in color (distinct from the quarry wall) and appeared to be one type of aggregate material, not a mixture of different rock types. Mr. Voss said that it was greenstone overburden transported from Lehigh Permanente Quarry to Stevens Creek Quarry for processing and sale. The loader was taking the material to the rock or sand plant for processing.
