Cupertino City Hall

Essential Services Facility Analysis

Final Report, Revision 1
March 27, 2012

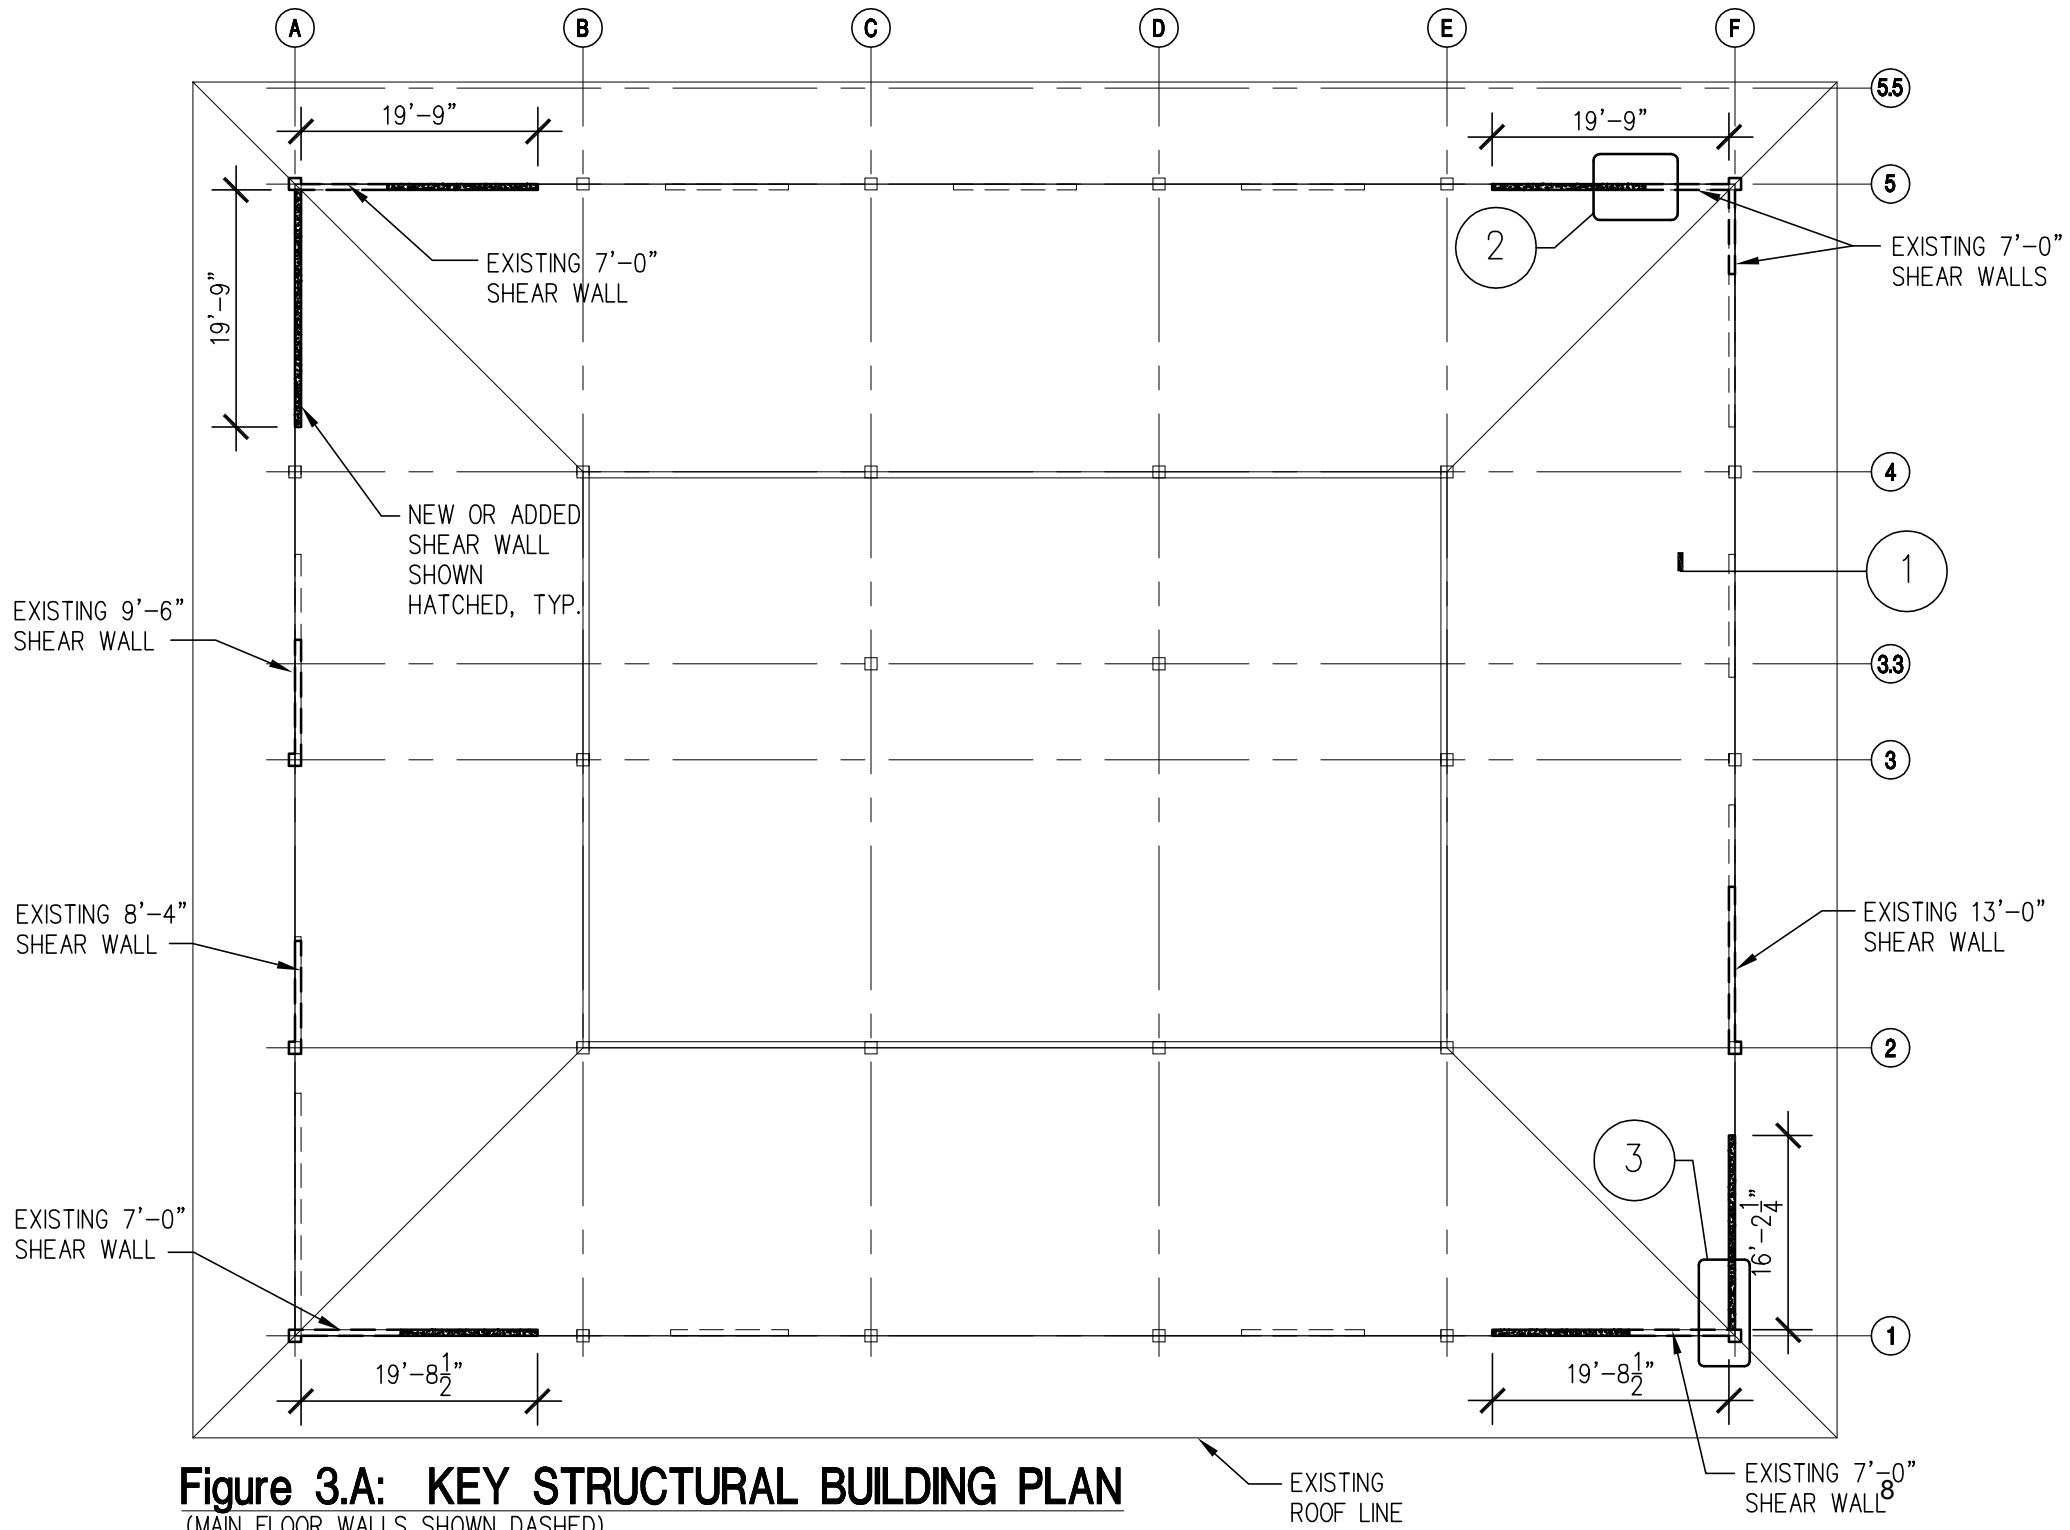
Figure 3.A: KEY STRUCTURAL BUILDING PLAN
 (MAIN FLOOR WALLS SHOWN DASHED)

only minimal redundancy. Overall, the smaller number and length of walls result in a structural configuration that has historically performed less than optimally in resisting lateral, seismic forces in moderate and major earthquakes. Therefore we recommend that additional shear walls be added on each side of the structure. The included key plan of the building indicates where concrete walls can be added to the building, utilizing portions of existing solid exterior wall. These proposed locations would affect the building's current aesthetics and function to only a limited degree, if at all. See Fig. 3.A.

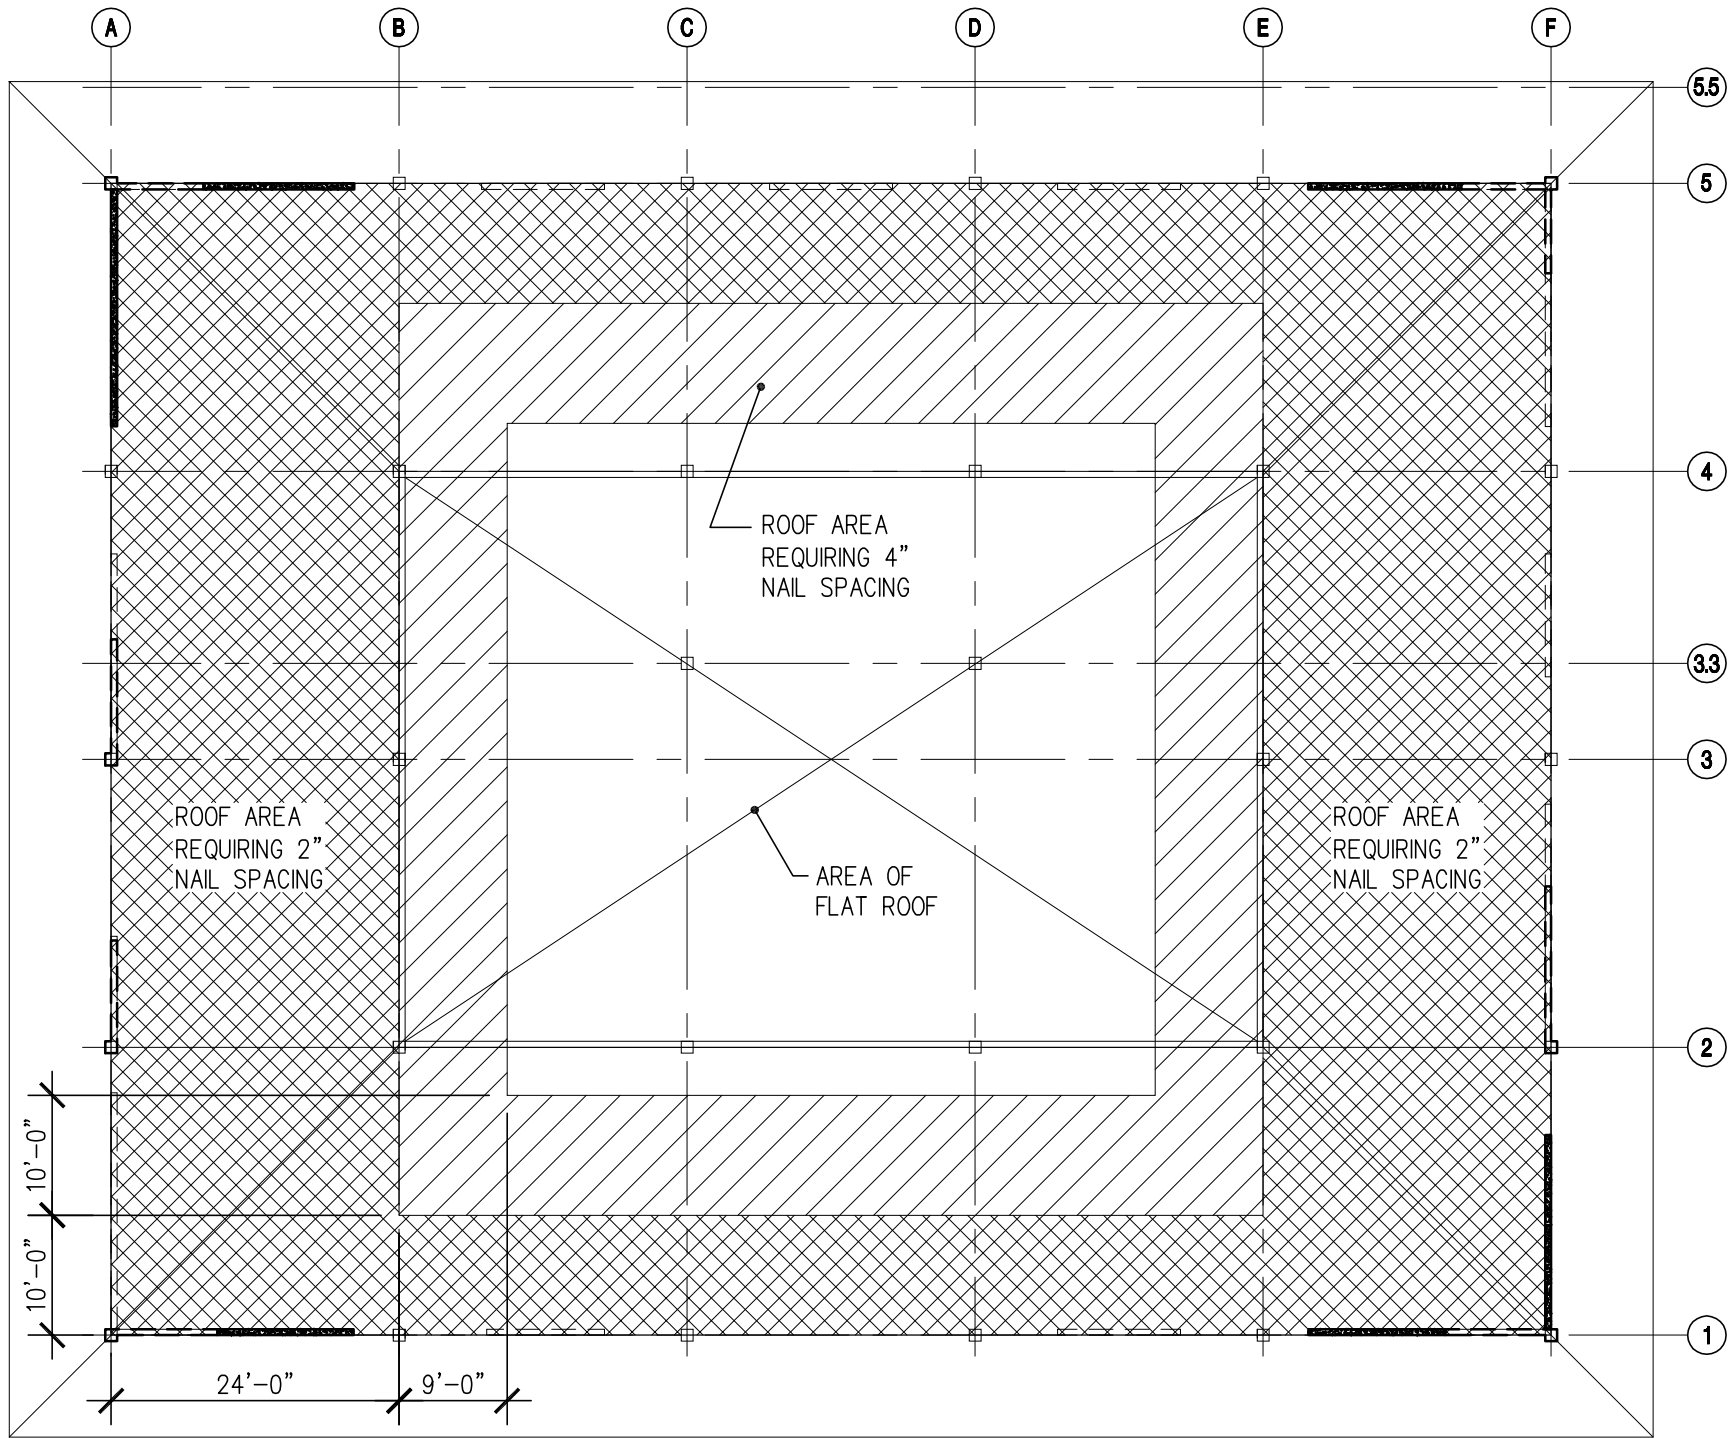
Figure 3.B: KEY ROOF PLAN
 (MAIN FLOOR WALLS SHOWN DASHED)

The existing roof diaphragm is comprised of plywood sheathing with specific nailing along its panel edges to common framing members. Its shear capacity is affected by the type and thickness of plywood used, and the size and spacing of nailing used. The existing roof diaphragm shear capacity is exceeded even if the existing roof tile were to be removed and replaced with a lighter roofing material. The roof diaphragm forces would be reduced significantly with the replacement of the heavy clay roof tiles, although the calculated diaphragm shears would still exceed the diaphragm near the building's perimeter, which is where the diaphragm shear forces are highest. The plywood diaphragm can be strengthened as needed with added panel edge nailing near the perimeter of the building. This added nailing would be installed while the roofing is being replaced. See Figures 3.B and 3.G.

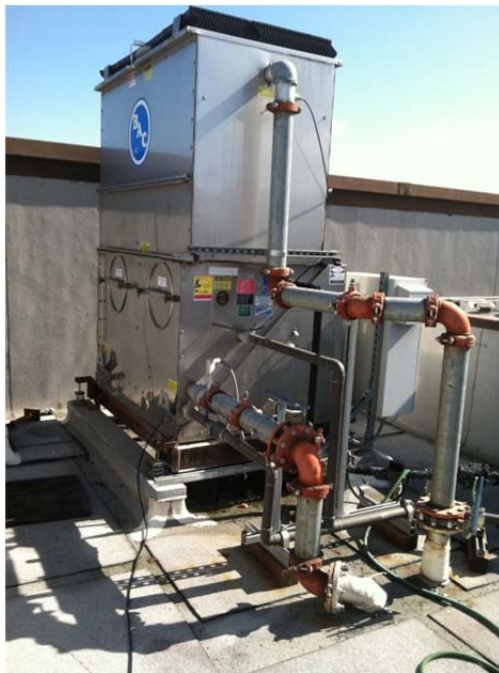
Figure 5A (Closed-Circuit 70 Ton Cooling Tower)

The HVAC system for the Cupertino City Hall consists of a water-cooled chiller plant (70 Ton) with the cooling tower located on the roof and the chiller located on the lower level. A gas fired non-condensing boiler generates heating hot water. The boiler is from the 1965 original building construction and is well past its life time. Both of these systems provide chilled and heating hot water to the Air Handling Units (AHU’s) located at the lower level that heat and cool the building through a VAV reheat design. All equipment was installed in ~1986 and is now 26 years old and at the end of its useful life. While the equipment appears to be well maintained, and the AHU’s have been retrofitted with VFD’s, the building operates inefficiently at a rate of \$3.63/SF-Year and 106 kBTU/SF-Year (based on 2009 utility bills). A modern, energy efficient office building operates at \$1.50/SF-Year and 50 kBTU/SF-Year.

Alt #2 Min Seismic Upgrade: Upgrade all duct, pipe, and equipment anchorage and seismic attachments to building structure. Replace duct and pipe connections with flexible joints where required.

Alt #3 Moderate Upgrade: Replace existing HVAC equipment with smaller, more efficient, better comfort equipment design.

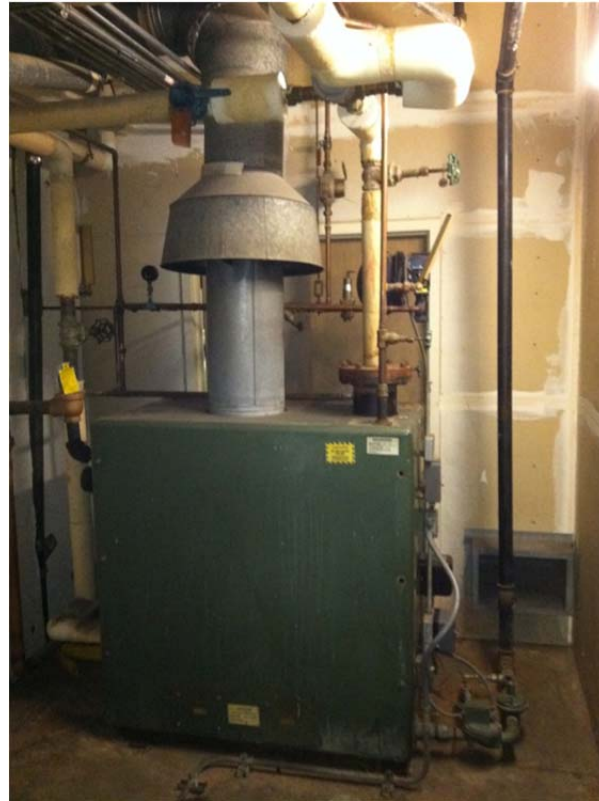
Figure 5C (Gas Fired Boiler)

In the lower level mechanical room, maintenance clearances and an exit pathway may not exist throughout the space. In addition, the combination of chiller, gas boiler, electrical gear, and generator equipment do not meet today's code

requirement to have separate rooms for each of these pieces of equipment. The room is also not equipped with a refrigerant detection and exhaust systems currently required for chiller rooms, and the combustion air ducts in the boiler room need to be routed to an outdoor location.

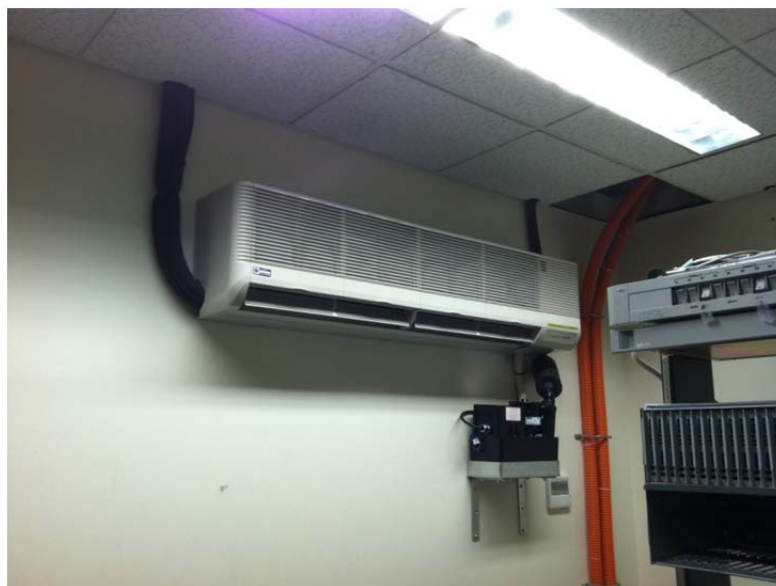
Figure 5D (Server room AC unit (1 of 2))

The Cupertino City Hall has a small server room that is cooled by split system AC units, with air-cooled condensers located on the roof. The AC units for the server room appear to have been installed more recently than the rest of the HVAC equipment.

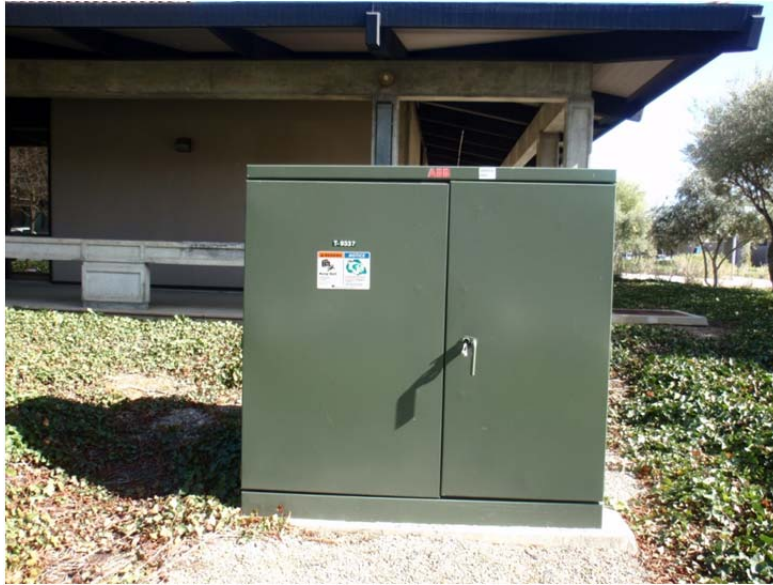
Figure 1E (PG&E Transformer)

The building is fed from a utility transformer (PG&E) located outside the building.

The transformer belongs to PG&E and was recently upgraded. It appears to be in good working condition.

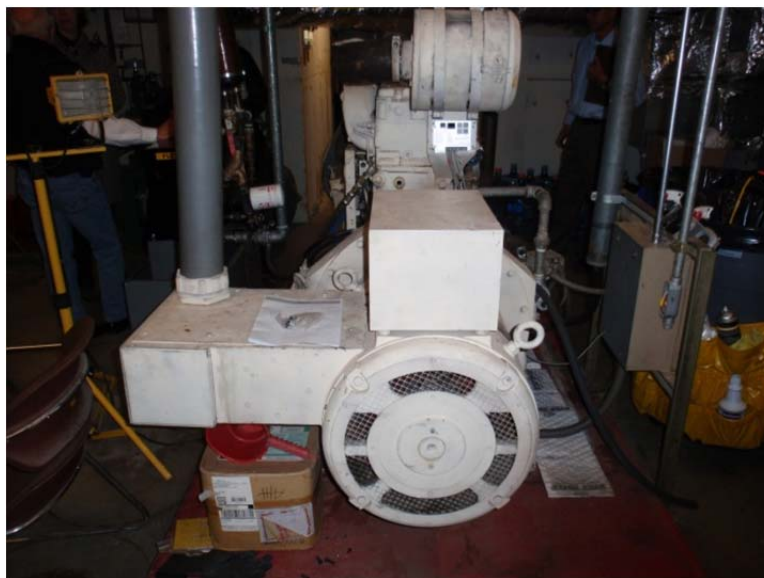
Figure 5G (Indoor Generator)

The emergency power system consists of a generator rated at 125KW, 208/120V and is located inside the main electrical room. The fuel tank, with 1000 gallon capacity, is located outside the room. In the event of a power outage, the generator provides power to the panel DP via a 400A automatic transfer switch (ATS) located in the main electrical room. The generator also provides power to the Chiller but the pump must be “jump” to move chilled water. The generator does not serve the existing elevator. or the chiller, as confirmed by discussions with facility personnel.

Alt #2 Min Seismic Upgrade: Provide adequate support suitable for the seismic and earthquake condition.

Alt #3 Upgrade: The generator should at the minimum be tested per manufacturer's recommendation to confirm its operation, and the batteries tested to confirm capacity and condition as well.

Alt #4 Replacement: The existing generator is currently loaded to its full capacity. In order to increase reliability and provide assurance of operation in the future, it is recommended that the generator be replaced with a new unit. We also recommend upsizing the generator to 175kW or above and its associated automatic transfer switch to 500A or above to provide capacity to serve additional loads such as the elevator and any future loads.
