DEPARTMENT OF PUBLIC WORKS

MEMORANDUM

SUBJECT: City Hall: Essential Facility Classification

December 9, 2005

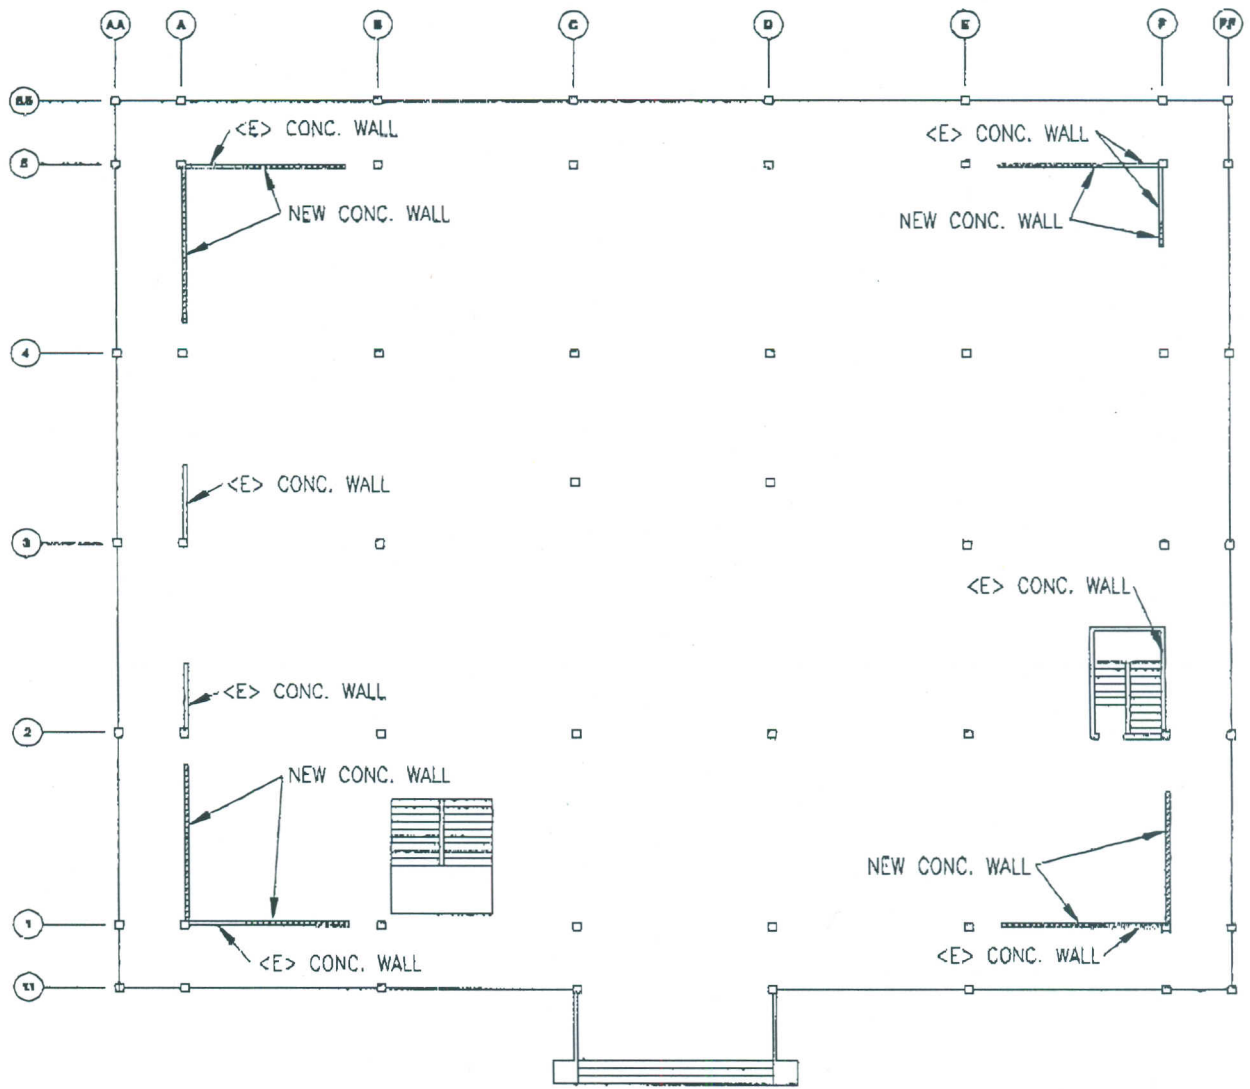
FLOOR PLAN - MAIN LEVEL

Our analysis shows that the existing structure generally has the strength to resist the required loads. The exception to this is the second level exterior concrete shear walls. These shear walls are considerably overstressed and do not meet the ductility requirements of the current Code. These shear walls would not be allowed to be constructed today. A significant amount of new concrete walls need to be added to the existing structure to bring the building into conformance with the current Code. Enclosed is a preliminary drawing indicating recommended locations of wall additions.

A rough cost estimate for the work of adding approximately 110 feet of new concrete shear wall, per the enclosed plan, is \$130,000. This represents approximately \$1,180.00 per foot of wall. This includes demolition of the existing stud walls, new concrete walls, furring the interior with gypsum board, painting, minor ceiling, floor and electrical work.
