DEFERRED MAINTENANCE AND CODE COMPLIANCE STUDY

COMPREHENSIVE FACILITY CONDITION AND USE EFFICIENCY ASSESSMENT | December 2018

CUPERTINO CITY HALL

10300 Torre Ave, Cupertino, CA

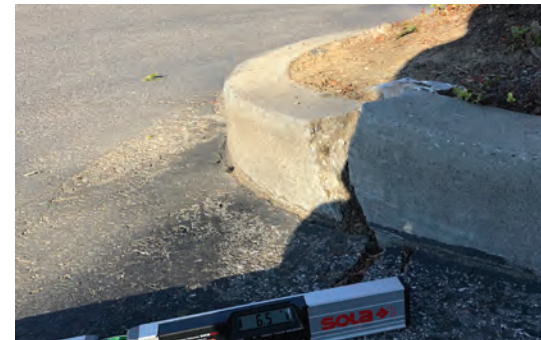
More than 7% Grade

- Grades exceeding 7% should be regraded and tree roots cleared so as to prevent more significant damage in the future.
- Sidewalk chipping should be repaired with epoxy, along with chipping on curbing throughout parking lot.
- Parking lot improvements could include an extensive ADA study to bring the site up to current code and improve building accessibility.

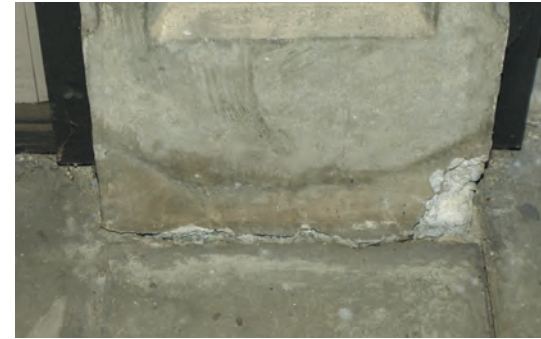
Cracking at Column Base

- Concrete column longitudinal reinforcement has been found to be inadequate in previous studies due to insufficient transverse confining tie reinforcements. The existing columns should be jacketed with Fibre-Wrap or reinforced concrete.
- The settlement on the Northwest corner of the building (and less serious settlement on all corners) can be repaired via slabjacking, commonly referred to as “mudjacking”. This process involves pumping grout underneath settled concrete to bring concrete height up to the original level. The cracking in the concrete railing surrounding the perimeter sidewalk should be repaired via epoxy injection to prevent further deterioration.

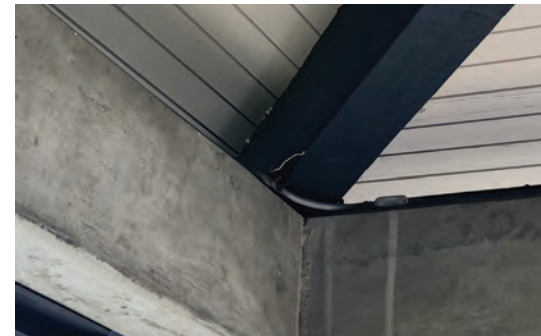
Crack in Beam

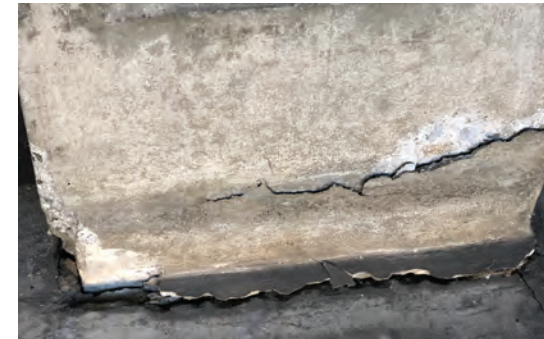
Additional Cracking at Column Base

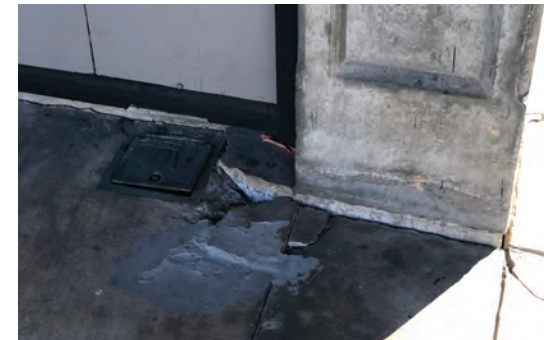
Crack in Column and Settlement

- With all of the aforementioned additional structural strengthening, additional weight will be required to be supported, and as such footings will have to be made adequate via helical piers or micropiles.
- Should an extensive remodel be the wish of City Hall, additional structural changes may be required.
- Any changes to the building structure should be recalculated to ensure seismic stability.
- Occupants of the building may be required to be relocated during structural repairs.
- Relocation costs are not included in project estimates.

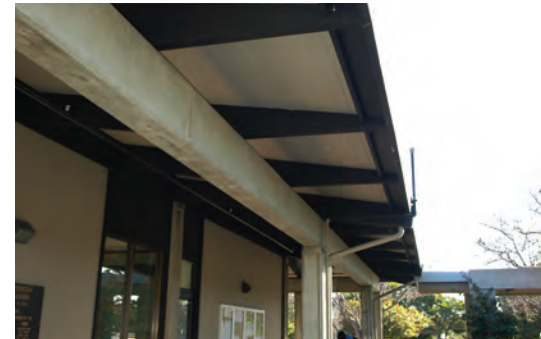
The exterior finish of City Hall is composed of 8" boards whose paint is peeling in places. Roof eaves are showing signs of deterioration and there is evidence of wasps living in soffits under the eaves. The clay tile roof is deteriorated with some tiles missing or cracked. Aluminum storefront surrounds the building and its sealant condition is dried out at several locations. Roof parapet sealant is deteriorating around metal caps. There is pooling water under rooftop equipment that is allowing algae to grow and this pooling water is susceptible to potential seepage. Roof drains are clear, but drains themselves are deteriorating due to rust.

Typical Exterior Beam and Soffit Condition

- It is recommended that the city repaint the cracked, peeling and warped boards and replace excessively cracked or warped boards.
- Windows with bad seals should be resealed.
- It is recommended to replace windows with insulated double or triple pane glazing.
- Wasps under the eave should be professionally removed to prevent further damage or deterioration to the building.
- Drainage properties of roof should be improved, especially at equipment or roof areas with pooling water.
- Damaged clay tiles should be replaced. Alternatively clay tiles should be replaced with a lighter material tile or a different roofing system material should be installed if desired. This is due to previous structural reports having recommended replacing the clay tiles due to excessive weight. However, a proper structural reinforcement should

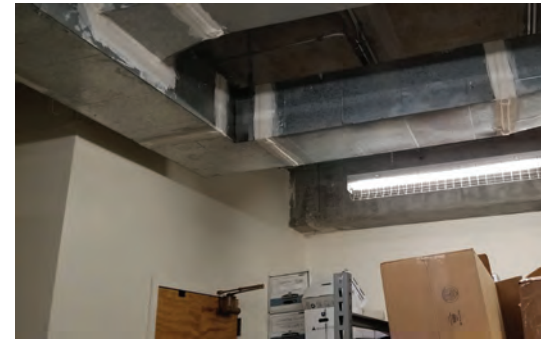
Deteriorated Ductwork

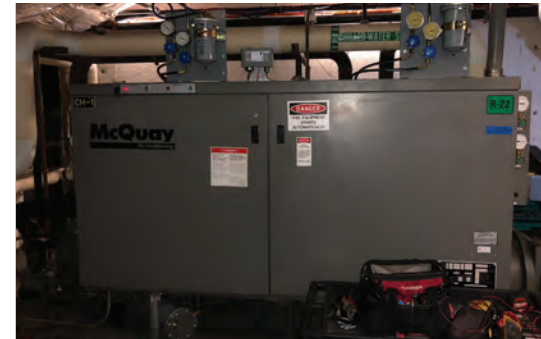
In general, City Hall's MEP systems are outdated and insufficient for building operations, modern building codes and energy efficiency standards. Most equipment is located on the basement level in a large mechanical room with smaller equipment mounted on the roof. Fire hazards exist within the haphazardly stacked and crammed systems located in this basement room. The HVAC system was most recently renovated in 1986 and its equipment is beyond its useful service life. The original boiler from the 1965 design of City Hall is still in operation and the HVAC system is fed by this boiler.

HVAC System

- Three months will be needed to replace the current pneumatic HVAC system with a newly designed digitally controlled system. A new system may require shutdowns of various sections of the building while new equipment is being installed, but likely not for more than a few days at a time.
- Removing the diesel generator and installing a new source of emergency power outside the building could take up to three months. Work would be minimally impacted during this time.
- Installing a new main electrical panel and streamlining the electrical systems throughout the building could take up to three months and would moderately impact work.

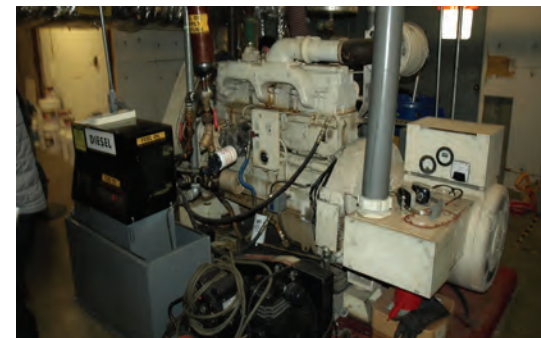
Located in the mechanical room is a diesel generator which is utilized for emergency power services. The fuel tank for the generator is located outside the building and diesel fuel is piped to the generator. Power is provided to the distribution panel via a 400 Amp automated transfer switch. This generator was installed in 1978 and is beyond its useful service life. The generator does not serve the elevator or the chiller.

Diesel Generator Inside Building

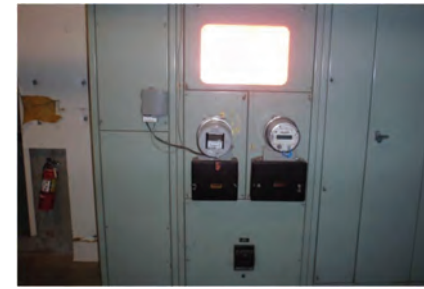
Figure 5F (Main Switchboard)

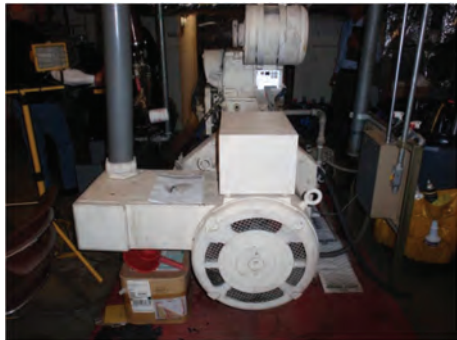
The emergency power system consists of a generator rated at 125KW, 208/120V and is located inside the main electrical room. The fuel tank, with 1000 gallon capacity, is located outside the room. In the event of a power outage, the generator provides power to the panel DP via a 400A automatic transfer switch (ATS) located in the main electrical room. The generator also provides power to the Chiller but the pump must be “jump” to move chilled water. The generator does not serve the existing elevator. or the chiller, as confirmed by discussions with facility personnel.

Figure 5G (Indoor Generator)
