City Hall Subcommittee

Meeting #2 Topic: Structural Analysis

9/01/2022

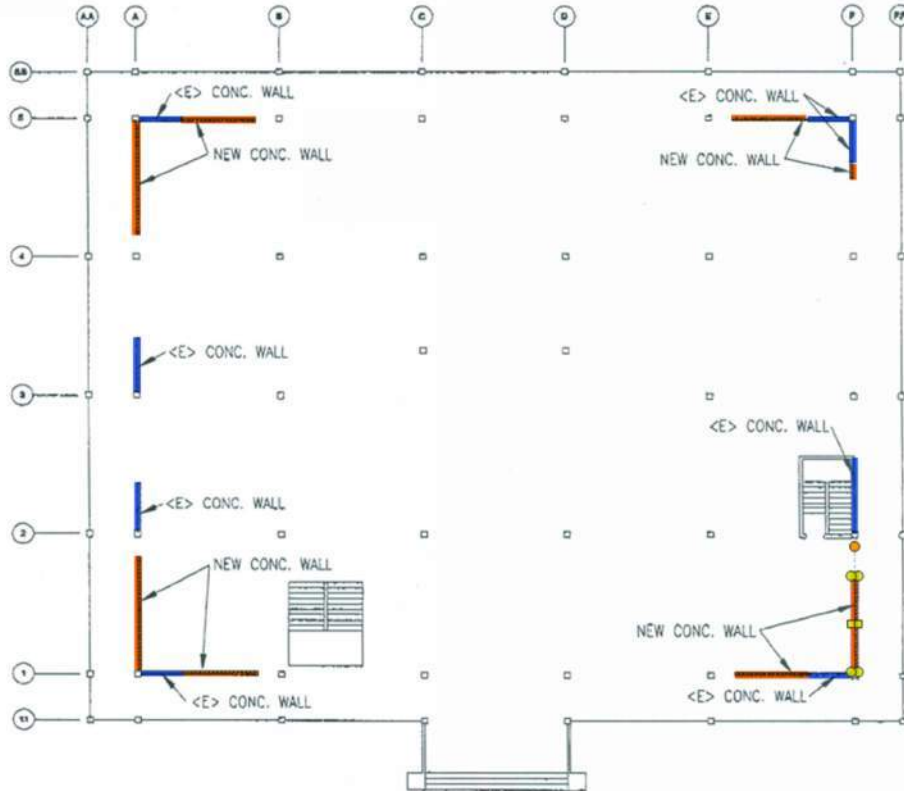
2005/06 Structural Report

2005/06 Structural Analysis determined the need for additional shear walls, reinforcement of the existing shear walls, and improvements to the roof to lessen the loading and strengthen the diaphragm.

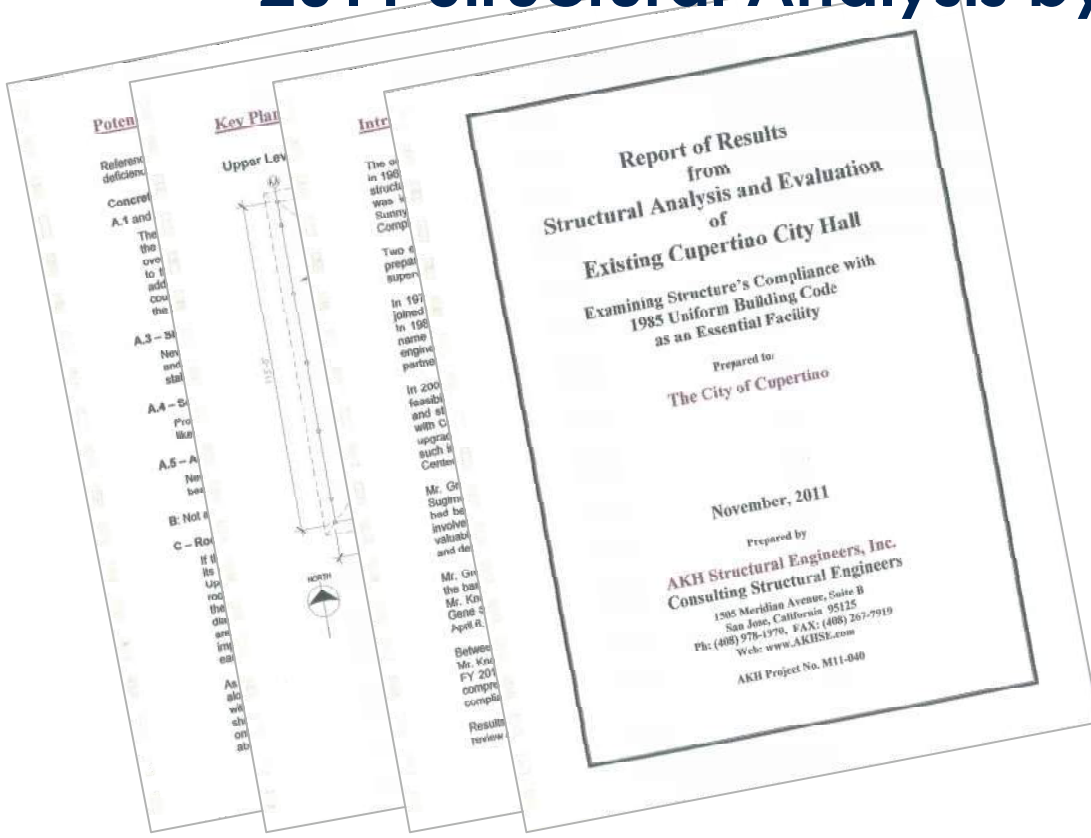
2011 Structural Analysis by AKH: Deficiencies

- The loading of the upper level was underestimated by approximately 45 – 59%
- The loading of the lower level was underestimated by approximately 24%
- Overall the building's loading was underestimated by approximately 34%
- The concrete is code compliant, but steel reinforcing and anchoring requires improvement

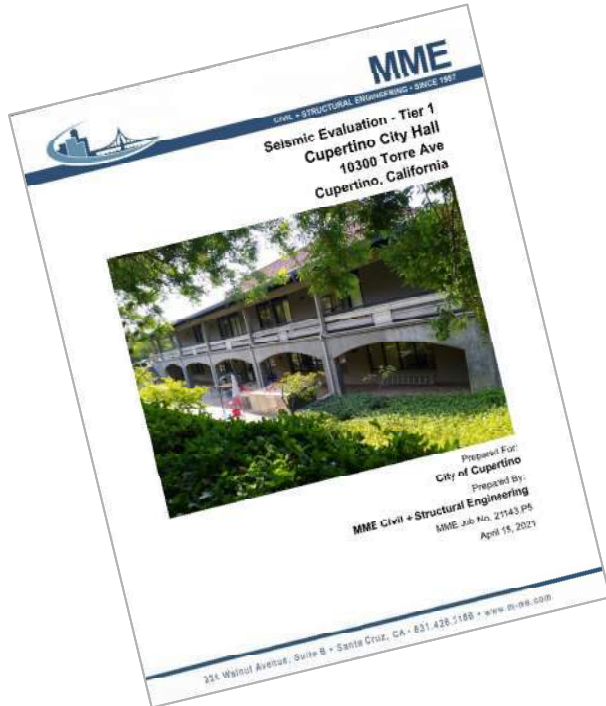
2021 Structural Analysis: Remedies

The following structural scopes require additional evaluation to confirm the requirements, but we believe this work is also required.

Seismic Remediations required for Essential Facility (IV) occupancy:

- Ground floor Wall [Horizontal] Reinforcing at Openings
- Improve Columns Reinforcement ties for Confinement
- Improve Foundation Dowels' capacity

Seismic Remediations required for both Essential Facility (IV) occupancy and Office Building (II) occupancy:

- Add Continuous Cross Ties at Upper Floor Shear Wall
- Repair Upper Floor Concrete Shear Wall adjacent to diaphragm openings
- Repair Column Splices and Girder Stirrups
