**Re: Permanente Quarry, Mine ID # 91-43-0004  
Proposed Schedule for Stipulated Order to Comply**

**To:** Erika Guerra and Tressa Jackson, Lehigh Southwest Cement Company  
**From:** Cindy Davis and Sarah Norris  
**Date:** October 12, 2018  
**Re:** Tree Removal Assessment along improved existing access Road for the Lehigh Permanente Quarry

**PERMANENTE QUARRY  
STEVENS CREEK QUARRY ROAD  
CROSS-SECTION**

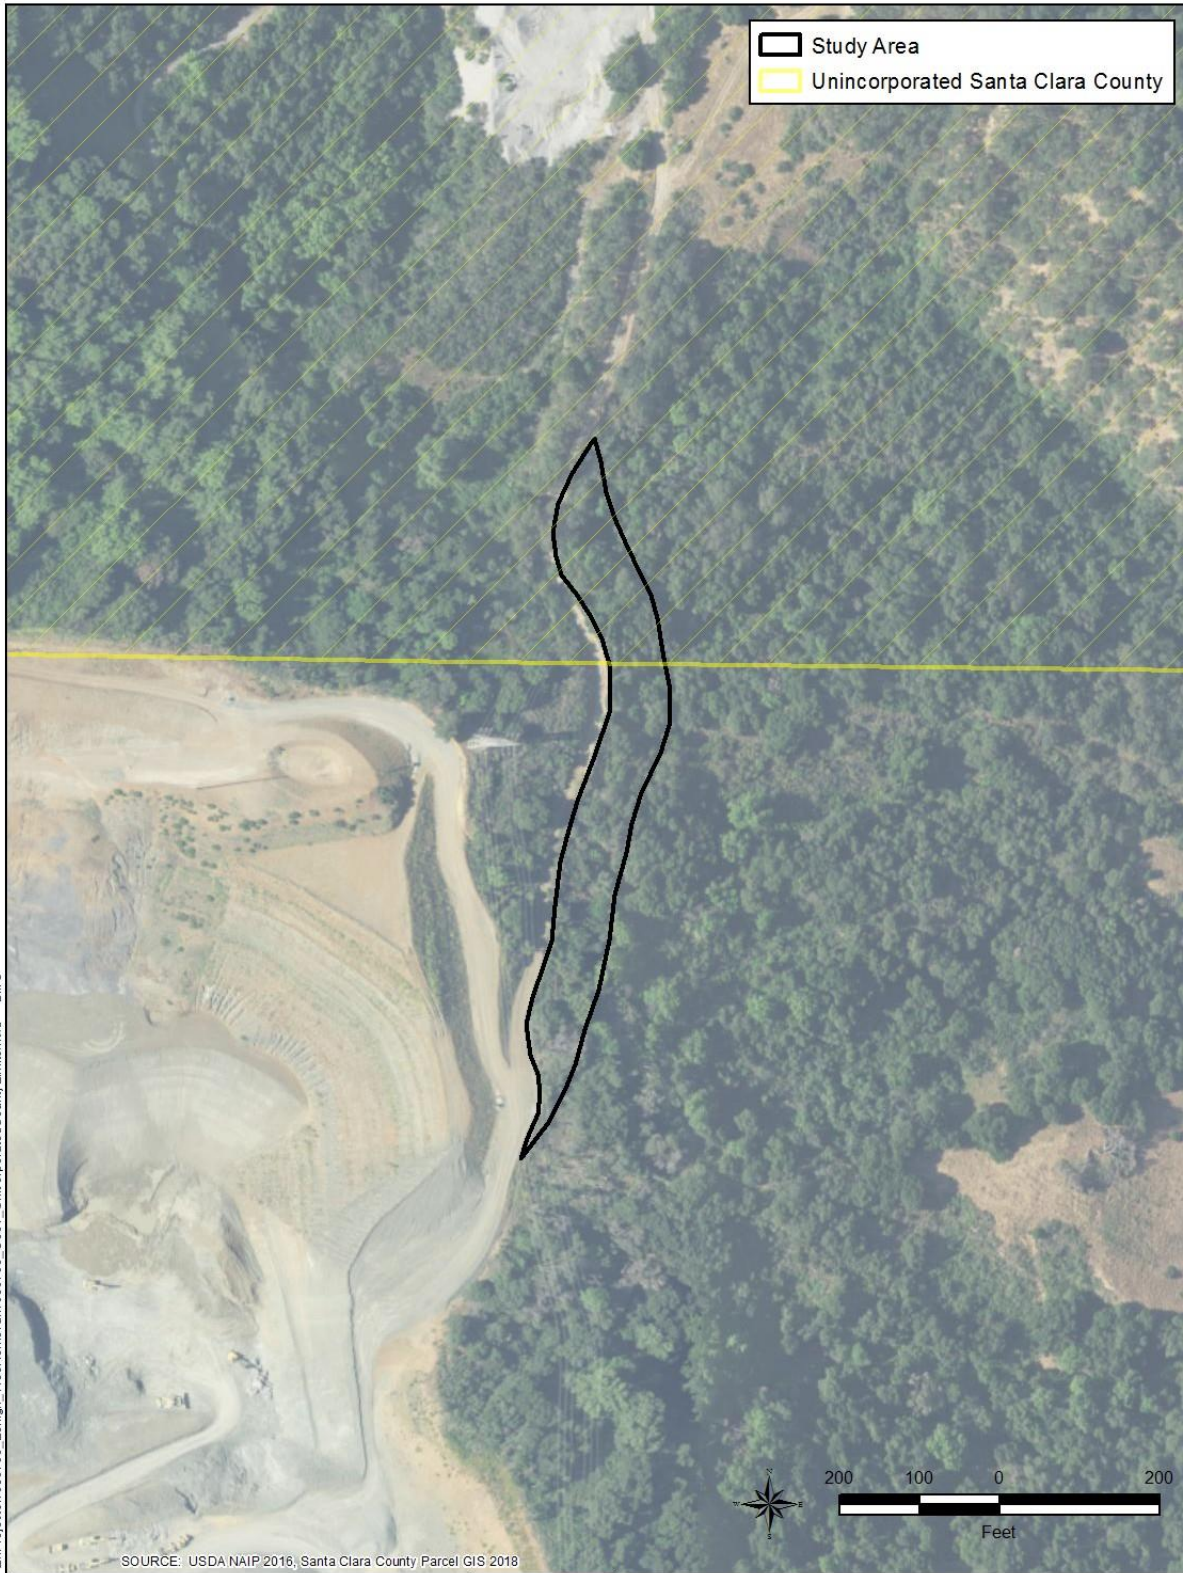
**Figure 2. Unincorporated Santa Clara County Jurisdiction**

Based on geographic information system (GIS), the disturbance associated with the new haul road occurs on lands within unincorporated Santa Clara County (APN: 351-10-033) and within the City of Cupertino (APN 351-10-017) (**Figure 2**). The length of disturbance on property within unincorporated Santa Clara County is approximately 352 linear feet, totaling approximately 0.45 acre. The length of disturbance on property within the City of Cupertino is approximately 536 linear feet, totaling approximately 0.92 acre.

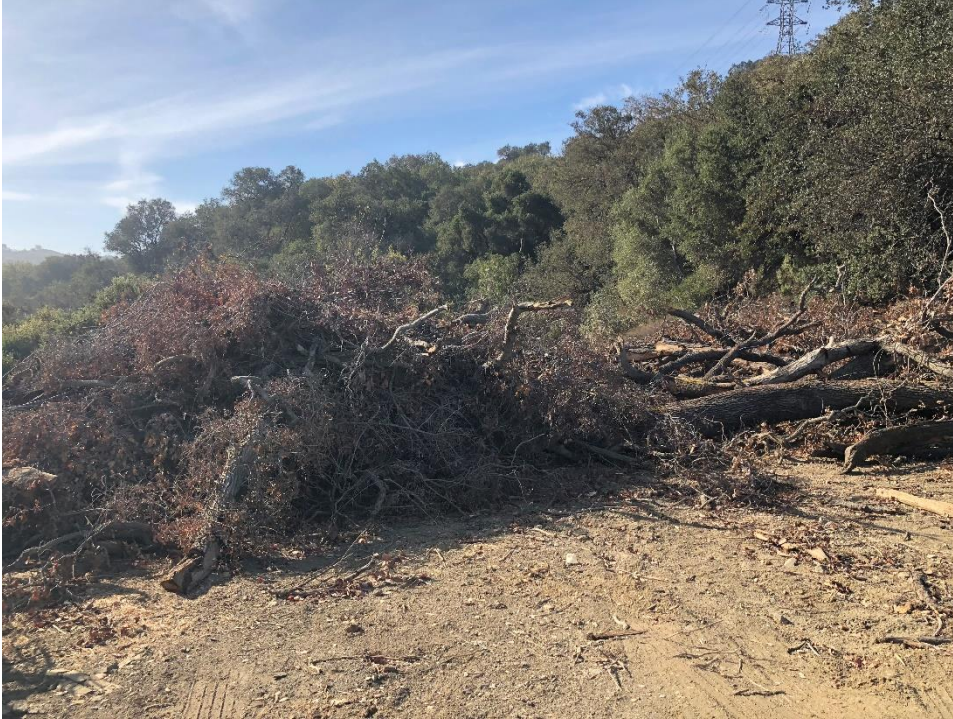
View of the primary debris pile.

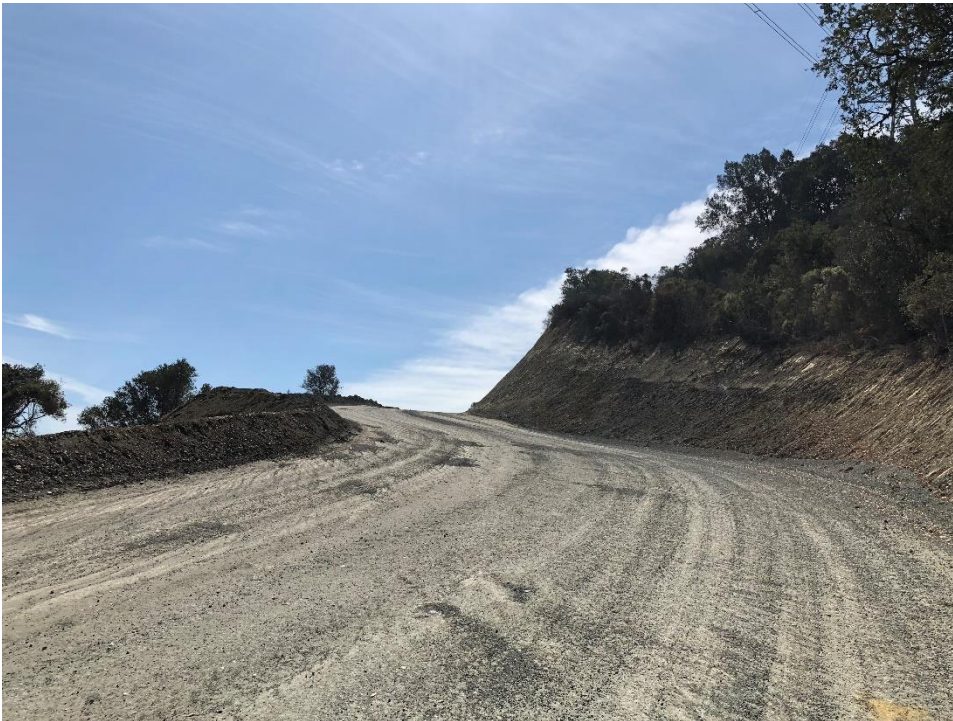
View to the north along the improved existing access road.

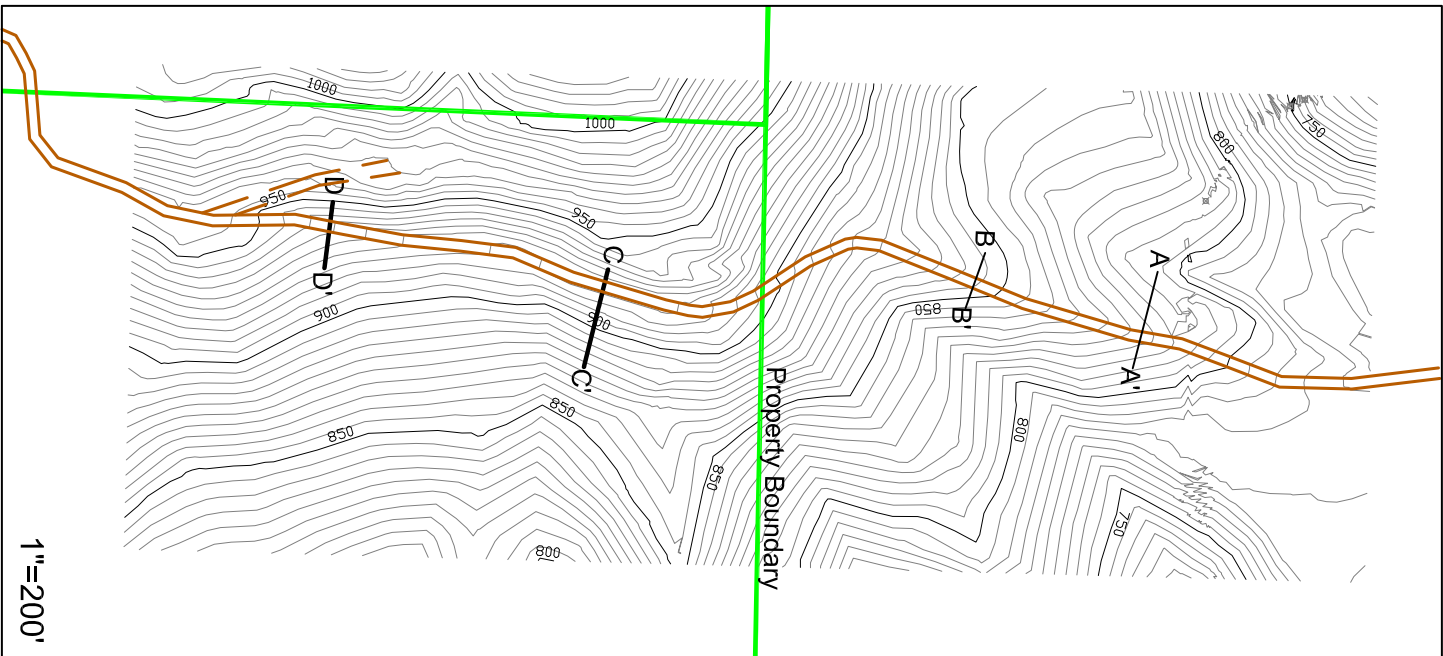
- Drawings showing the topographic changes associated with the improvements to the preexisting access road.
- A report by a certified arborist and biologist estimating the number of trees and cords of wood removed in the unincorporated area in connection with the improvements to the preexisting access road.
