**OFFICIAL NOTICE OF INSPECTION**

| Facility Name:<br><b>Goodyear Tire &amp; Rubber Co.</b> | Inspection Date:<br><b>8/28/8</b> |
| Site Address:<br><b>10934 N. De Anza Blvd. Cupertino</b> | Employee No.:<br><b>4656</b> |

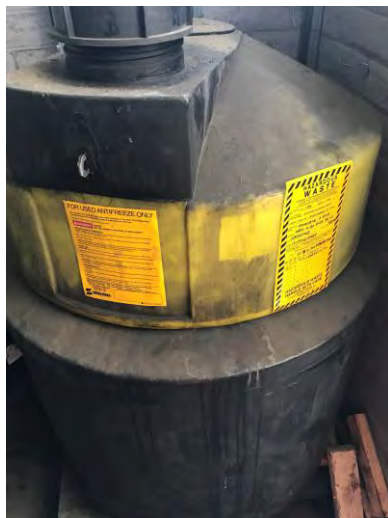
| VC | Class | Violation | Corrective Actions Taken |
|---|---|--|---|
| G020 | M | <p><b>MARKING OF HAZARDOUS WASTE [3030007]</b><br/> Facility failed to properly mark a hazardous waste tank and/or container.</p> <p><b>The following containers were missing complete hazardous waste markings:</b></p> <p><b>3 x 15 gallon used oil rollers</b><br/> <b>1 x 120 gallon container of waste coolant</b></p> <p>Mark all hazardous waste tanks with the words "HAZARDOUS WASTE" and the accumulation start date. Mark all hazardous waste containers and portable tanks with the words "HAZARDOUS WASTE," the accumulation start date; the name and address of the generator; and the composition, physical state, and hazardous properties of the waste. Additionally, mark used oil containers, aboveground tanks, and fill pipes for underground tanks with the words "USED OIL." [CCR 66262.34(f), 66279.21(b)]</p> | |

We were not sure what was meant by 3x15 used oil rollers.  
Here is a photo of the waste coolant label.

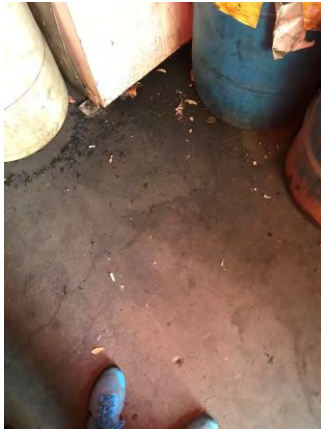
| VC | Class | Violation | Corrective Actions Taken |
|---|---|---|---|
| G110 | M | <p><b>MAINTENANCE AND OPERATION OF FACILITY [3030030]</b></p> <p>Facility is not maintained or operated in a manner to minimize the possibility of a fire, explosion, or any unplanned release of hazardous waste to air, soil, or surface water that could threaten human health or the environment.</p> <p><b><i>Observed saturated absorbent on the floor surrounding the secondary containment and free flowing amounts of used oil in the secondary containment areas. Per facility, the absorbent has been accumulating there "for years" Ensure that secondary containment and surrounding areas are clean and free of saturated absorbent and free flowing liquids to minimize the event of an unplanned release into the environment.</i></b></p> <p>Maintain and operate the facility in a manner that minimizes potential emergencies and unplanned releases. [CCR 66265.31, CFR 265.31]</p> | |

Floor around secondary containment has been cleaned. Saturated pads and clean up items shipped to Safety Kleen on 9/26. Manifest B Brake Fluid Absorbents is attached.

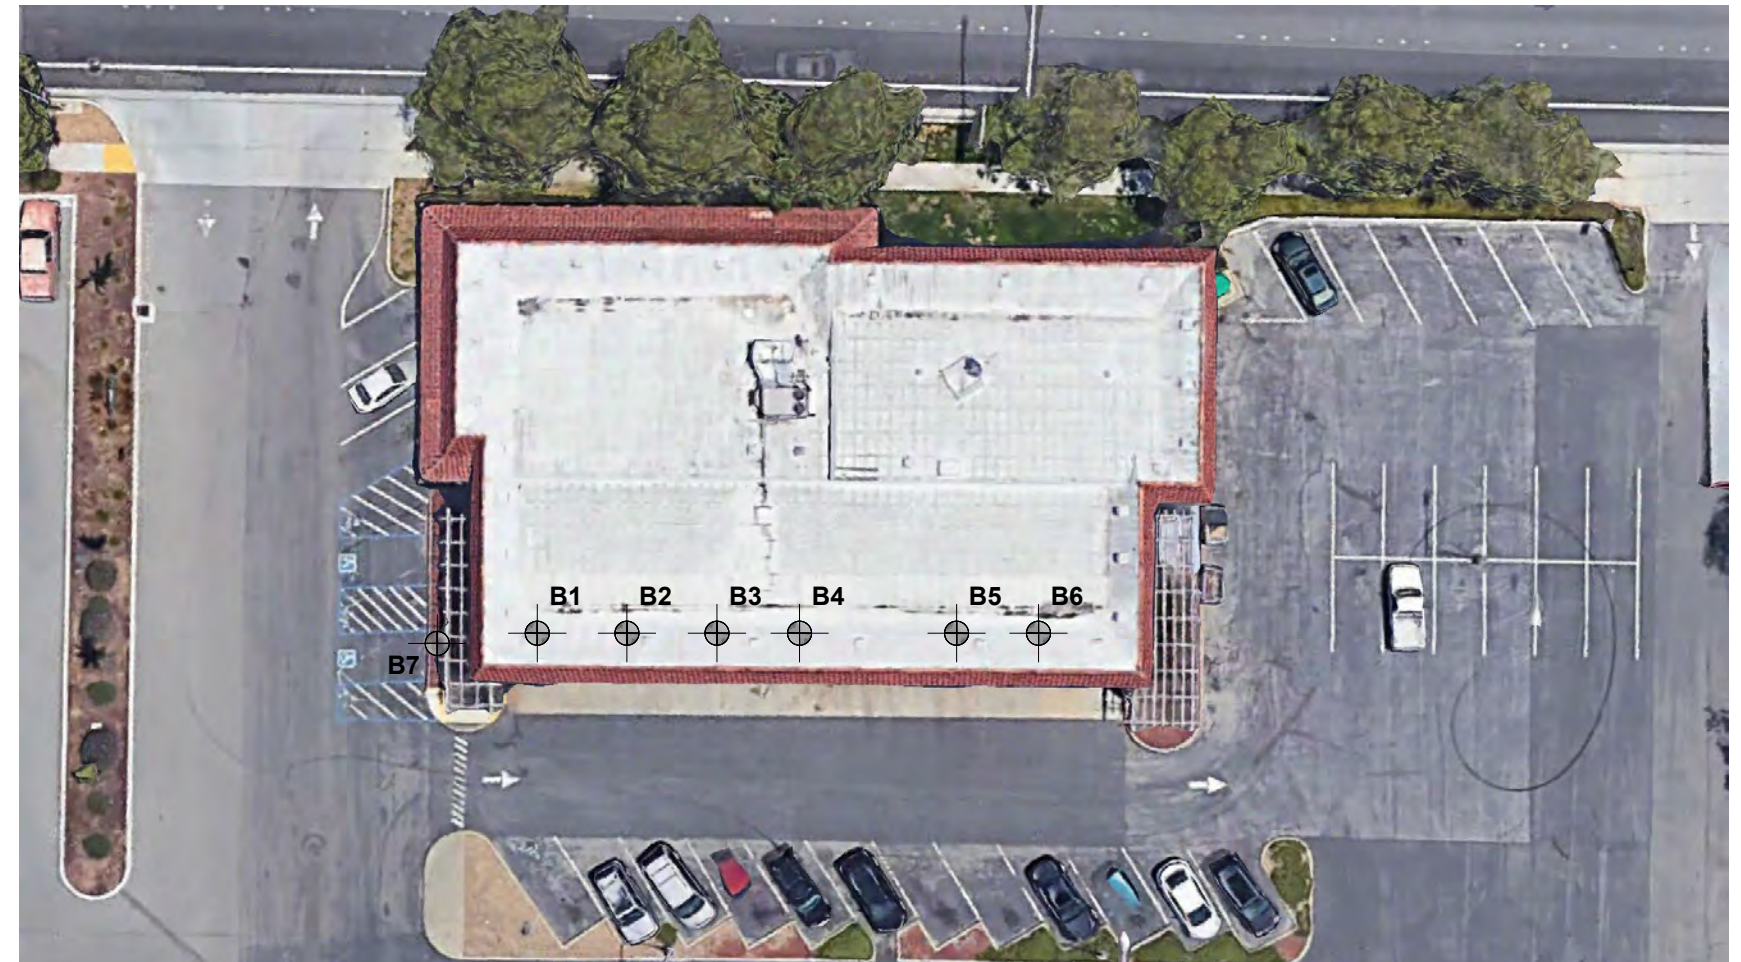
B-1 APPROXIMATE LOCATION OF SOIL BORINGS BY APPLIED REMEDIAL TECHNOLOGIES, INC. (DRILLED 10/10/18)

BASE MAP FROM GOOGLE MAPS 2018 (NOT TO SCALE)  
NOTE: BORING & WELL LOCATIONS ARE APPROXIMATE

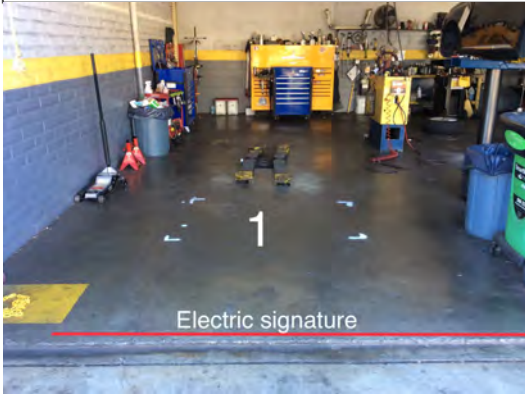
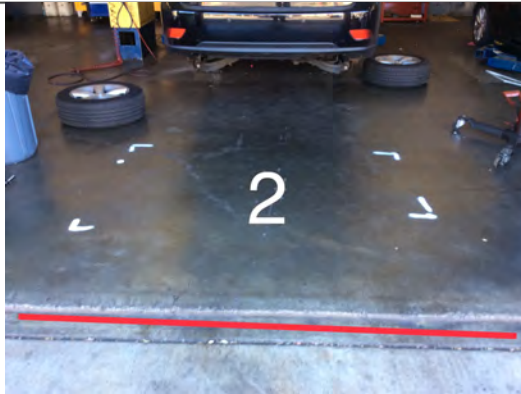
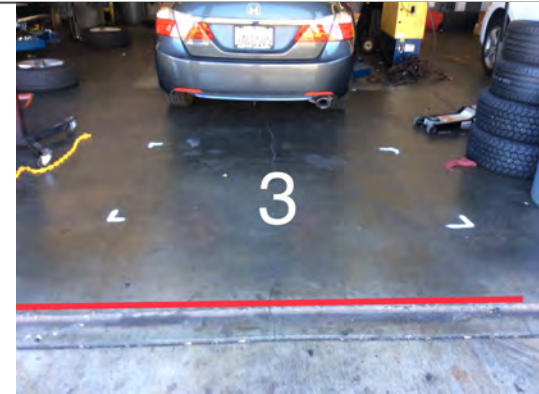
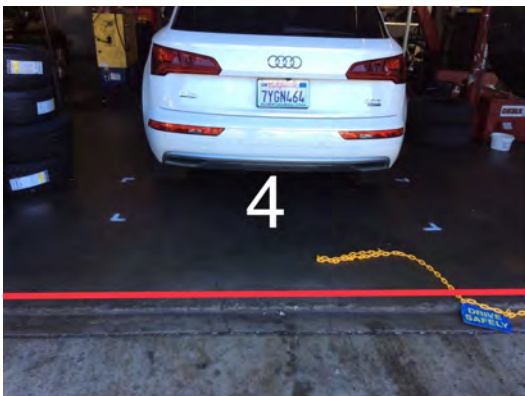
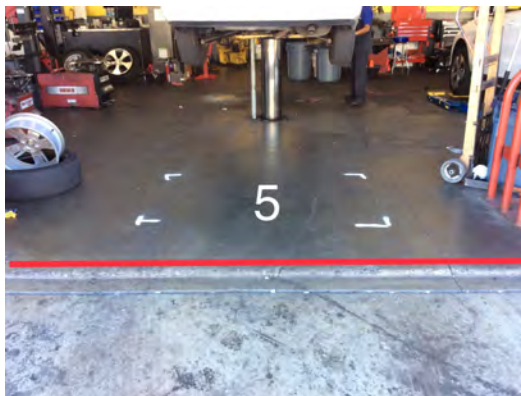
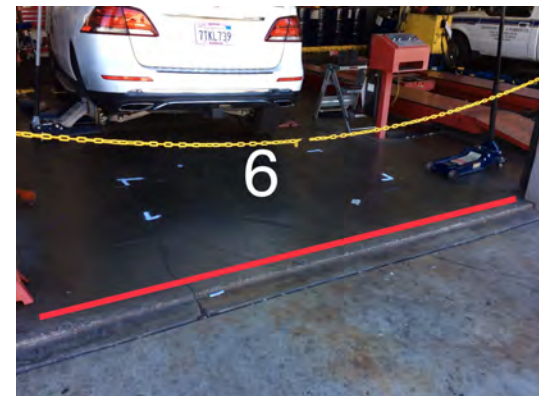
Service Agreement Page 2 Additional Notes, Findings, Pictures

Along entrance to each garage port there was an electrical utility detected, but was outside of white boxed boundary, so no markings were made. Area inside white boxes are clear. Vehicles inside working garage ports prevented full complete GPR cart scans to be conducted. 4 bore locations outside were marked by Apri with white dots near main entrance side of building. Electrical line was marked with red paint near one location (see photos). Passive power and radio scans were conducted on outside locations and no new signatures detected other than one marked out in red paint. GPR cart scans were conducted on outside white dot locations and no anomalies/possible utilities were located other than marked red electrical line. Apri was unable to view final findings.
