2.0 Assignment & Background

Walter Levison, Consulting Arborist (WLCA) was initially retained in 2015 to tag and assess 895 trees throughout the existing site that extends from perimeter road west to perimeter road east, and from freeway 280 to Stevens Creek Boulevard, Cupertino, California, including median trees along North Wolfe adjacent to the project site. The east boundary of the survey area was a property owned by Apple Inc. The west boundary of the survey area was a developed single family residential area. Tags in this area are tagged #1 through #875 (round-shaped tags), with median trees tagged as #1,106 through #1,125 (racetrack-shaped tags) along N. Wolfe Road.

WLCA was later retained in September 2015 to prepare a formal written arborist report that was to include the following items:

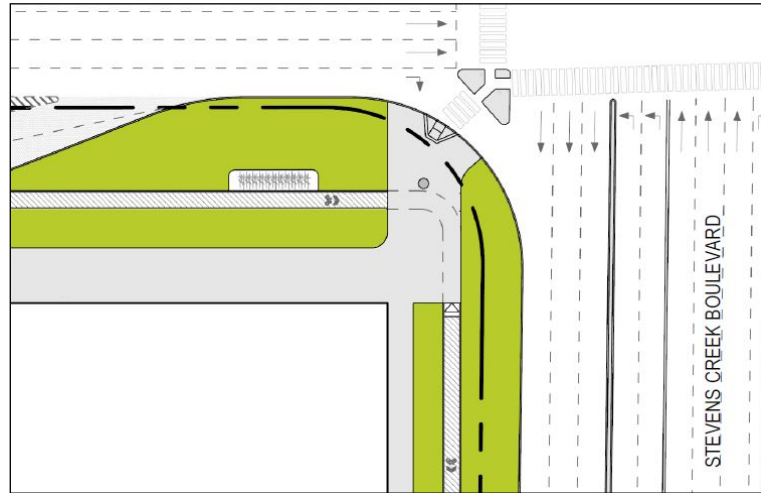
Demolition of existing curbs, planting areas, asphalt parking stall surface materials, etc. to make way for new landscaping may cause significant or severe damage to the below ground portions of trees being retained such as shamel ash at the southwest end of the site along the south boundary of the former Sears parking lot (see sample blowup at right, showing proposed planting plan, street level, sheet P-0605).

WLCA’s main concern in areas such as this involves demolition crew activities during removal of surface hardscape and deep curbs, which may be comingled with existing woody tree root systems. When pulling out the curbs and hardscape piece by piece, these roots may become tangled with the machinery bucket teeth and be pulled, ripped, or otherwise destroyed or damaged in the process. Therefore, an arborist monitor is suggested during demolition of any material within approximately 20 feet of a tree to be retained. As noted above in this report, we know that woody tree roots can extend laterally as far as 3x to 5x the canopy dripline distance from the trunk edge, which means that a 20 foot radius canopy tree may theoretically have roots extending as far as 60 to 100 feet radius out from trunk, even under asphalt, if there are no physical impediments to growth extension such as deep curbs or deep foundation footings.

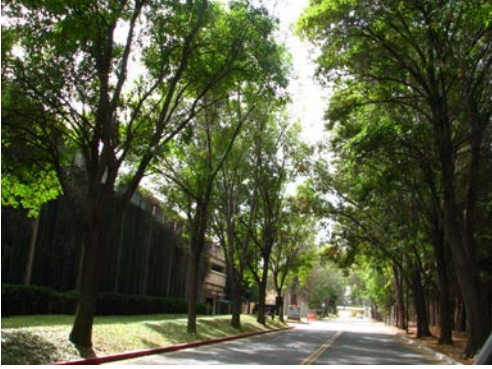
<p>Redwood specimens along the west side of west perimeter road are suffering severely from soil moisture deficit, and are generally declining or dying</p>

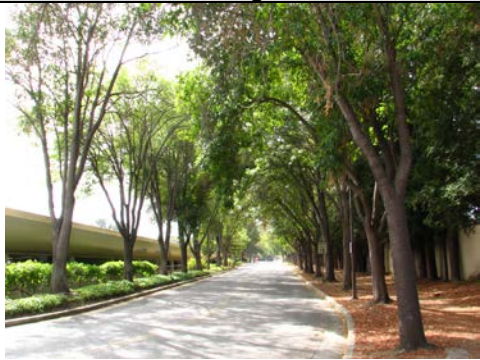
<p>The dense screen along the west side of west perimeter road as shown here near tree 771 is in danger of dying due to soil moisture deficit. Replacement of these high water use trees with drought tolerant evergreen species is a viable option.</p>

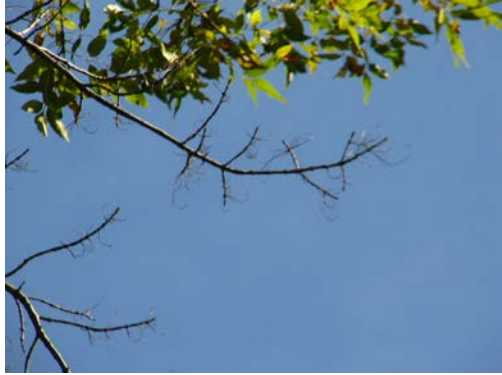
<p>Fruits are borne as long clusters of “keys” or “samaras” on evergreen ash specimens, extending a great distance along a stem, making it relatively difficult to determine from the ground whether bare stems are dead or are simply going through normal leaf drop and fruit drop in Fall.</p>

<p>Note the short wispy stems that remain behind on the fruit branch clusters after the evergreen ash samaras drop to the ground. These are an indication that the woody stems in this image are alive and are actually associated with a recently-dropped fruit cluster, rather than representing a dead or dying tissue region of the canopy. In some cases, there are both dead stems and bare fruit branches mingled together throughout an evergreen ash, making determination of overall condition rating very difficult during the Fall/Winter period.</p>
