Cupertino City Hall

Essential Services Facility Analysis

Final Report, Revision 1
March 27, 2012

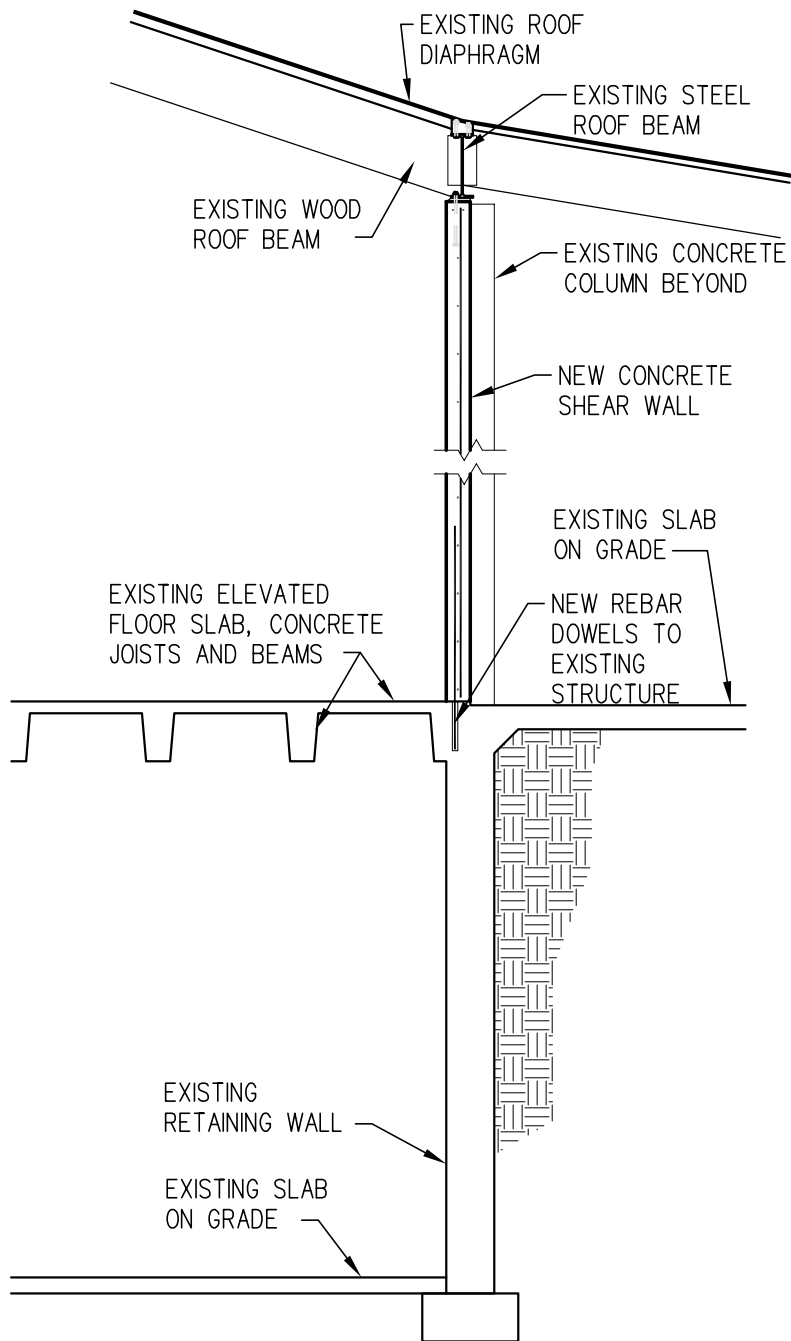
Figure 3.B: KEY ROOF PLAN
 (MAIN FLOOR WALLS SHOWN DASHED)

The existing roof diaphragm is comprised of plywood sheathing with specific nailing along its panel edges to common framing members. Its shear capacity is affected by the type and thickness of plywood used, and the size and spacing of nailing used. The existing roof diaphragm shear capacity is exceeded even if the existing roof tile were to be removed and replaced with a lighter roofing material. The roof diaphragm forces would be reduced significantly with the replacement of the heavy clay roof tiles, although the calculated diaphragm shears would still exceed the diaphragm near the building's perimeter, which is where the diaphragm shear forces are highest. The plywood diaphragm can be strengthened as needed with added panel edge nailing near the perimeter of the building. This added nailing would be installed while the roofing is being replaced. See Figures 3.B and 3.G.

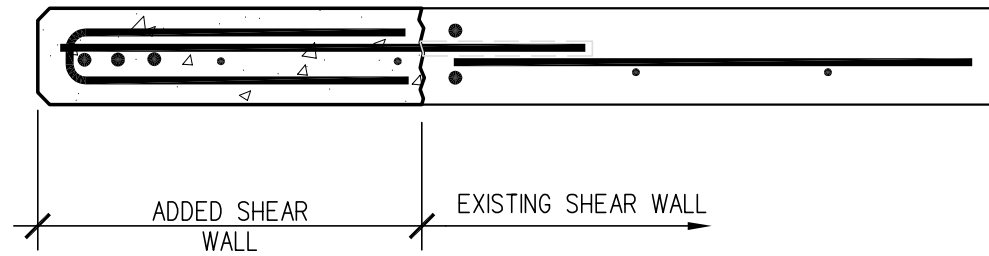
Figure 3.C: SECTION AT NEW SHEAR WALL

only minimal redundancy. Overall, the smaller number and length of walls result in a structural configuration that has historically performed less than optimally in resisting lateral, seismic forces in moderate and major earthquakes. Therefore we recommend that additional shear walls be added on each side of the structure. The included key plan of the building indicates where concrete walls can be added to the building, utilizing portions of existing solid exterior wall. These proposed locations would affect the building's current aesthetics and function to only a limited degree, if at all. See Fig. 3.A.
