DEFERRED MAINTENANCE AND CODE COMPLIANCE STUDY

COMPREHENSIVE FACILITY CONDITION AND USE EFFICIENCY ASSESSMENT | December 2018

CUPERTINO CITY HALL

10300 Torre Ave, Cupertino, CA

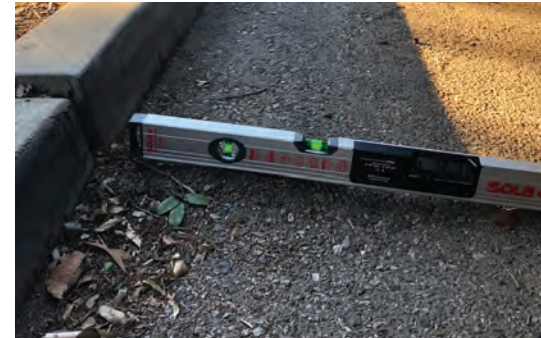
More than 7% Grade

- Grades exceeding 7% should be regraded and tree roots cleared so as to prevent more significant damage in the future.
- Sidewalk chipping should be repaired with epoxy, along with chipping on curbing throughout parking lot.
- Parking lot improvements could include an extensive ADA study to bring the site up to current code and improve building accessibility.

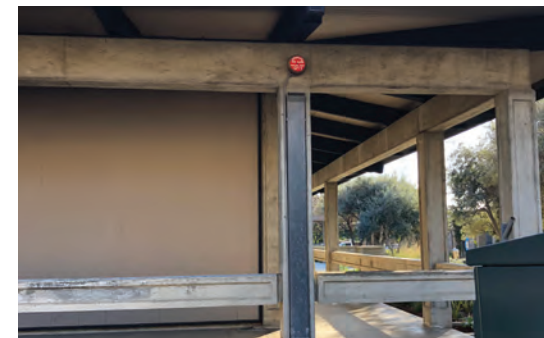
Typical Exterior Structure at Main Level

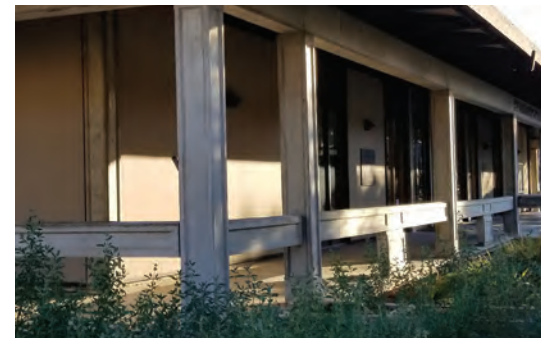
Typical Concrete Columns and Handrails at Porch Area

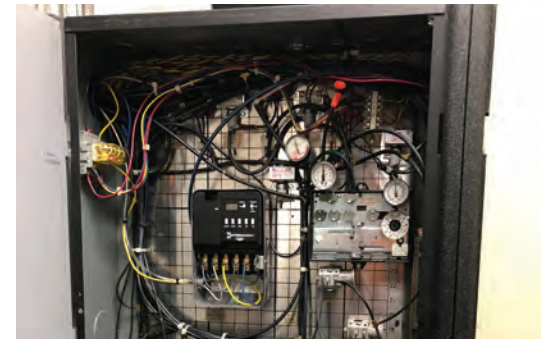
In general, City Hall's MEP systems are outdated and insufficient for building operations, modern building codes and energy efficiency standards. Most equipment is located on the basement level in a large mechanical room with smaller equipment mounted on the roof. Fire hazards exist because of haphazardly stacked and crammed systems located in this basement room. The original boiler from the 1965 design of City Hall is still in operation and the HVAC system is fed by this boiler. The HVAC system was most recently renovated in 1986 and its equipment is beyond its useful service life. The HVAC control system is a pneumatic system which requires a significant amount of maintenance.

Pneumatic Controls

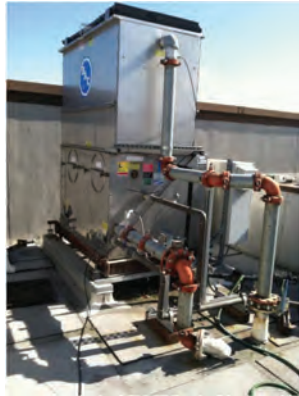
The HVAC system for the Cupertino City Hall consists of a water-cooled chiller plant (70 Ton) with the cooling tower located on the roof and the chiller located on the lower level. A gas fired non-condensing boiler generates heating hot water. The boiler is from the 1965 original building construction and is well past its life time. Both of these systems provide chilled and heating hot water to the Air Handling Units (AHU’s) located at the lower level that heat and cool the building through a VAV reheat design. All equipment was installed in ~1986 and is now 26 years old and at the end of its useful life. While the equipment appears to be well maintained, and the AHU’s have been retrofitted with VFD’s, the building operates inefficiently at a rate of \$3.63/SF-Year and 106 kBTU/SF-Year (based on 2009 utility bills). A modern, energy efficient office building operates at \$1.50/SF-Year and 50 kBTU/SF-Year.

Figure 5A (Closed-Circuit 70 Ton Cooling Tower)

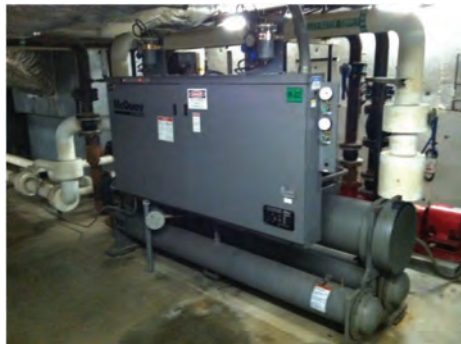
Figure 5B (Water-cooled 70 Ton Chiller)

In the lower level mechanical room, maintenance clearances and an exit pathway may not exist throughout the space. In addition, the combination of chiller, gas boiler, electrical gear, and generator equipment do not meet today's code

requirement to have separate rooms for each of these pieces of equipment. The room is also not equipped with a refrigerant detection and exhaust systems currently required for chiller rooms, and the combustion air ducts in the boiler room need to be routed to an outdoor location.

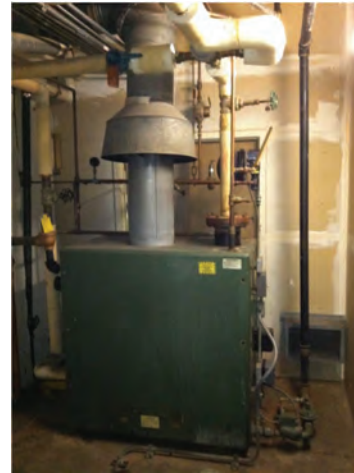
Figure 5C (Gas Fired Boiler)

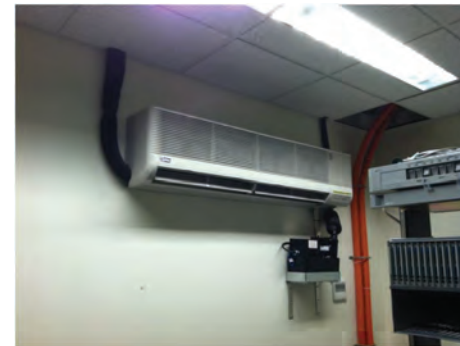
The Cupertino City Hall has a small server room that is cooled by split system AC units, with air-cooled condensers located on the roof. The AC units for the server room appear to have been installed more recently than the rest of the HVAC equipment.

Figure 5D (Server room AC unit (1 of 2))

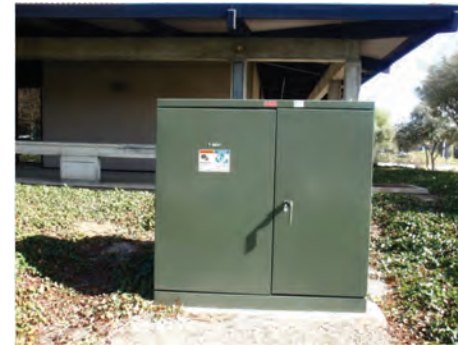
The building is fed from a utility transformer (PG&E) located outside the building.

Figure 1E (PG&E Transformer)

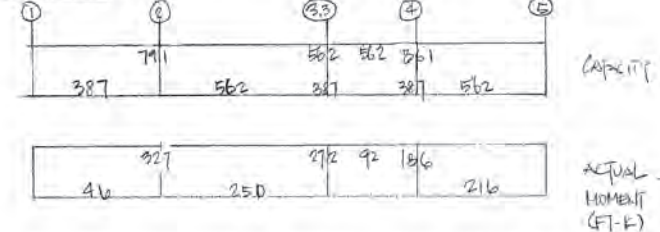
LINE C

IN COMPARING ACTUAL MOMENTS AND ALLOWABLE CAPACITIES, THE EXISTING GIRDERS ARE MORE THAN ADEQUATE.
